STAFF REPORT 7-24-2019 MEETING APPLICATION NUMBER 19-6346 ADDRESS: 3475 IROQUOIS HISTORIC DISTRICT: INDIAN VILLAGE APPLICANT: BEN CARBURY DATE OF STAFF VISIT:

PROPOSAL

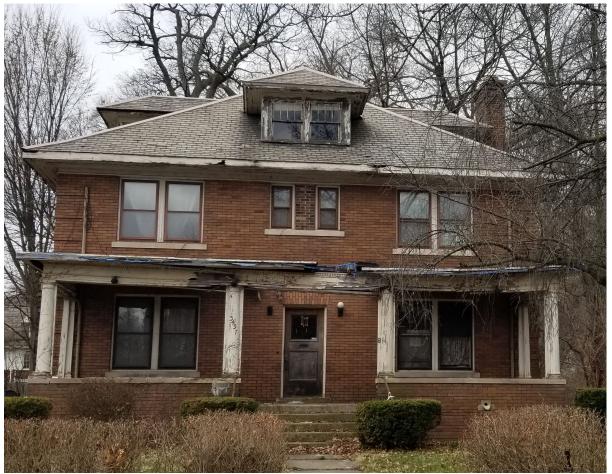
3457 Iroquois, porch prior to unapproved removal

As per the above photos, the original porch included a concrete deck with centrally-located concrete steps and brick railing with a cast stone cap. Four, round wood Doric columns sat atop the brick railing and supported a wood cornice with dentilated detailing and a flat roof. As per the below photo, the historic-age front porch was recently removed without permit and/or HDC approval. Specifically, only the square wood pilasters, concrete deck with centrally-located concrete steps and brick railing with cast stone cap remain.

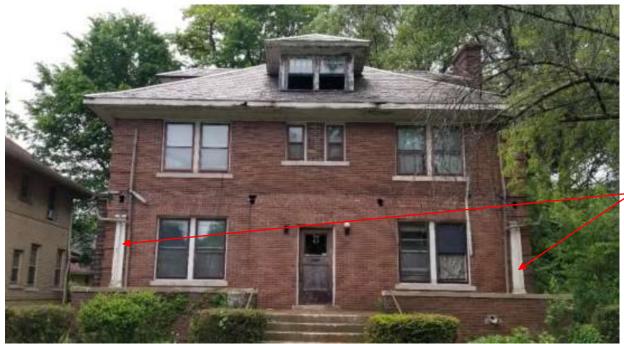
3457 Iroquois, current condition, after unapproved porch removal

Note that the two wood pilasters concrete deck, concrete steps and brick railing remain

Note that the applicant removed the historic-age wood columns, cornice, and roof at the front porch without HDC approval and/or permit. Please see the below photos, which depicyt the front porch's recent condition/level of deterioration at the structure prior to the unapproved work. It appears clear that portions of the roof/ceiling were rotted out, however, it is not clear to staff that all of the porch's wood components were deteriorated to a point which merited their wholesale removal. Also, the remaining wood pilasters proposed for replacement with new composite pilasters do not appear to be deteriorated beyond repair. It is staff's opinion, the wood porch elements which were removed without approval, to include the columns and cornice, were distinctive, character-defining features at the home, as are the remaining wood pilasters. Note, that the standards require that "...deteriorated historic features be repaired rather than replaced. Where the severity of deterioration requires replacement of a distinctive feature, the new feature shall match the old in design, color, texture, and other visual qualities and, where possible, materials." Please see the proposal to rebuild the front the porch. Specifically, note that the applicant narrative proposes to rebuild the front porch to match the original design. However, the current submission does not provide a dimensioned elevation drawing of the new porch within the context of the front facade and does not provide drawings which indicate that the original porch details will be exactly replicated. Also, note that the submission does not provide dimensions for the section of the proposed new rear elevation porch, nor does it provide an elevation drawing which indicates where the new rear porch will be installed.

- The applicant shall retain the two remaining wood pilasters at the front elevation.
- The applicant shall provide HDC staff a dimensioned elevation drawing which depicts the building's front elevation; the existing wood pilasters, brick walls, and concrete steps; and the proposed new columns, cornice, and roof prior to the issuance of the project COA. HDC Staff shall be afforded the opportunity to review and approve the new dimensioned elevation drawing prior to the issuance of the project COA. If HDC staff determines that any of the new porch elements *do not exactly replicate the historic porch*, staff shall forward the porch proposal to the commission for review at a future meeting.

- The applicant shall provide drawings to HDC staff which indicate that the original front porch cornice and columns will be exactly replicated in material, dimension, style/type, and detailing prior to the issuance of the project COA. HDC Staff shall be afforded the opportunity to review and approve the new detail drawings. If HDC staff determines that any of these new elements *do not exactly replicate the historic porch*, staff shall forward the porch proposal to the Commission for review at a future meeting.

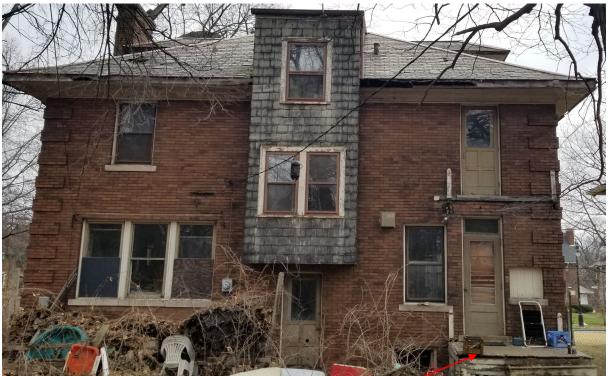
The remnants of a porch, to include a deteriorated wood deck and steps, remain at the rear of the home.

Rear elevation, current condition. Note, remaining wood deck and steps

- At rear elevation, remove existing deteriorated wood deck and steps/porch, and replace with a new, wood, two-story porch, painted Yellowish White
- Remove existing basement windows and replace with new glassblock windows

- The applicant shall provide HDC staff a **dimensioned elevation drawing** which depicts the building's rear elevation and the proposed new porch prior to the issuance of the project COA. HDC Staff shall be afforded the opportunity to review and approve the new dimensioned elevation drawing prior to the issuance of the project COA. If HDC staff determines that any of the new porch does not meet the Standards, staff shall forward the porch proposal to the commission for review at a future meeting.

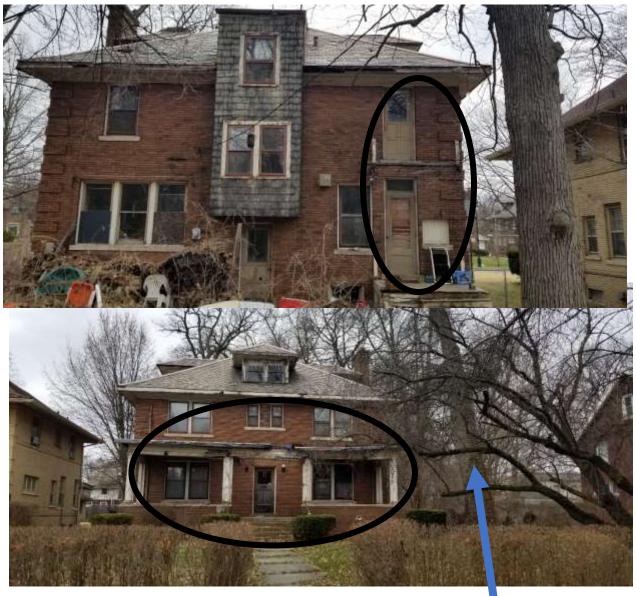
Tree proposed to be removed

- Landscape, to include the removal of a dead tree on the right of house, front yard; removal of a number of small" junk trees" that have grown about 10-15 feet high, including those in the driveway; remove "junk bushes," existing deteriorated dog kennel, and wire fencing

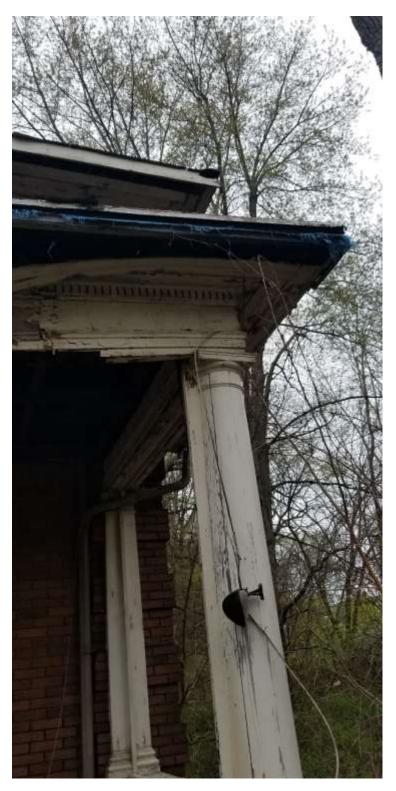
Structural porch members split and water logged and disintegrated

(A)Front Porch: At present the front porch roof, pillars and supporting wood is completely water damaged and in need of complete replacement. Pillars are split and damaged and roof sheathing has in numeral leaks and sunlight is visible in numerous areas through the roof decking. Porch ceiling completely non-existent.

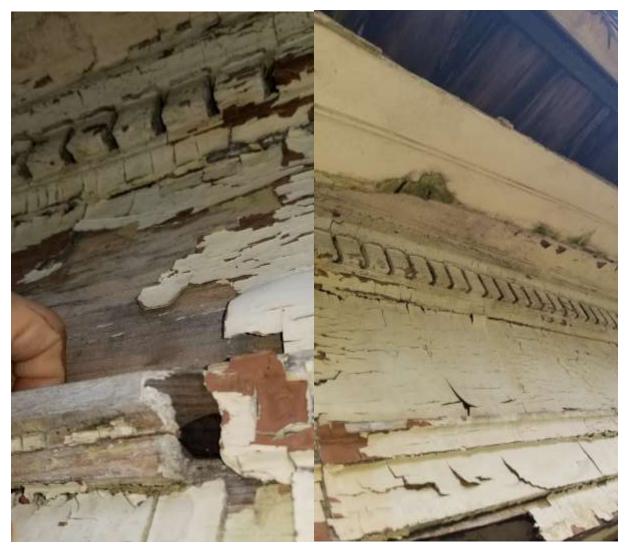
Porch Trim Details (original, above), Side yard completed trashed and broken fencing and junk bushes

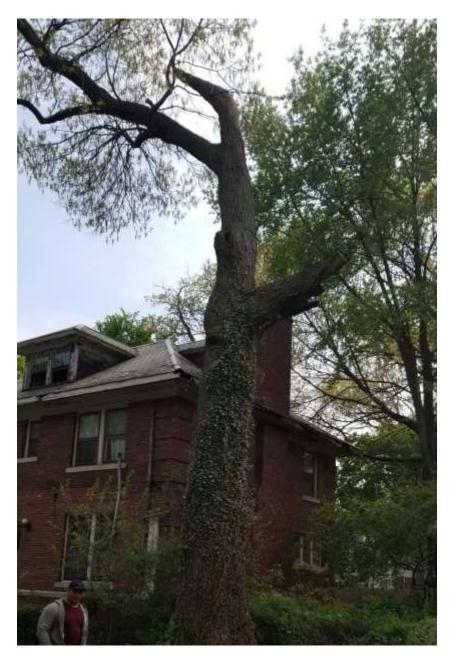
Half cut and overhanging the roof, which is potential for roof damage, unattractive and detracts from curb appeal

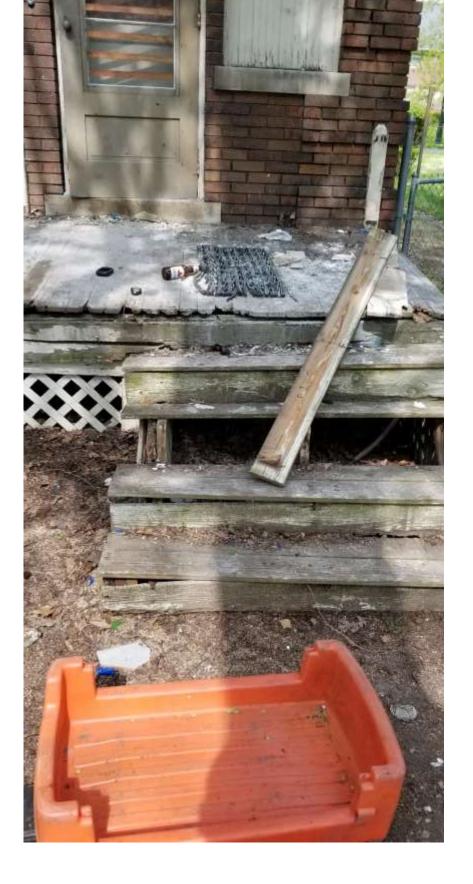
Back Porch, water damaged and structure unstable

(B) Back Porches (both stories): At the back of the house, the 2-story porch is completely removed and needs to be replaced. There is a porch for the lower, and a porch for the upper. Only the lower porch exists, which is water damaged, unsafe stairs, porch incline is not correct and needs complete replacement

The back porch is completely missing the 2nd floor. We plan on removing the first floor porch which is damaged and is not structurally sound anymore. Afterwards we will rebuild the 1st and 2nd floor porches.

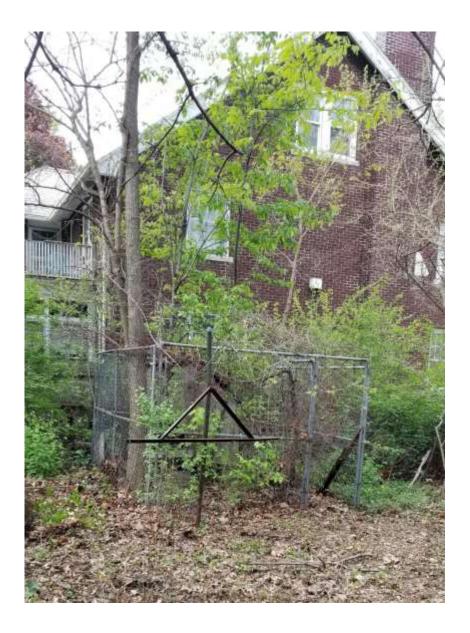
Side Yard, junk trees and bushes, dog kenel and metal clothes drying post

Landscaping: Clean up landscaping. Removing 1 large dead tree to the right of the front of the house. Remove all smaller junk trees, remove all trash and debris from the exterior of the property including waterlogged firewood, barrels and collapsed garage.
