STAFF REPORT: 7-10-2019 MEETING  
APPLICATION NUMBER: 19-6320  
ADDRESS: 874 CHICAGO  
HISTORIC DISTRICT: BOSTON EDISON  
APPLICANT: YVONNE SEBREE  
DATE OF STAFF VISIT: 7/6/2019

PREPARED BY: J. ROSS

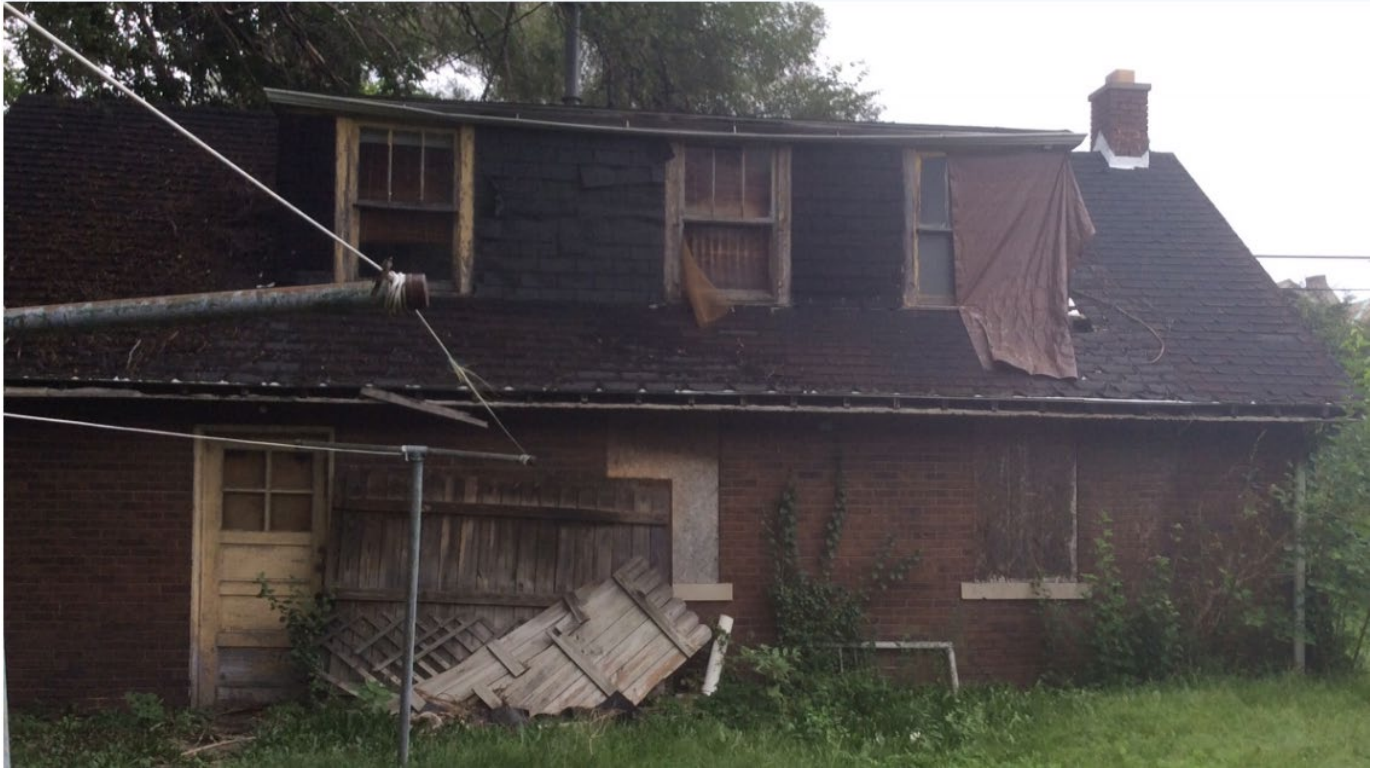
Rear garage/carriage, prior to window replacement

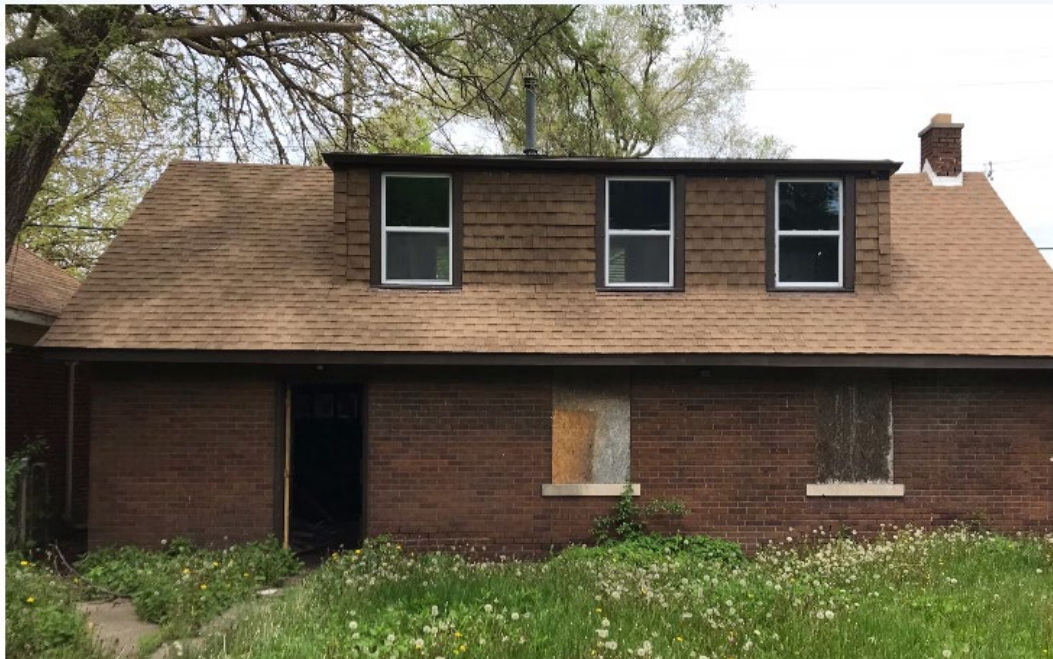
In February 2019, a resident contacted HDC staff to note that existing 3/1 wood windows at the property's carriage house (at the roof dormer) had been replaced with new 1/1 white vinyl units **as per the below photo**. Staff reviewed building files maintained by the Planning and Development Department and noted that the vinyl windows had not been approved by the HDC. Staff therefore forwarded the complaint to the Detroit Building, Safety, Engineering, and Environmental Department (BSEED) for enforcement. In May 2019, the applicant visited HDC staff offices with a proposal to replace the existing deteriorated concrete at the home with new concrete. At that time, staff noted the existing vinyl window violation and alerted the current applicant that the work must be submitted to the Commission for review. The applicant subsequently painted the white vinyl windows and associated wood trim brown **as per the below photo**. With the current submission, the applicant is seeking the Commission's approval of the vinyl windows that were installed at the garage without permit and/or Certificate of Appropriateness.

It is noted that the garage is minimally visible from the public right-of-way, despite that fact that it is located to the rear of the home/yard. It is staff's opinion that the historic-age garage does contribute to the property's historic character and its original wood windows were/are character-defining features of the structure. Therefore, in staff's opinion, if the windows are too deteriorated to be repaired, they should have been replaced with new windows which match the original as per the Secretary of the Interior's Standards for Rehabilitation, standard number 6. The light configuration of the new vinyl windows are 1/1 and do not replicate/reflect the original windows' 3/1 light configuration.

Rear garage/carriage, immediately after window replacement

As noted above, it is staff's opinion that the historic-age garage does contribute to the property's historic character and its original wood windows were/are character-defining features of the structure. Therefore, in staff's opinion, if the original 3/1 wood windows are too deteriorated to be repaired, they should have been replaced with new windows which match the original. Staff therefore recommends that the Commission deny the issuance of a Certificate of Appropriateness for the current vinyl windows at the garage/carriage house because they do not meet the Secretary of the Interior's Standards for Rehabilitation standard number 6) *Deteriorated historic features shall be repaired rather than replaced. Where the severity of deterioration requires replacement of a distinctive feature, the new feature shall match the old in design, color, texture, and other visual qualities and, where possible, materials. Replacement of missing features shall be substantiated by documentary, physical, or pictorial evidence.*

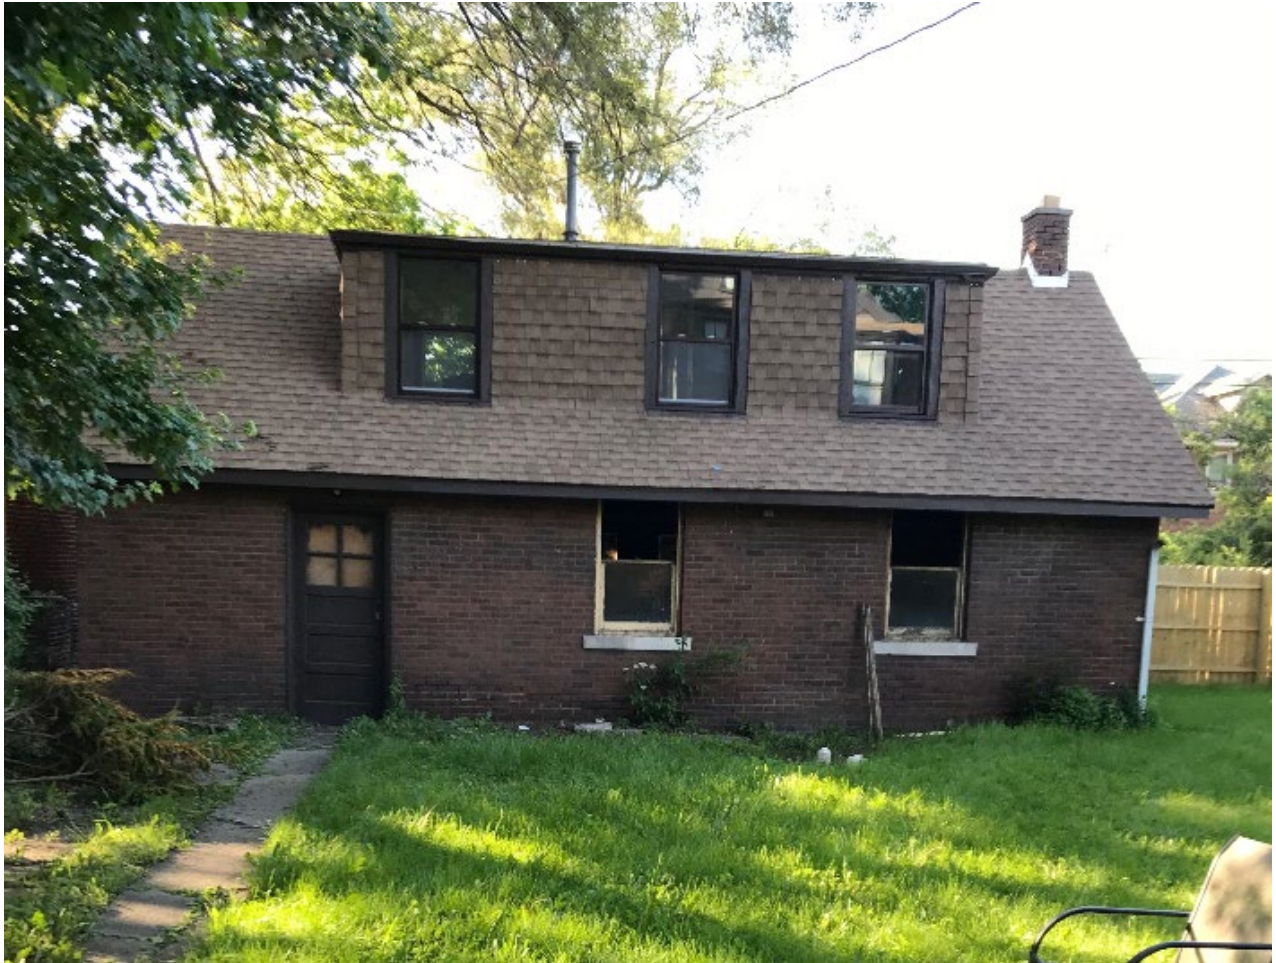
Rear garage/carriage after window replacement. Note that vinyl windows have been painted brown
