**STAFF REPORT 09-11-2019 REGULAR MEETING**  
**APPLICATION NUMBER: 19-6410**  
**ADDRESS: 1682 LONGFELLOW STREET**  
**HISTORIC DISTRICT: BOSTON EDISON**  
**APPLICANT: MARIE BROOKS**  
**DATE OF COMPLETE APPLICATION: 8-7-2019**  
**STAFF SITE VISIT: 08-30-2019**

**SCOPE: DEMOLISH EXISTING GARAGE (PUBLIC HEARING)**

# GARAGE INSPECTION REPORT

1682 Longfellow St.

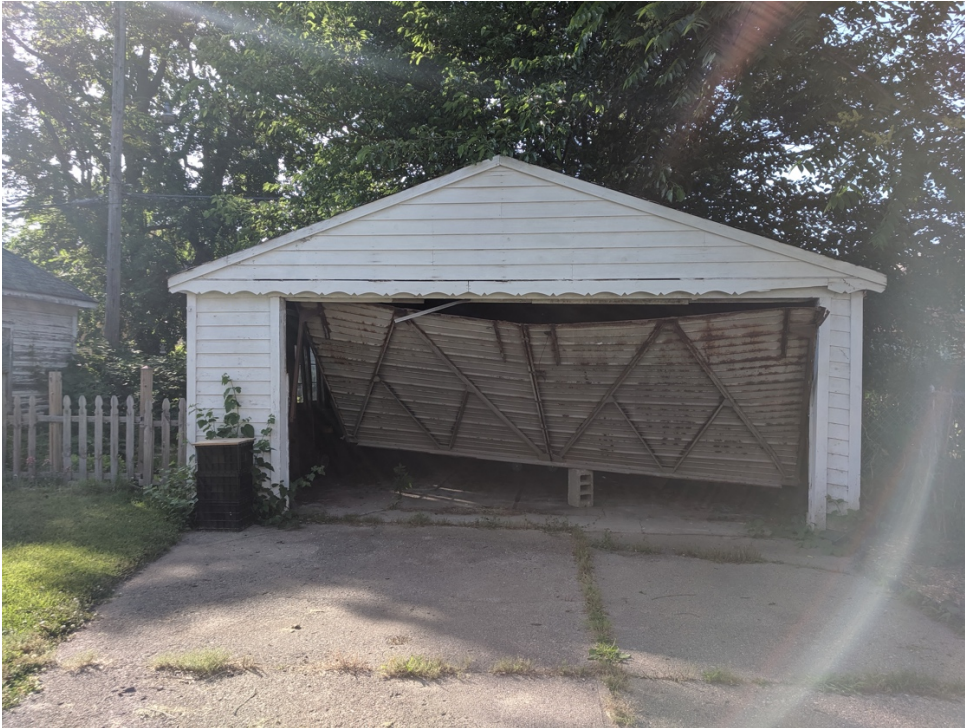
Door Condition: The metal door is buckled and inverted due to spring failure. It can no longer move on its tracks.

Front: Note inverted door and broken springs

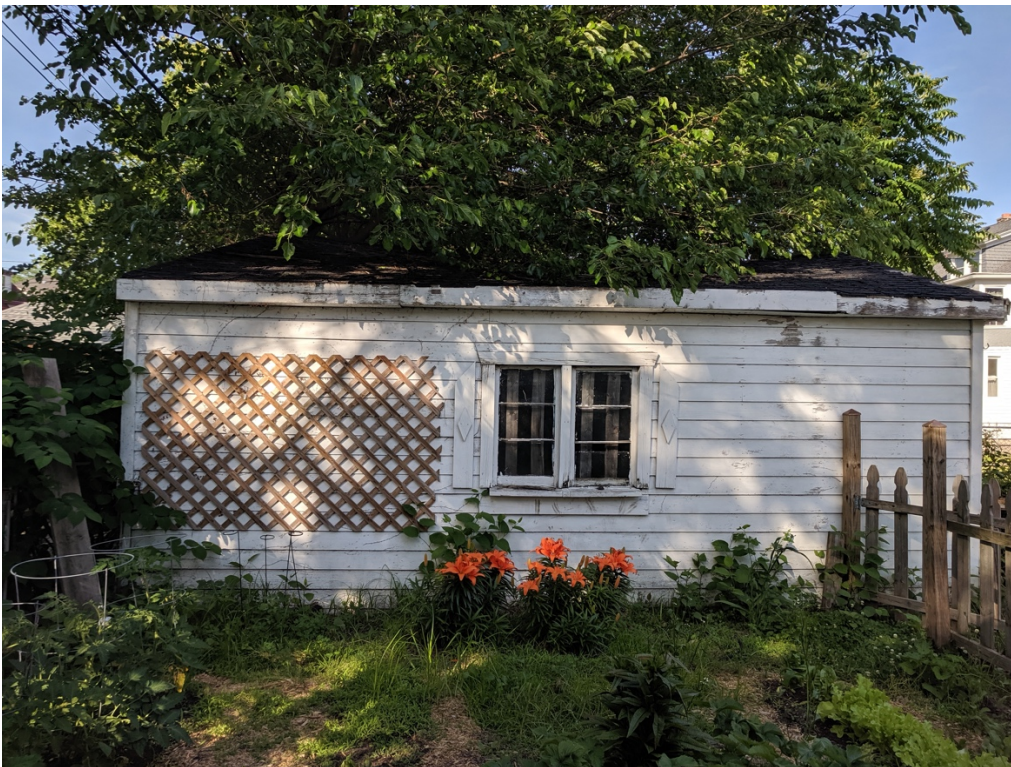
Garden side: Windows are missing glass or have broken glass

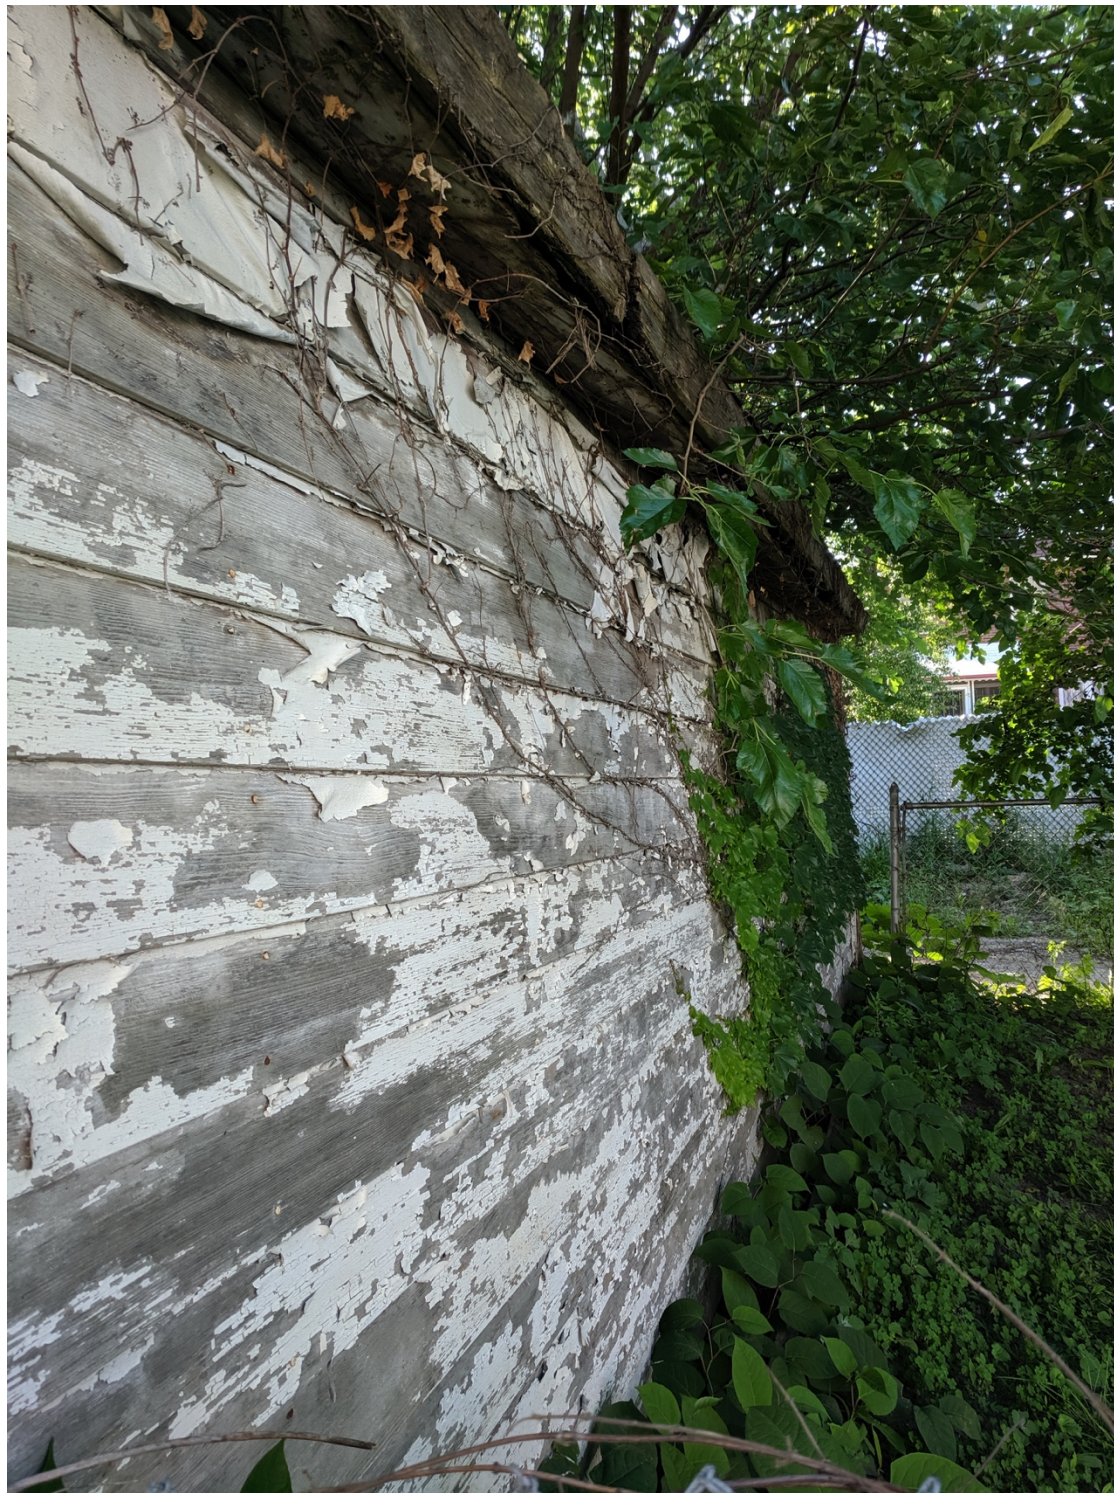
Side next to Neighbors (note chainlink fence, which would be extended along alleyway until new garage is built):

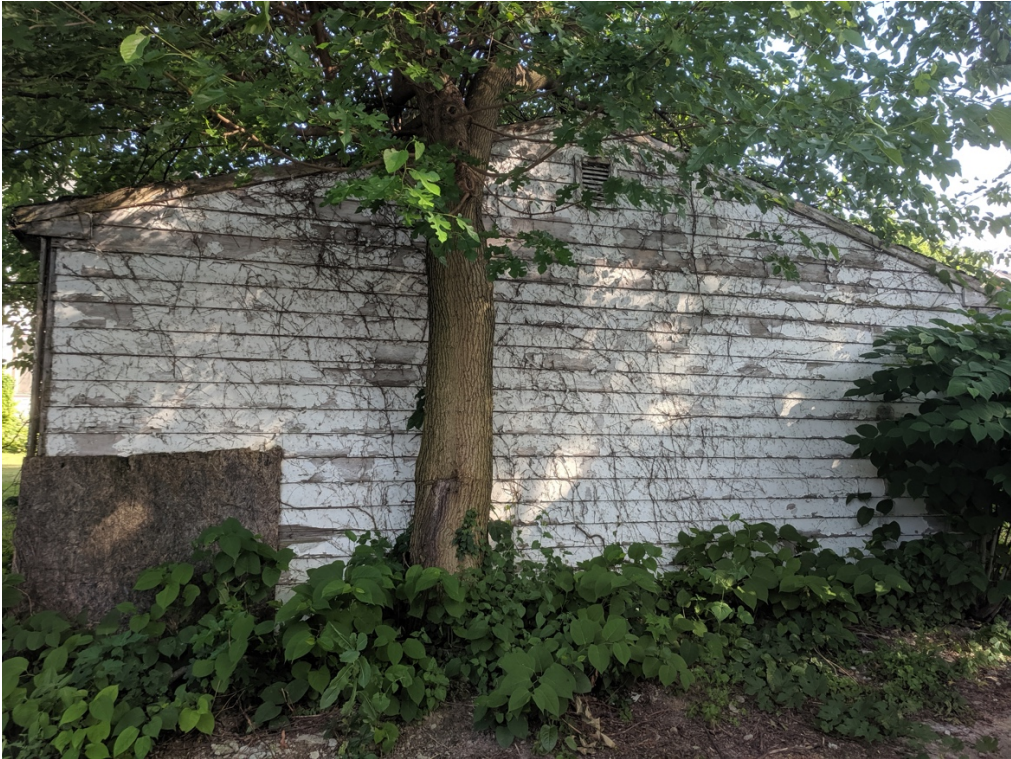
Back: Note tree, to be removed as it has grown into the garage and pad

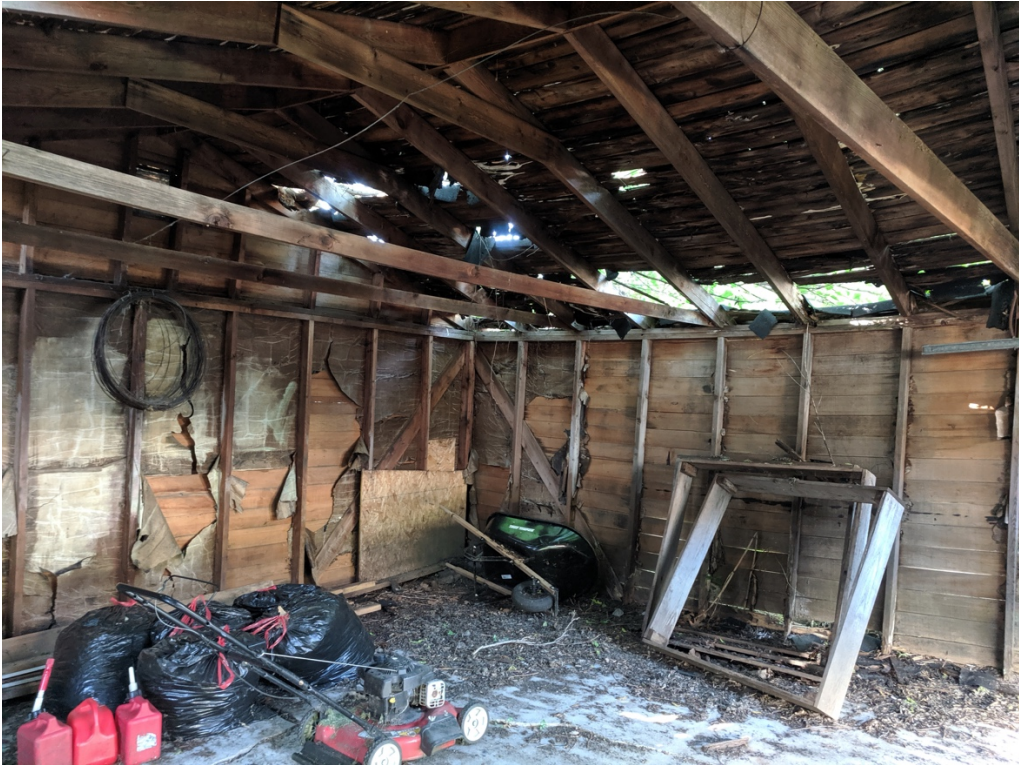
Roof Condition: The roof has extensive damage, including many large holes. The wood is almost entirely rotted. More shingles come off it every time there is substantial wind.

Interior (note roof condition):

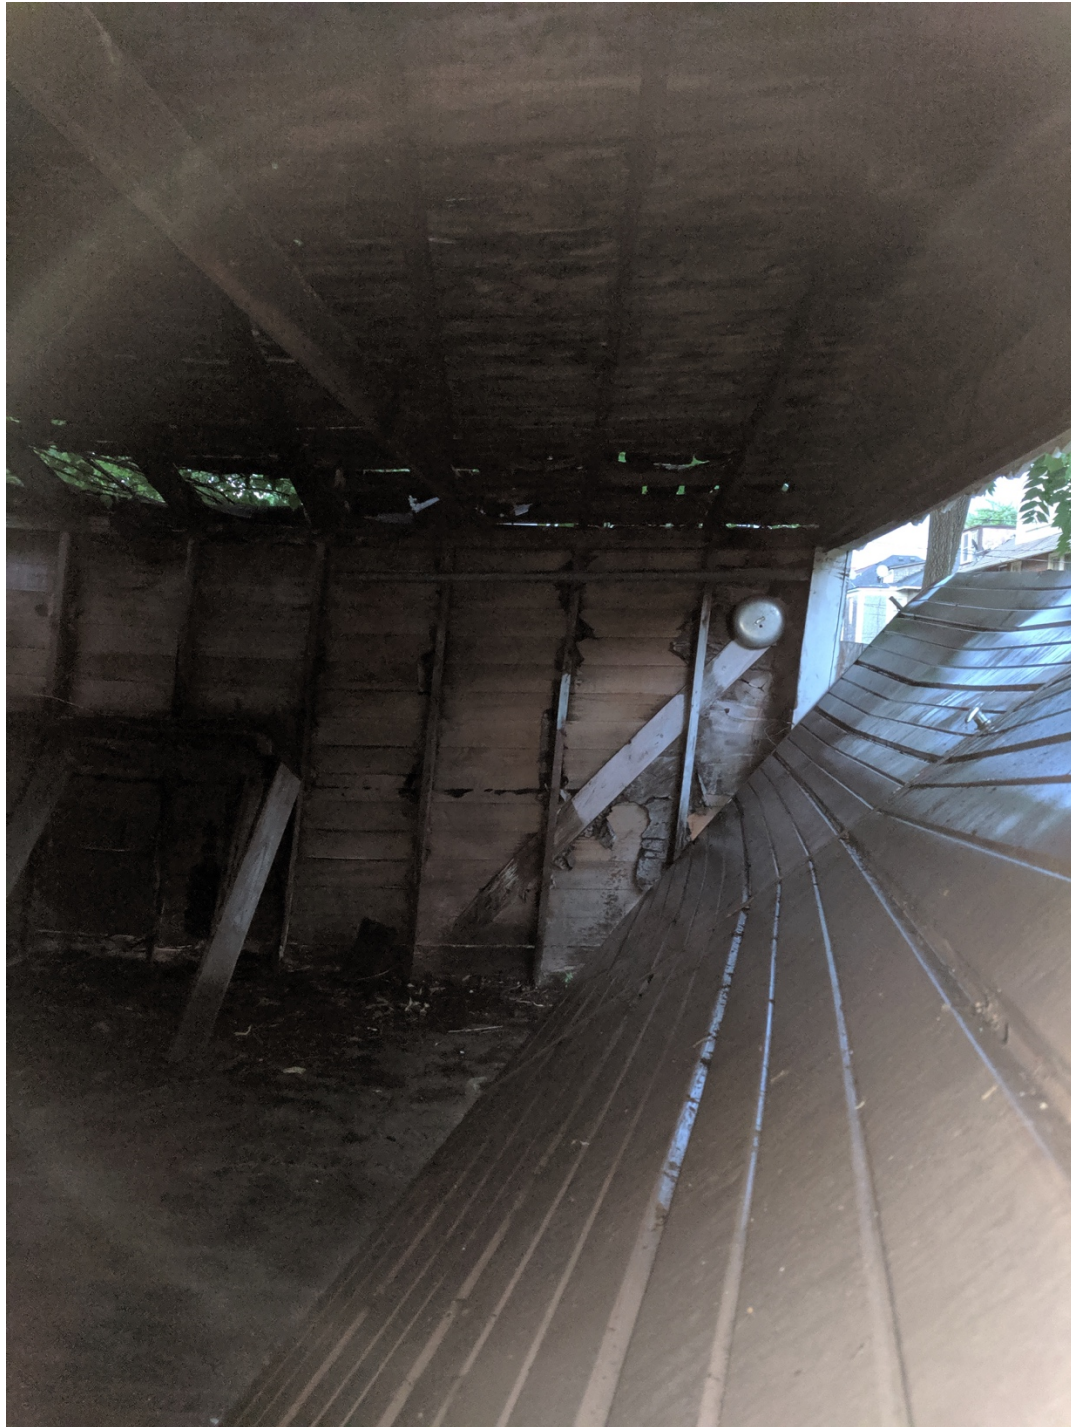
Frame Condition: Wood beams are ok, but not square, as the whole structure is tilted.

Corner: Note that the frame does not form right angles. This is true throughout the structure, as it is all leaning.

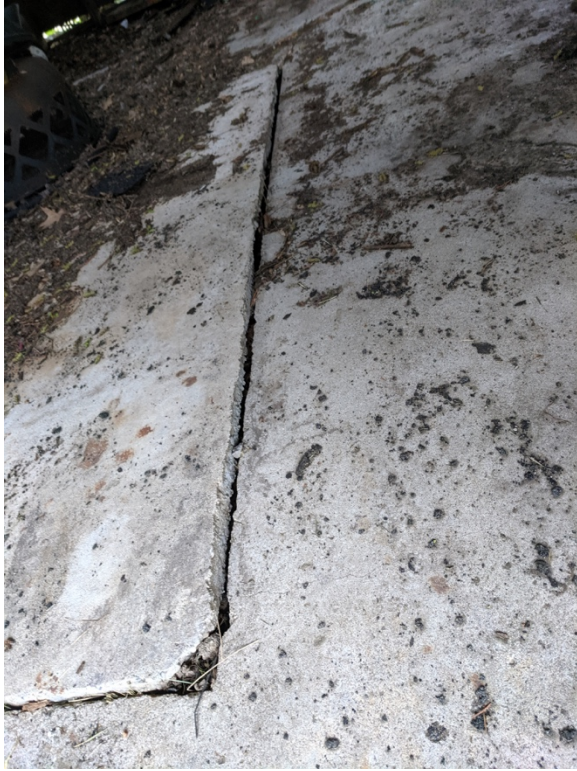
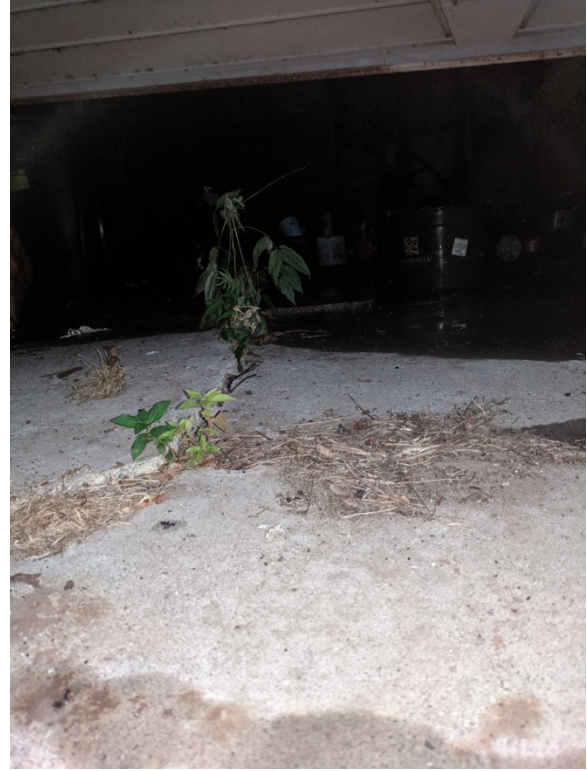
Pad Condition: The concrete pad is badly cracked and not level.

Pad: It is hard to capture the pad as a whole, but there are many places like this, where sections of the pad are visibly cracked and raised above other sections.

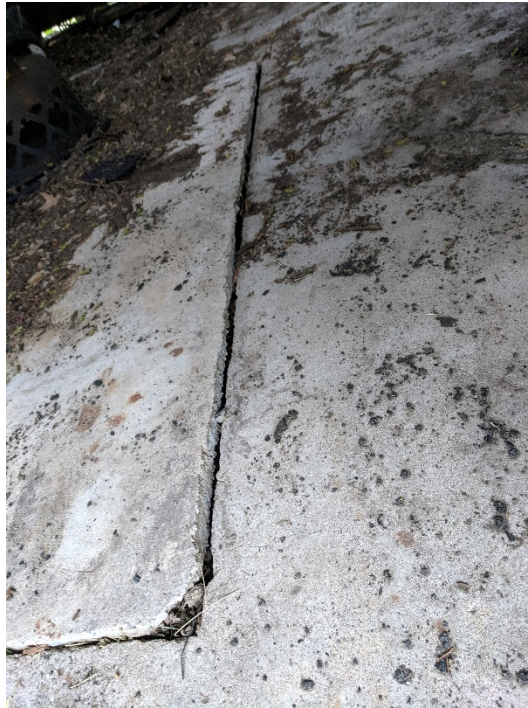
FIGURE 3 – SLAB LIFTING

The existing garage sits on a concrete slab with a varied thickness of 4" to 6" with no signs of reinforcement. The concrete slab is severely deteriorated, and there are numerous cracks across the length and width of the slab. The slab has lifted in various areas. See figures 3 and 4. The cracking and lifting of the slab have happen due to numerous reasons, including inadequate compaction of the sub base, no concrete reinforcement, no frost protection and age. The existing concrete foundation is not repairable and will need to be removed and replaced.

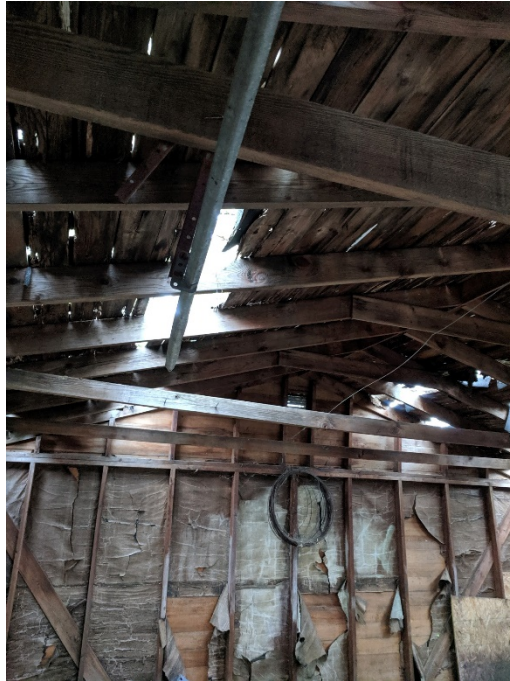
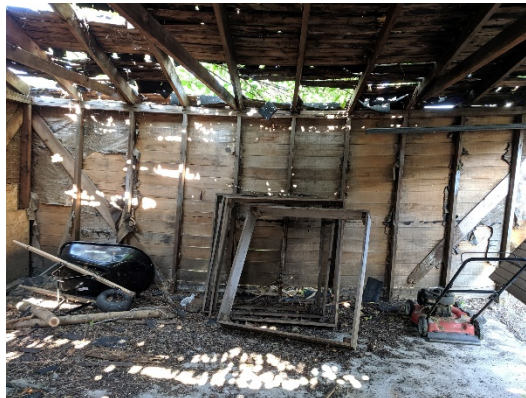
The garage is a typical stick framed building. The exterior walls are made up of a 2" x 4" lumber spaced out at 16" to 24" with bottom and top plates. The roof of the building consists of 2" x 6" hand cut rafters with plywood sheeting and asphalt shingles. Due to the lifting concrete slab which the building sits on, the garage is not leveled, square or plumb. The exterior walls have lifted. Most of the wood bottom plates and studs are rotten or deteriorating. The roof of the building is currently falling in, due to the snow loads over the years. Very little of the existing wood structure is repairable or salvageable. It would be very expensive to repair the structure, and unsafe to work in.

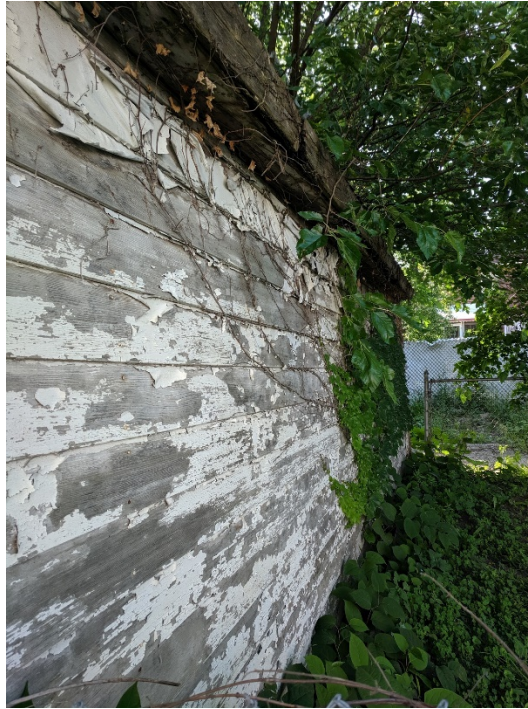
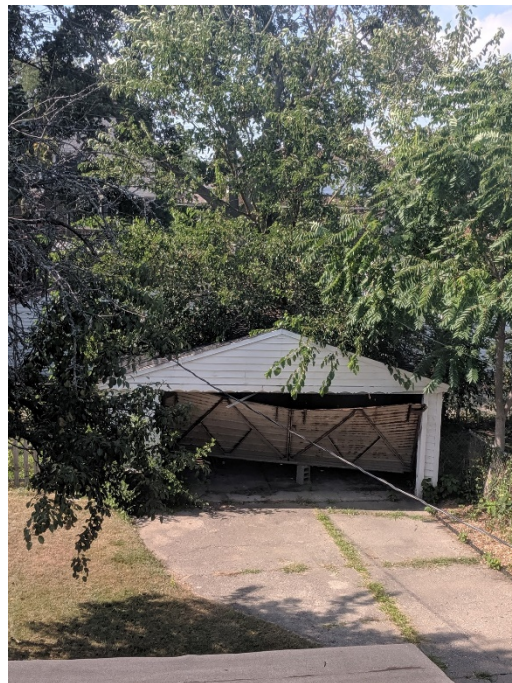
The exterior of the building consists of wood siding that is fastened to the wood frame. The wood siding is weathered, various areas are rotten and deteriorated. Since the exterior walls have lifted the garage door is not operational, and it cannot be opened or closed. The shingles on the roof are severely damaged. It would not be reasonable to simply replace the wood siding, garage door or roof shingles due to the fact that the underlying structure will need to be replaced first.
