STAFF REPORT: 9-11-2019 MEETING
APPLICATION NUMBER: 19-6426
ADDRESS: 1448 SHIPHERD
HISTORIC DISTRICT: WEST VILLAGE
APPLICANT: RIEMER PRIESTER AND ALEX DECAMP
DATE OF COMPLETE APPLICATION: 9-3-2019
DATE OF STAFF VISIT: 9-3-2019

SCOPE: DEMOLISH EXISTING BUILDING

Historical Structural Assessment Report

Property Address: 1448 Shipherd St.
Detroit, MI 48214-2455

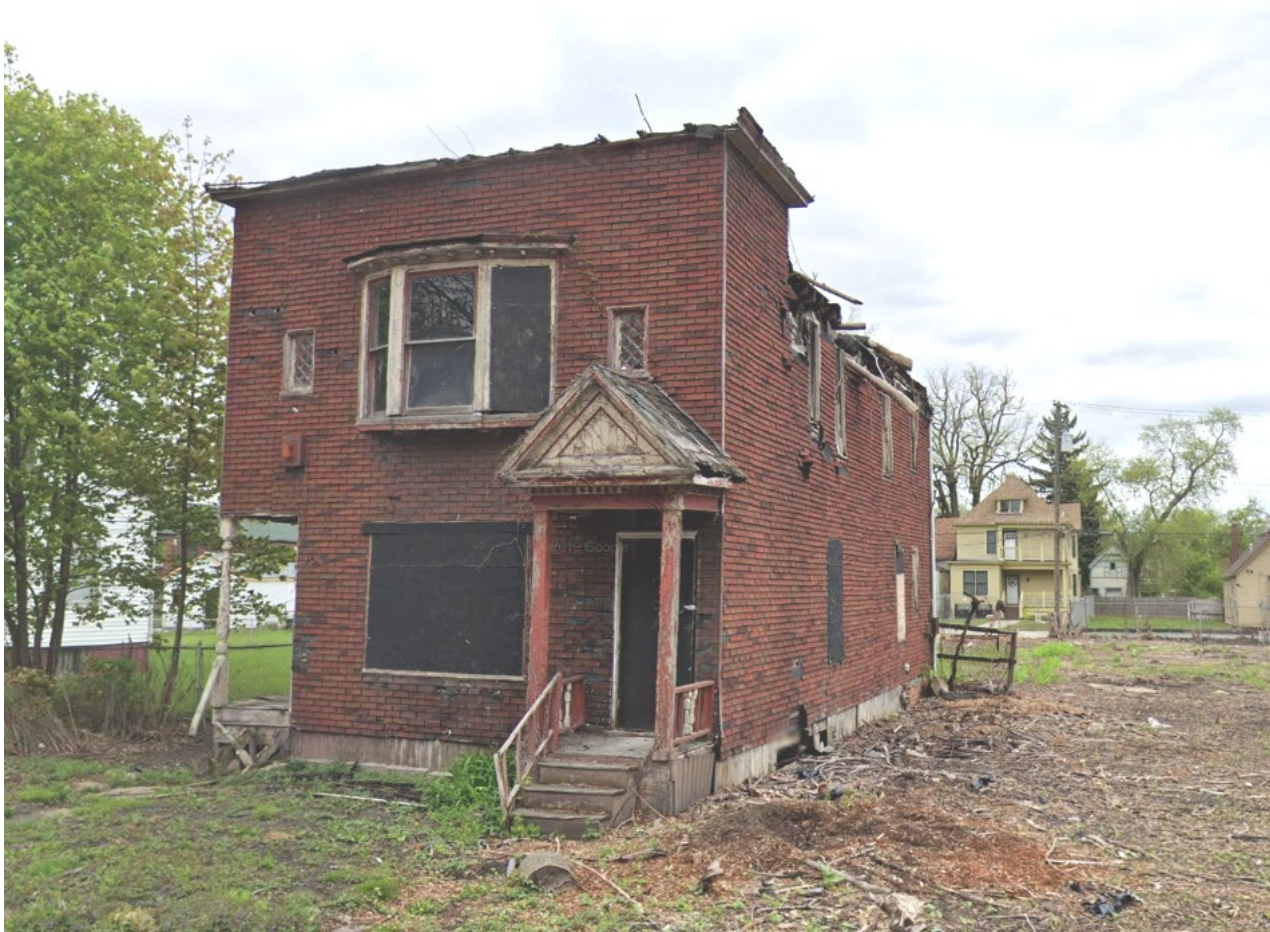
Erected ca. 1900, the building located at 1448 Shipherd is a two-story, wood-frame, multiple-family dwelling. The building is two stories in height and is covered with a faux brick, asphalt (Insulbrick) siding. Windows, where visible and intact, are wood double-hung or leaded glass casement units. Many of the window openings on the first story are covered with plywood, while all of window units at the second story are highly deteriorated because the rear portion of the roof has collapsed. A wood porch with a decorative gable and wood steps at the front elevation mark the building's primary entrance. A second inset entrance opens to a staircase which leads to the second story apartment. The building sits in a highly deteriorated state due to the rear roof collapse.

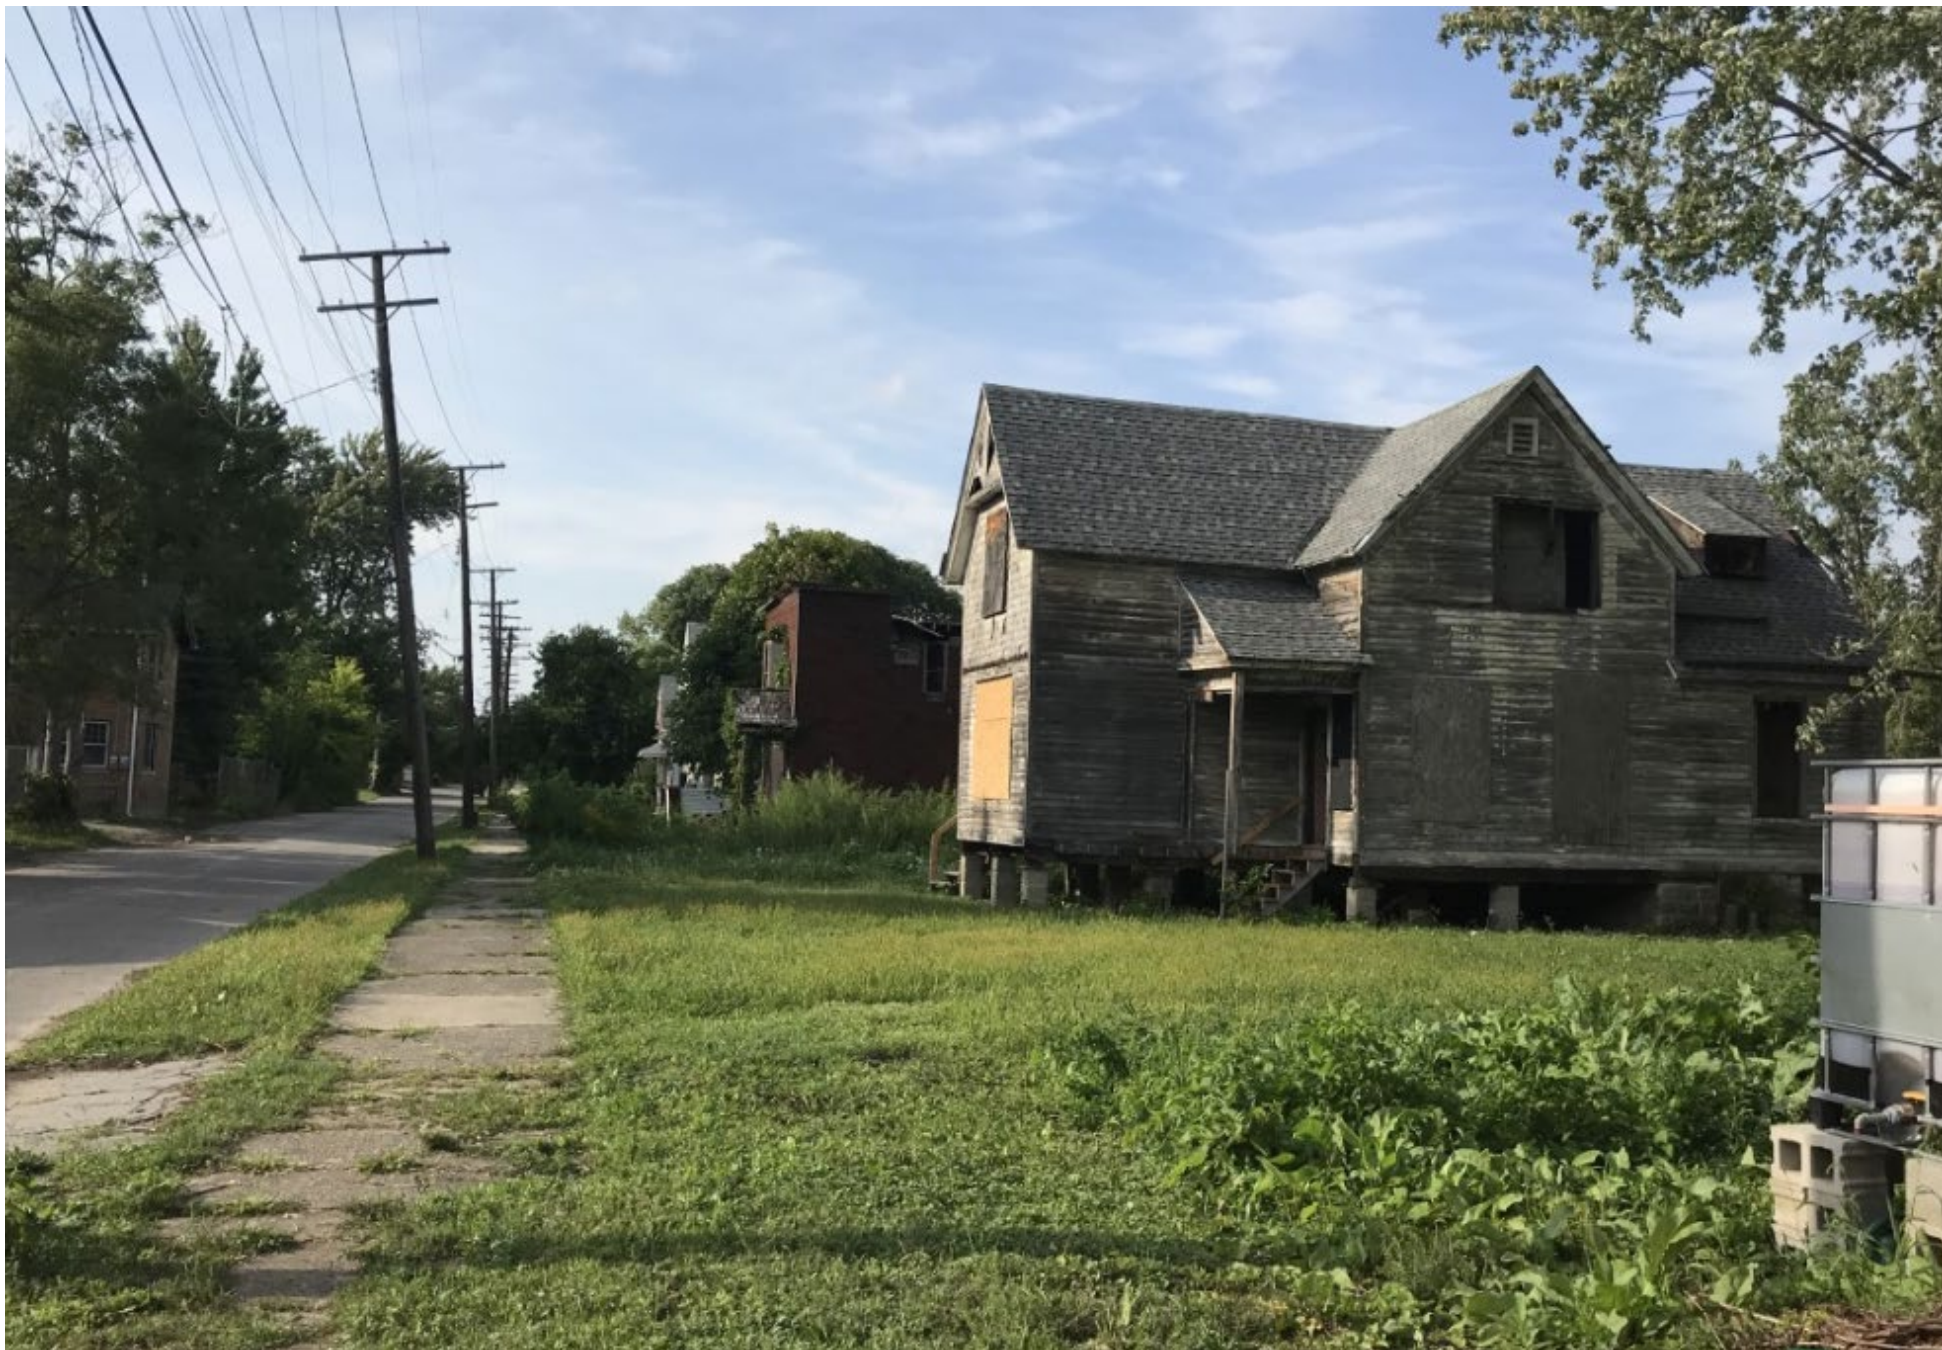
Current conditions.
Note lack of fencing and landscaping

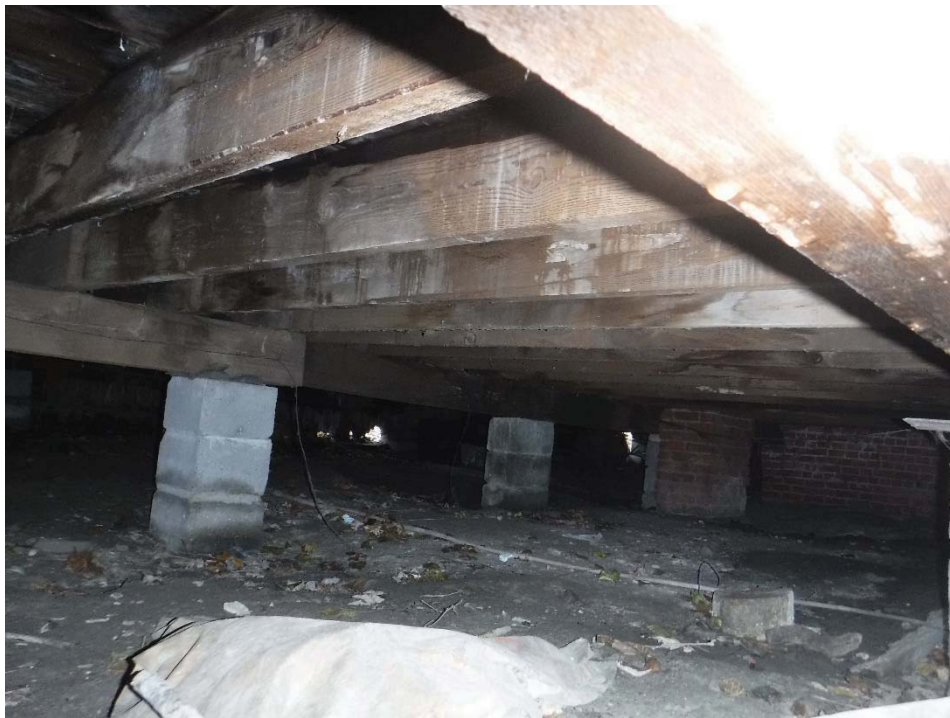
Photo 6: Crawl space framing

1st floor girder beams at the crawl space appear to not be attached to the concrete masonry block piers. Most of the first-floor level joists are water damaged and deterioration varies from 25% to 60%.

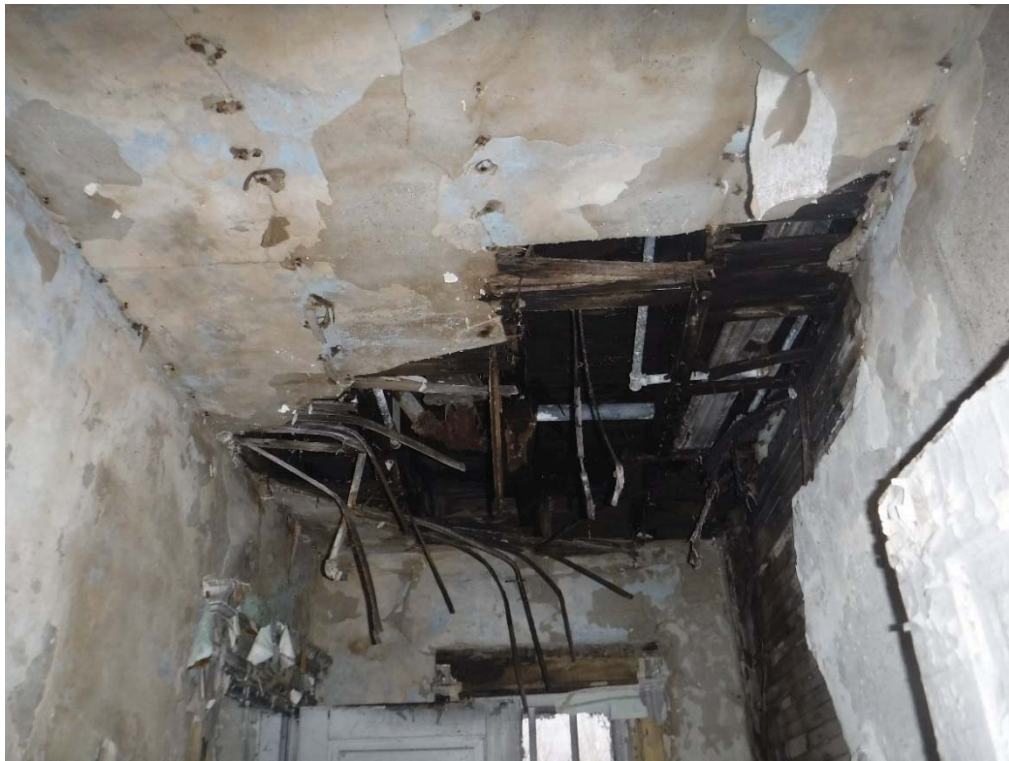
Photo 18: Interior room with pipes exposed at ceiling

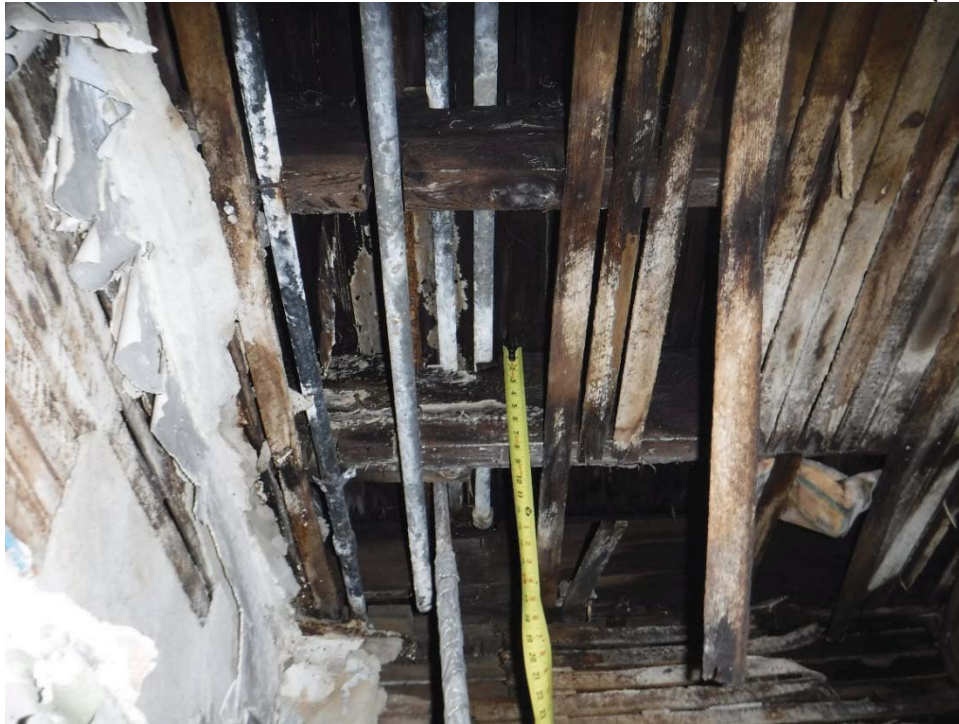
Photo 21: Interior room with ceiling joists and plumbing pipes exposed

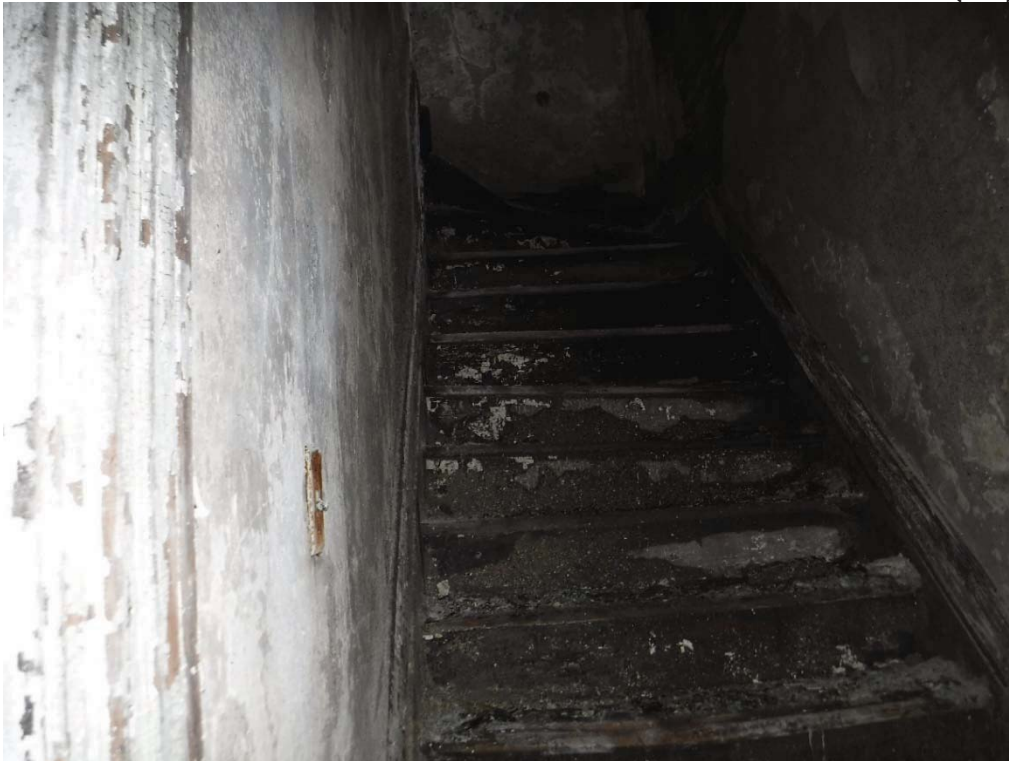
The interior of the house has been exposed to the elements for many years. At the time of visual inspection, the property was only accessible at the first level. The stairs to the 2nd floor and stairs to the basement were water-soaked and were unsafe and therefore prevented access to the 2nd floor and basement.

Photo 30: Stair landing with exterior wall opening

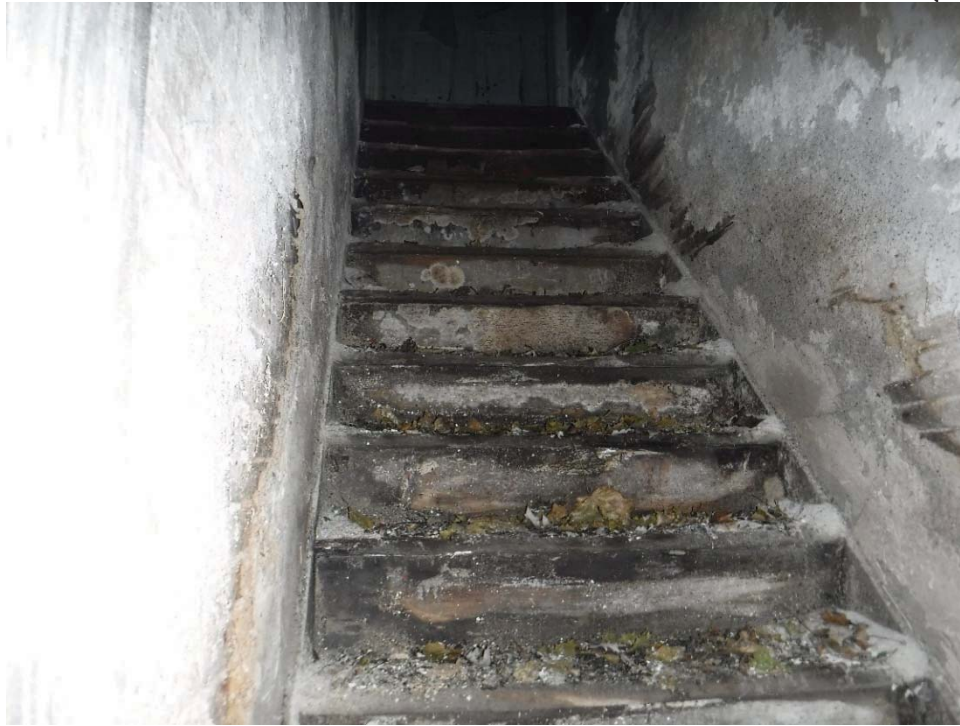
Photo 31: Stairs up to 2nd floor. Stringers and steps are soft.

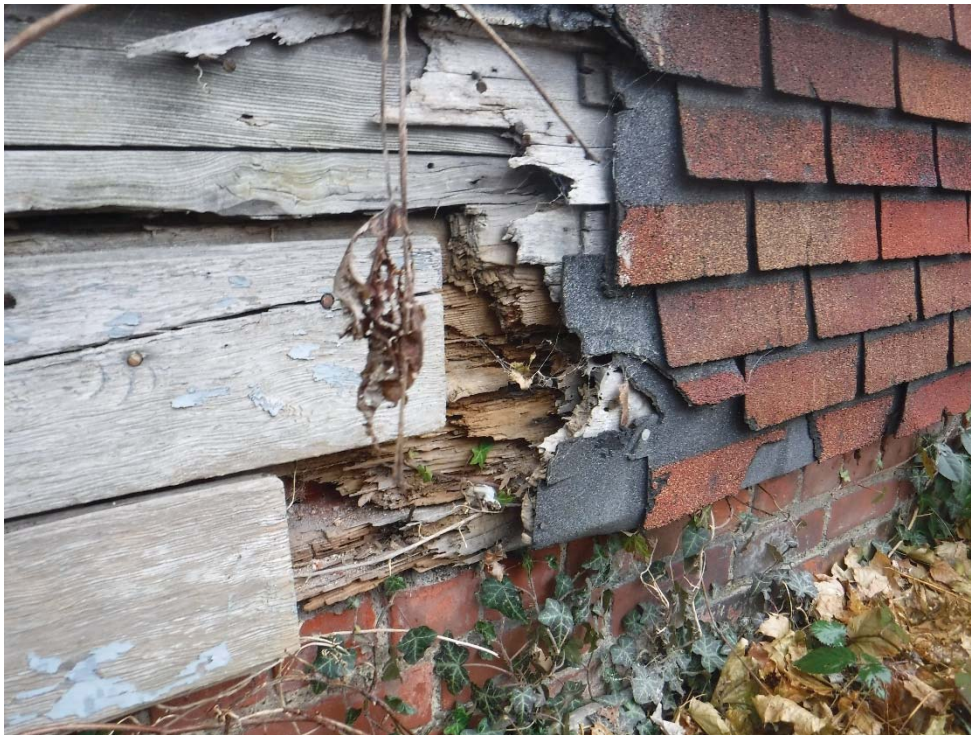
Photo 36: North-east corner with damaged wood siding.
