PREPARED BY: J. ROSS

SCOPE: NEW WINDOWS, LANDSCAPING, AND PARKING PAD

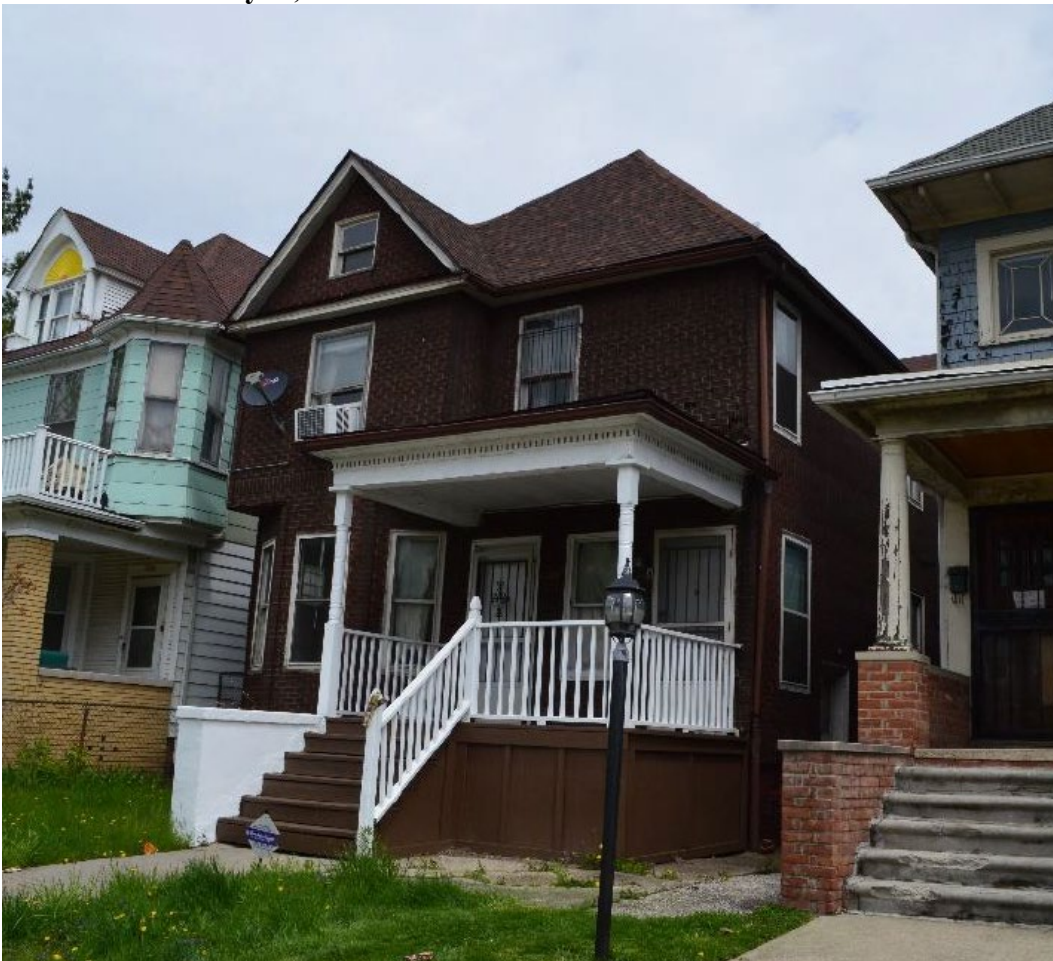
1718-1720 Van Dyke, current conditions

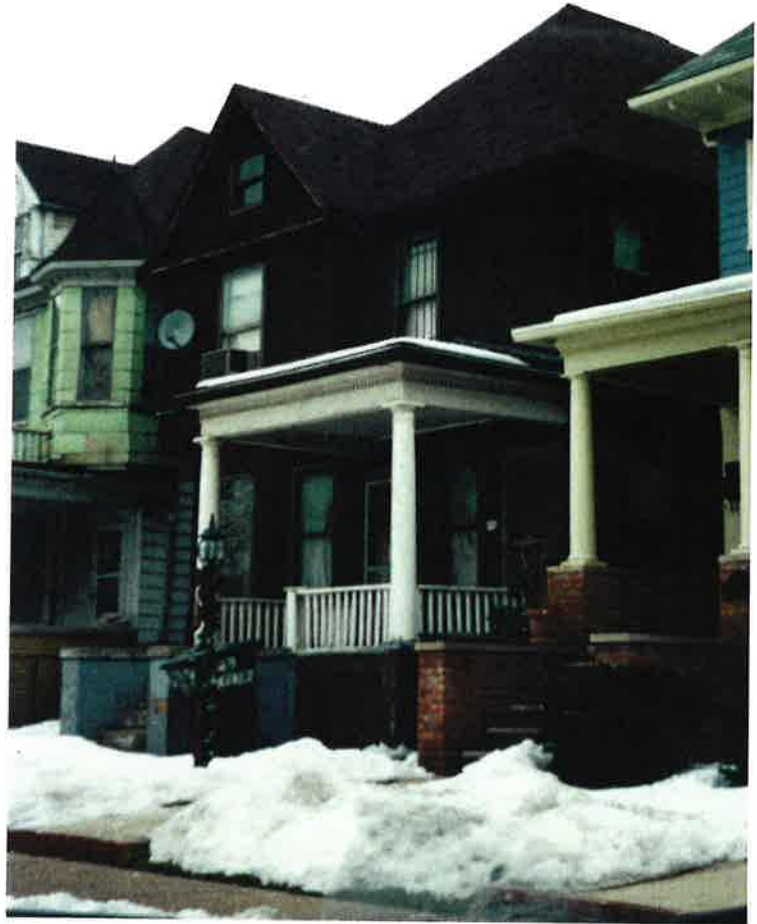
Photo from 2001, showing original porch columns

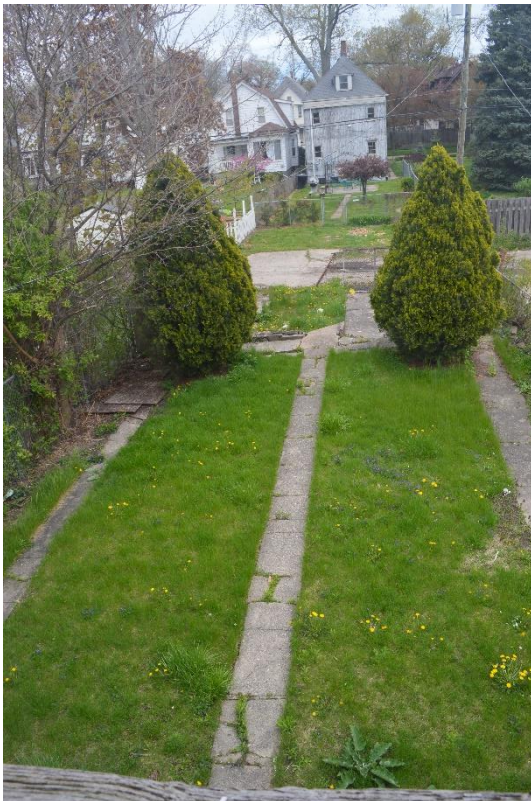
The front and side concrete walkways will be repaired to match the existing as needed. The front lawn will remain as is. In the rear the arborvitae, former garage slab, two outside walkways and the rear chain link fence will be removed. The rear half of the lot is proposed to be paved in asphalt to create six parking spaces. A low masonry retaining wall is proposed between the parking area and rear lawn. The center walkway to the of the house will remain. The chain link fencing on the side lot lines will remain.

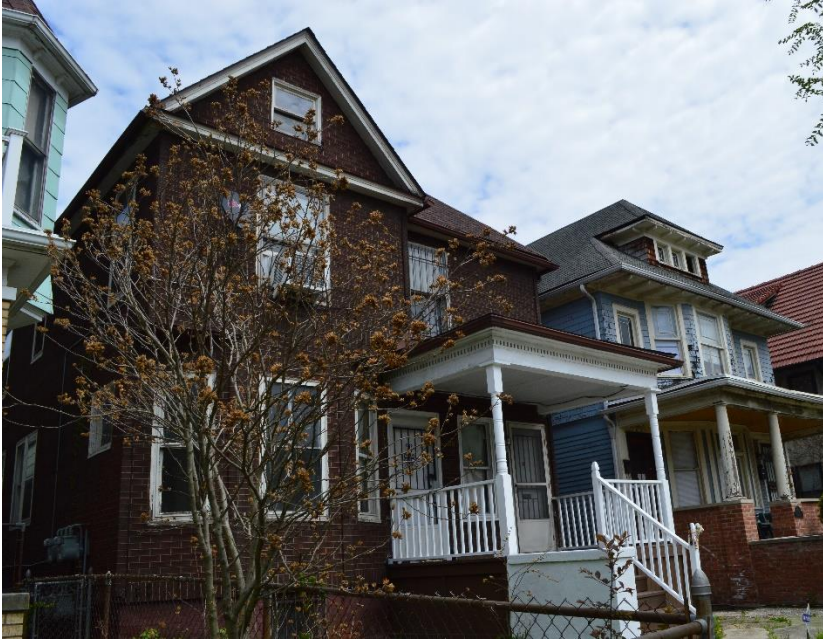
Front and north side

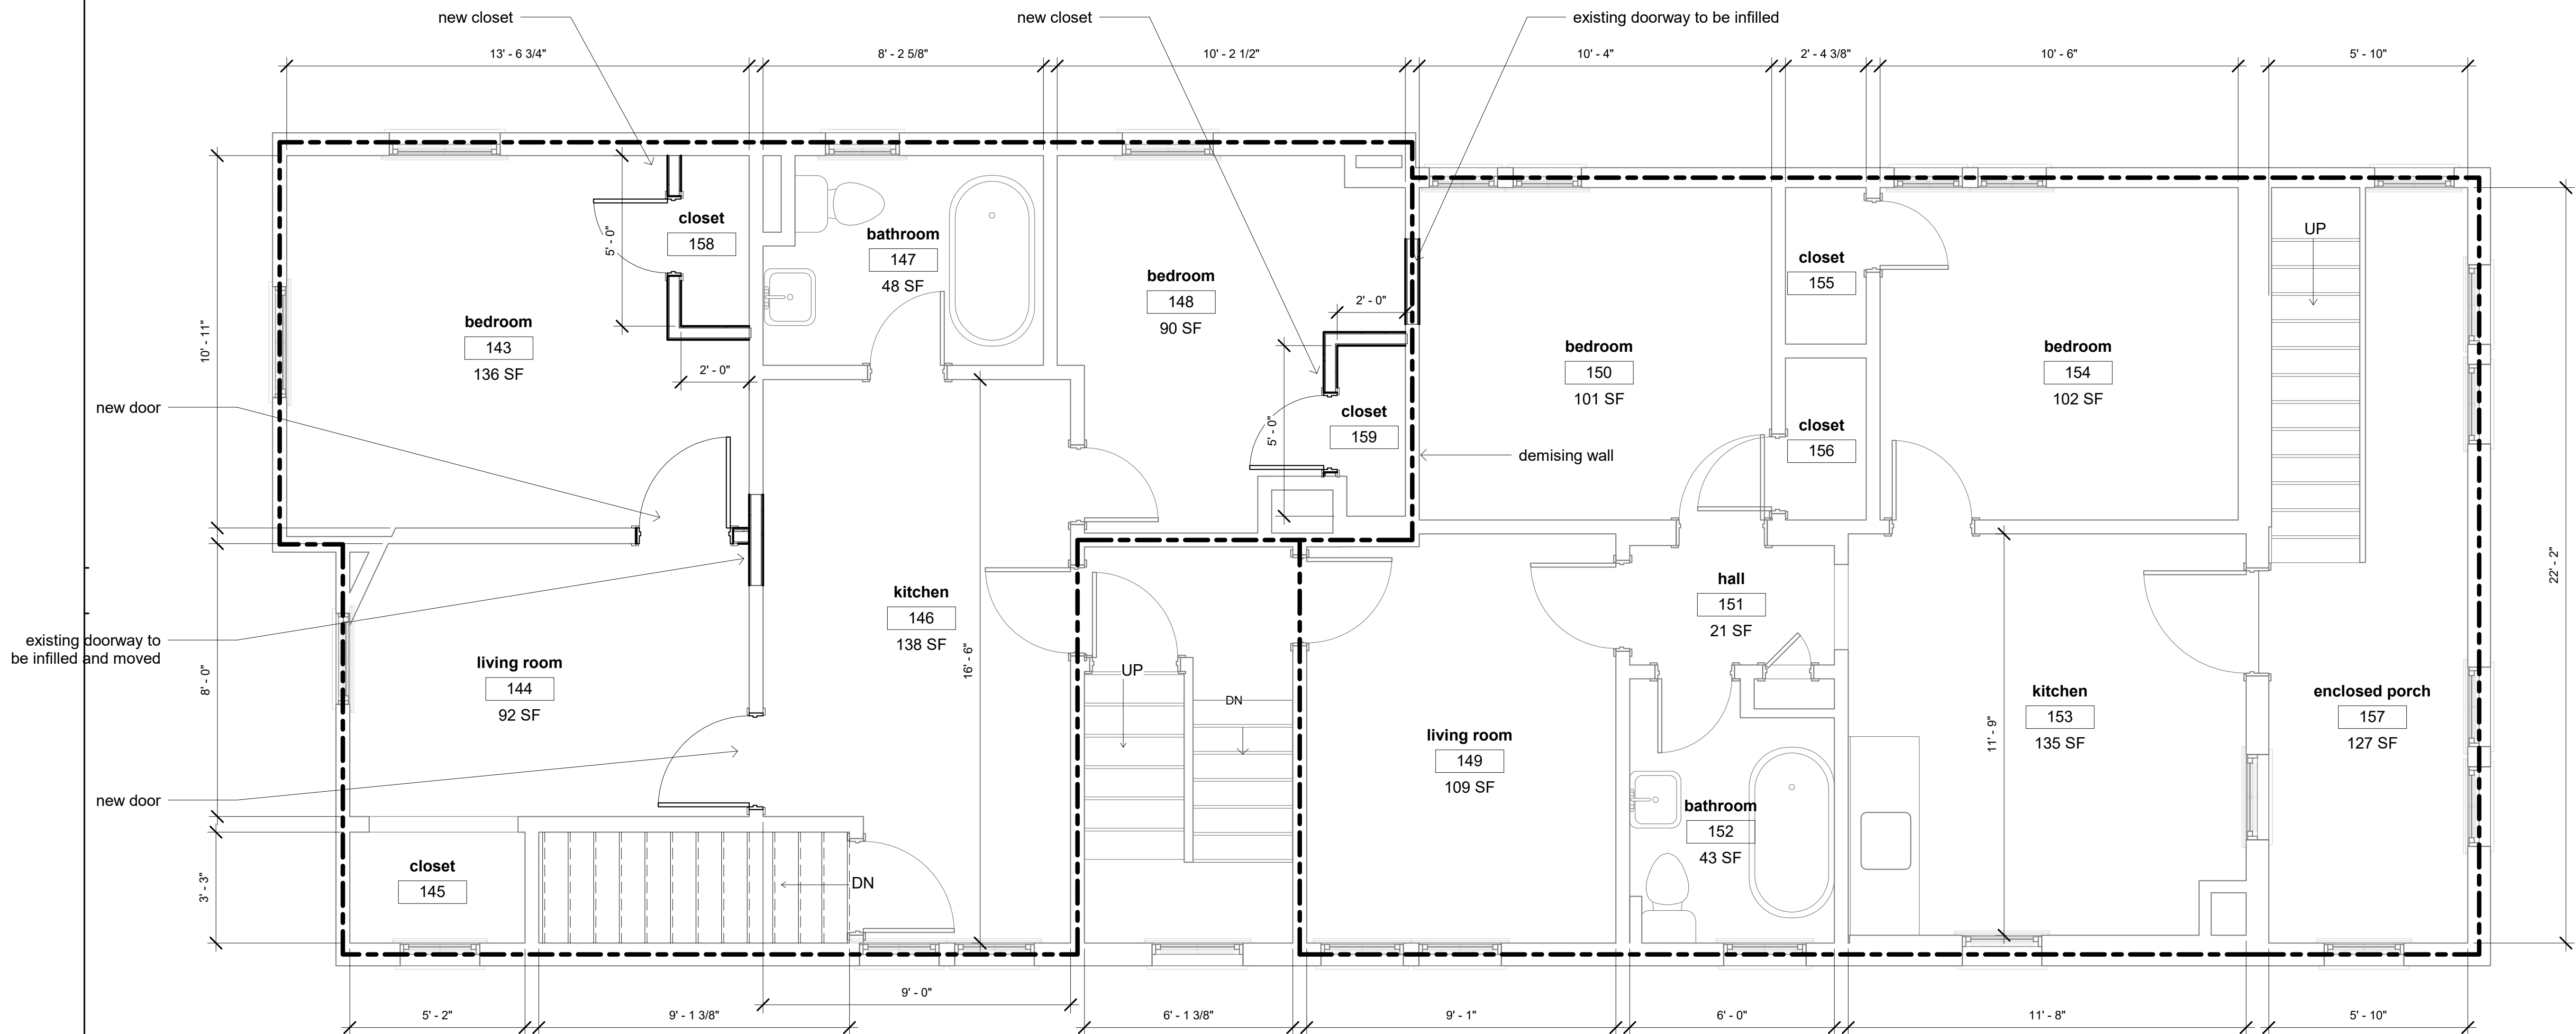
plan / second floor 1
3/8" = 1'-0"

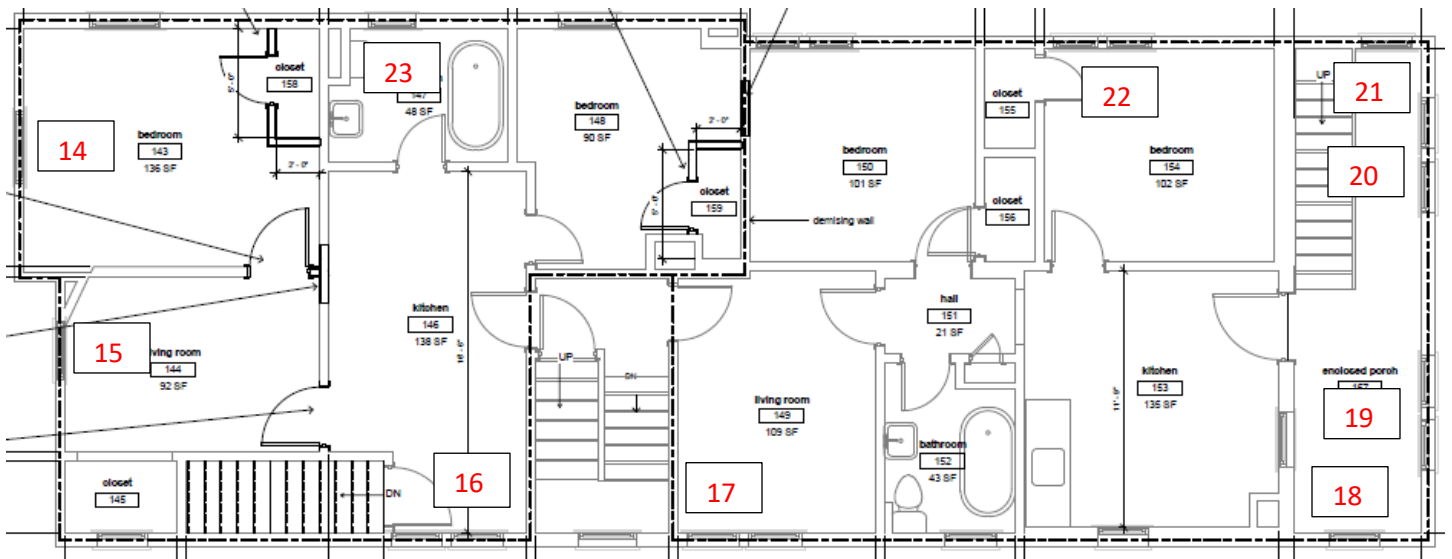
BASEMENT (windows not numbered) – All of the basement windows require replacement – some are missing, all of the sills and frames are rotted due to neglect and water damage from the close proximity to the ground. Below are interior and exterior photos of the majority of the basement windows showing typical damage. New windows will be wood to match the existing opening size. The metal grills over the windows will be removed.

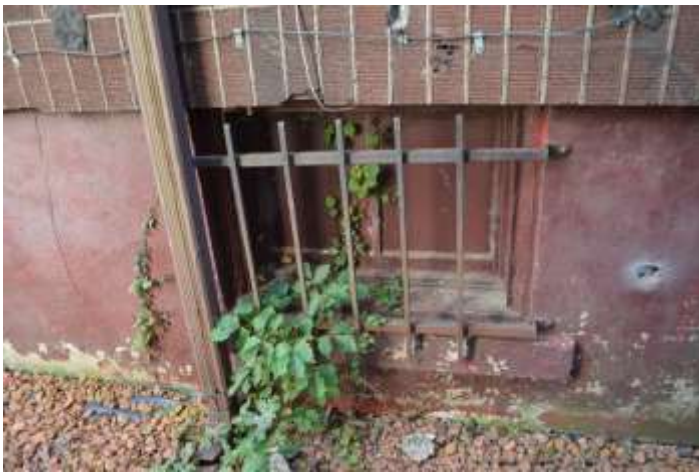
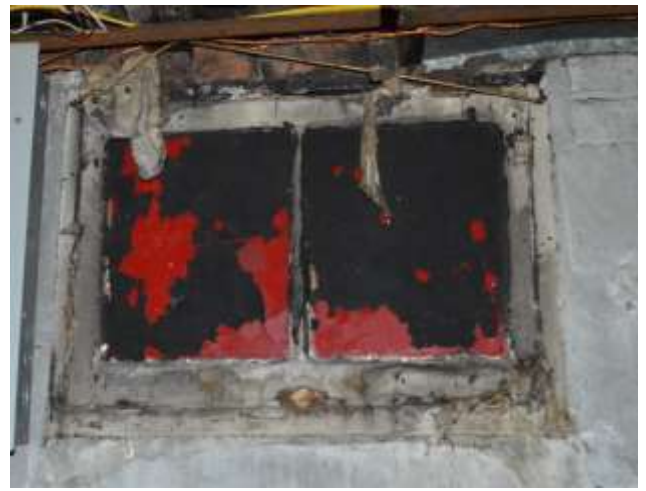
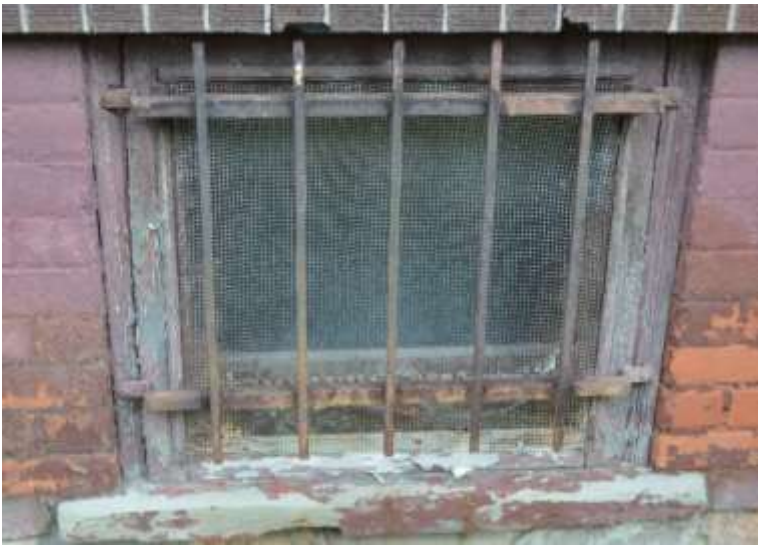
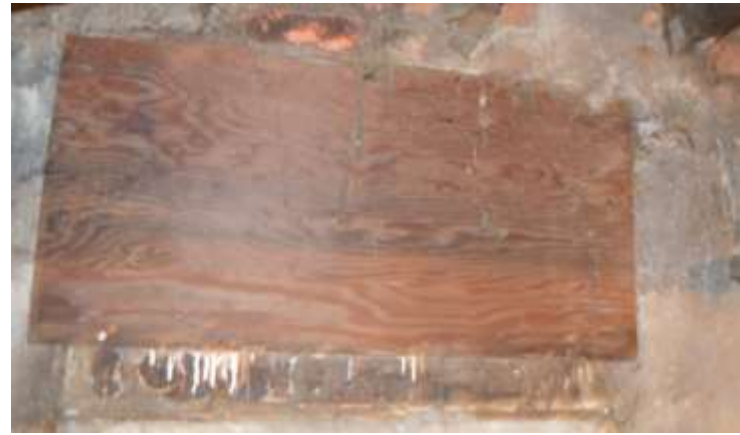
FIRST FLOOR WINDOWS (See numbers on plans above)

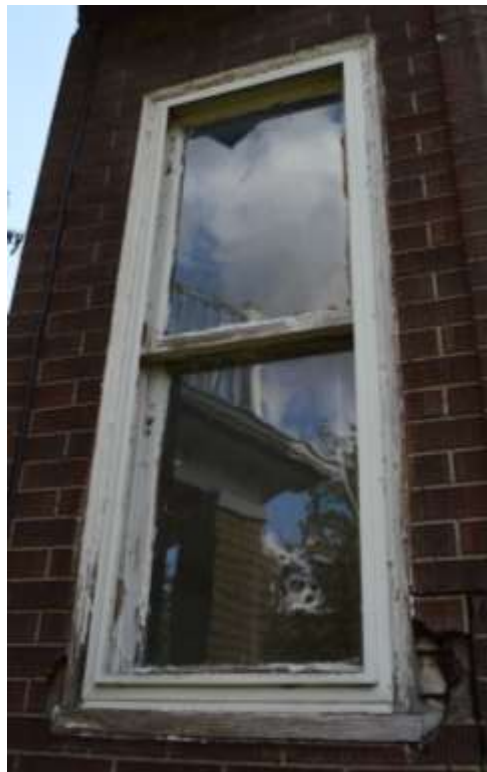
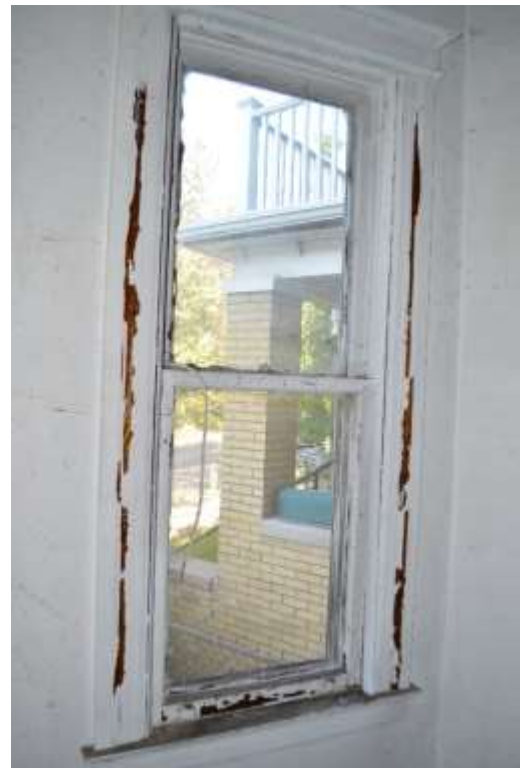
2 – there are no interior sash – new sash laying in room which will attempted to be used, but unclear if will be able – frame rotted on exterior

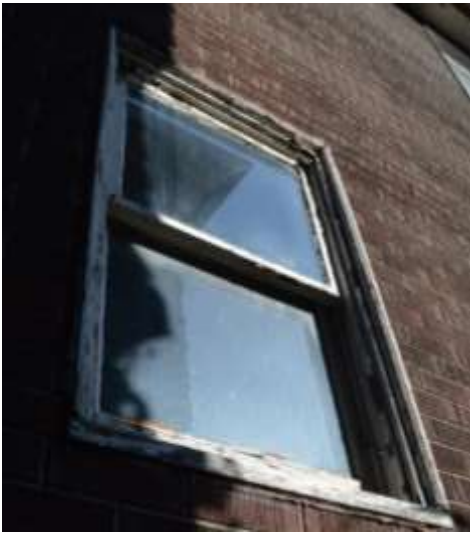
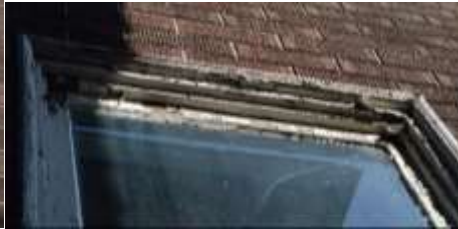
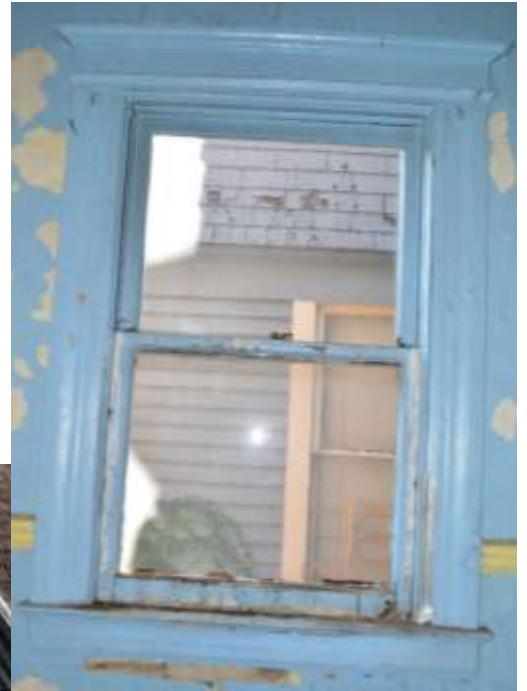
7 – Rotted and brittle frame, bottom sash rail deteriorated

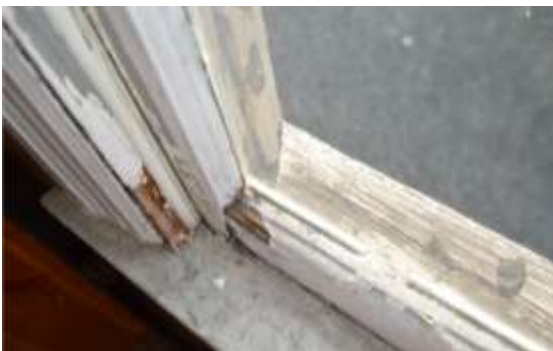
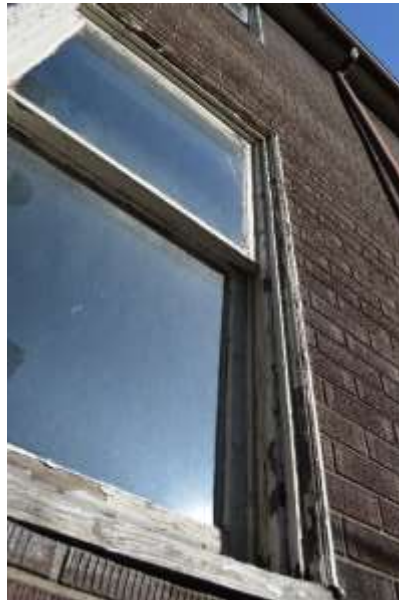
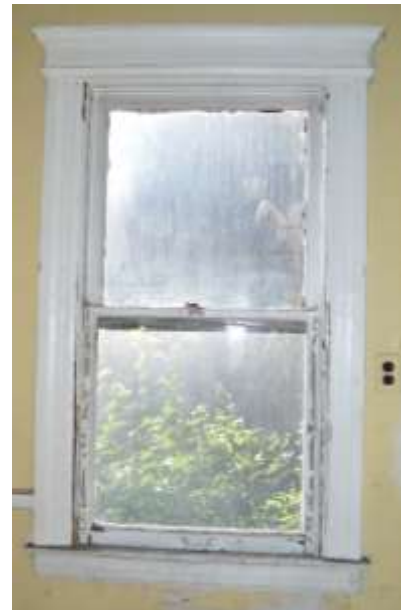
NOTE: windows located in the enclosed rear porch are in worse condition than in the main house, the wall structure is not as stable as the main house. This includes 1st floor windows 8-10, and 2nd floor windows 18-21. Additionally it seems like the first floor windows were salvaged from another location as they are different than any other windows in the house

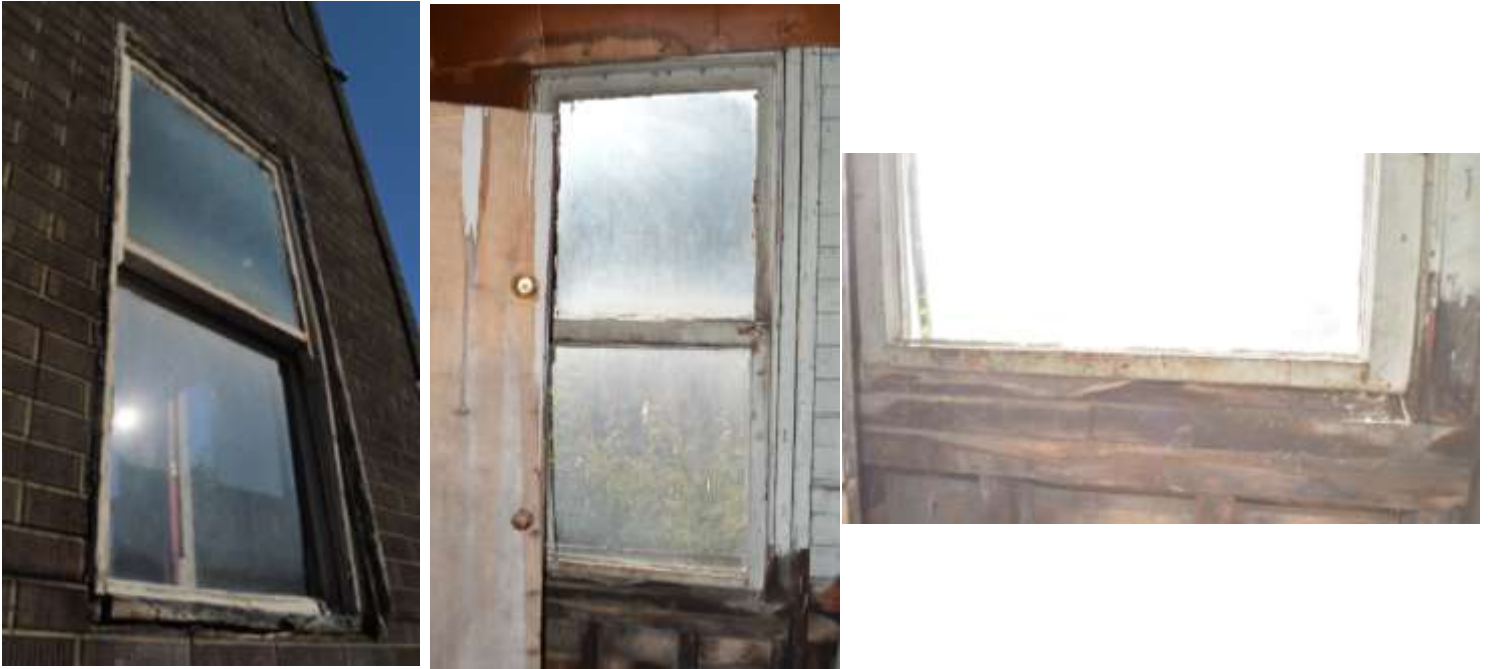
9 – exterior frame rotted, interior frame mostly missing

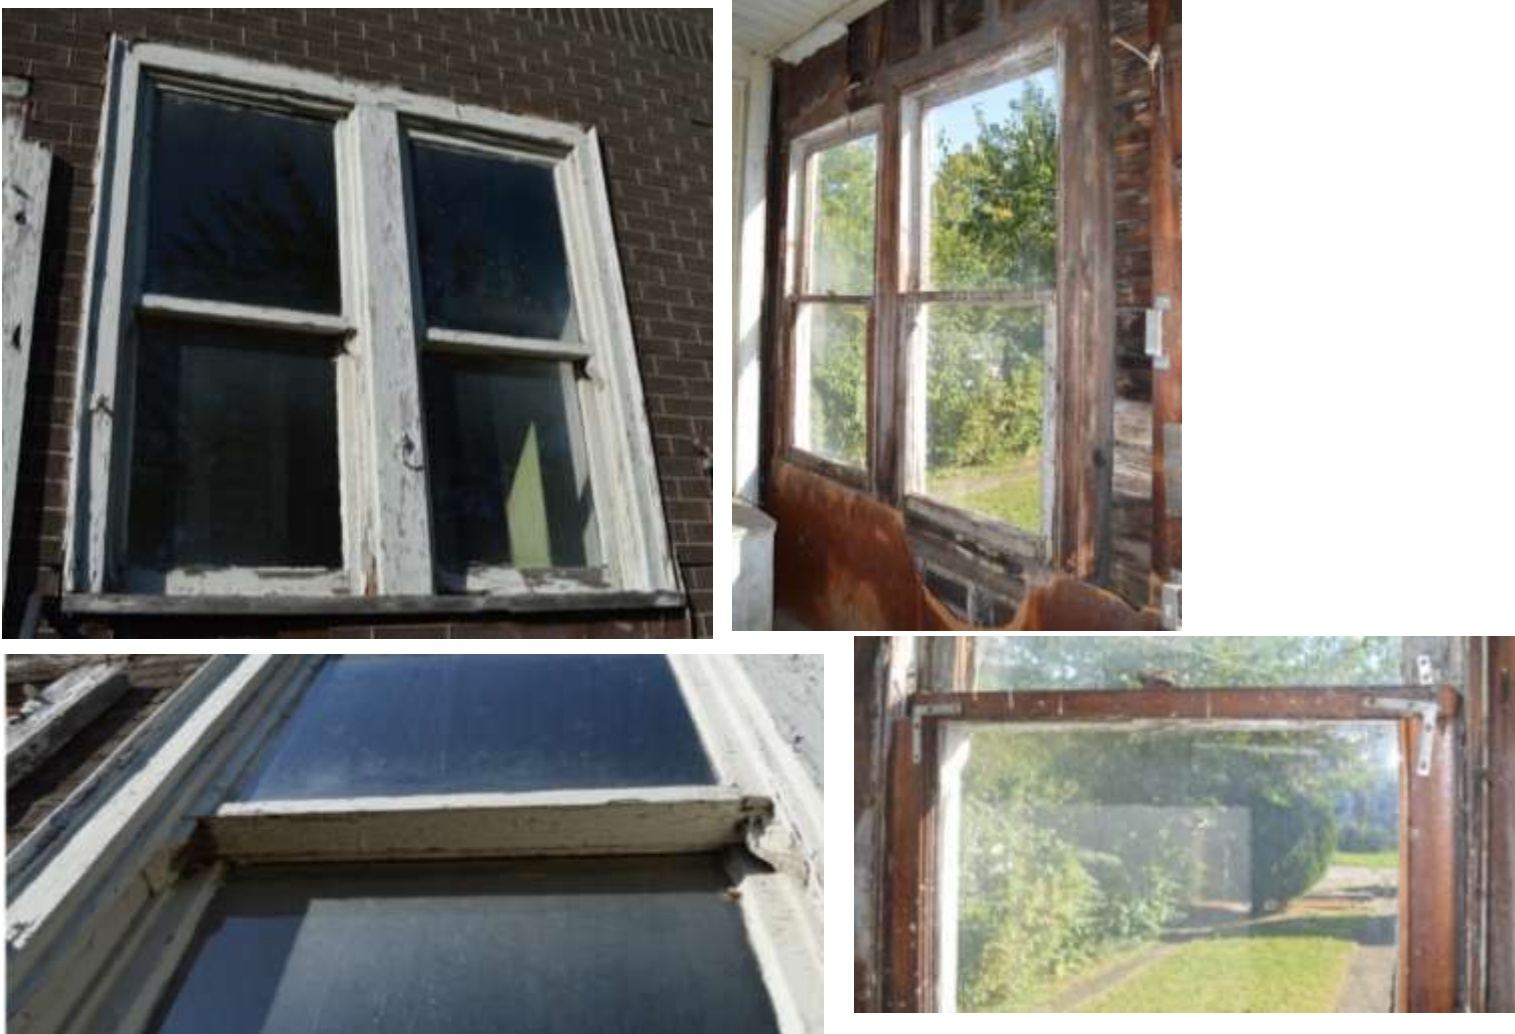
10 – bottom rotted and mildewed (no interior photo)

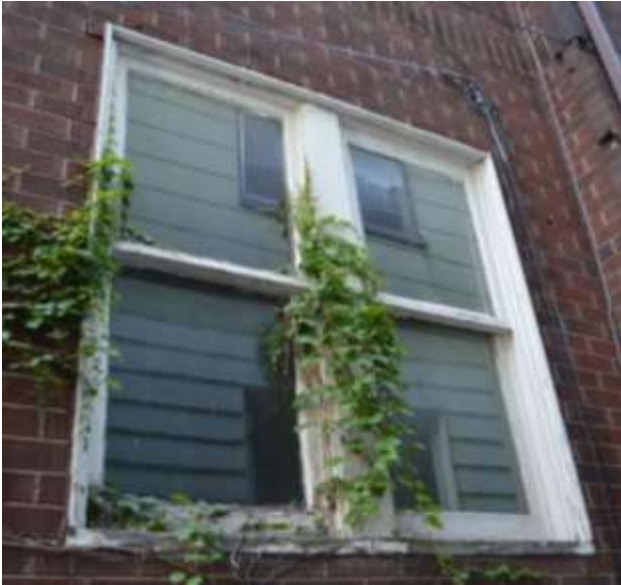
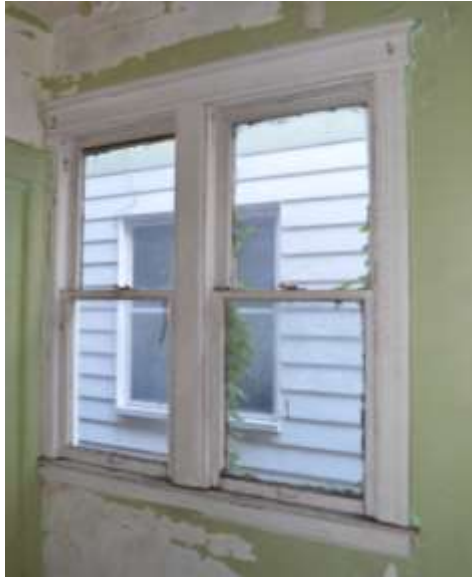
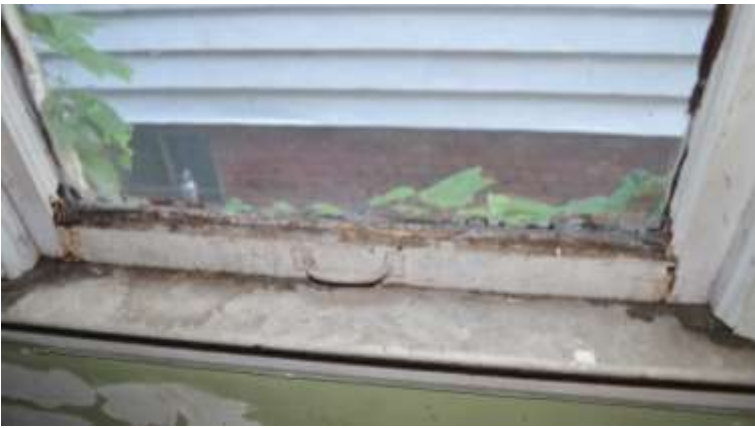
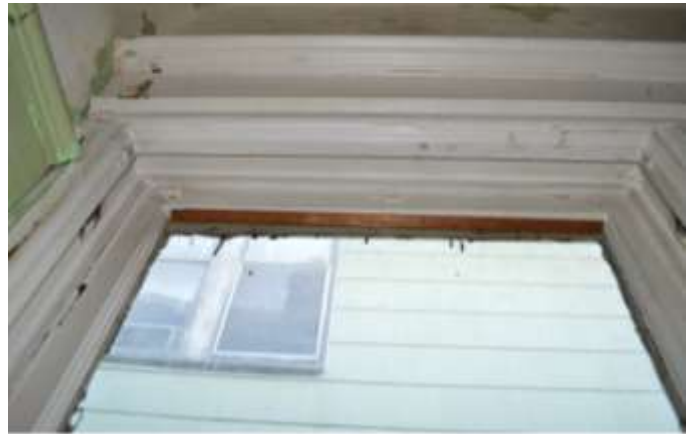
13 – bottom sash rotted – in bathroom, high moisture

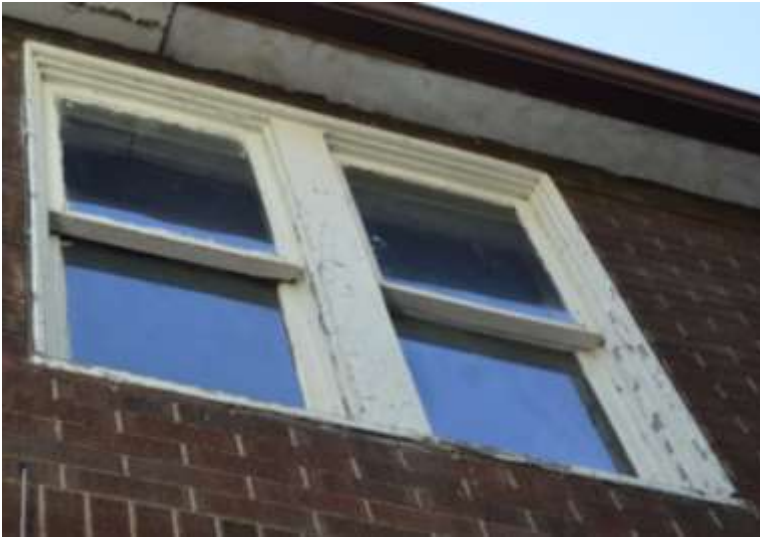
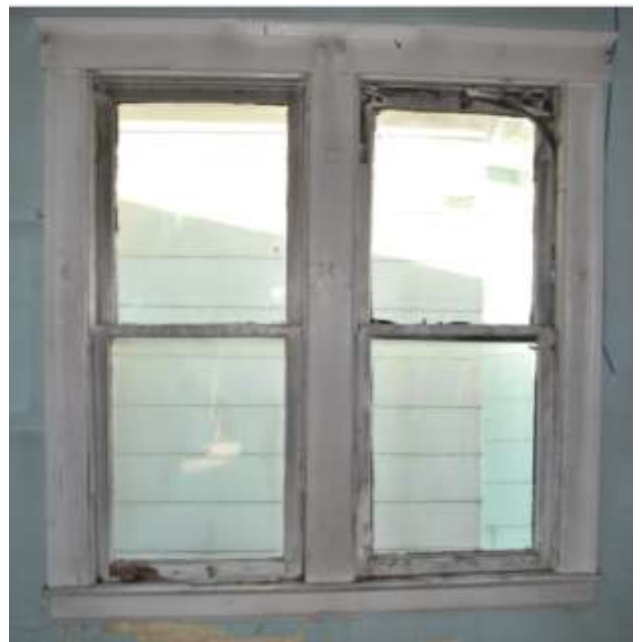
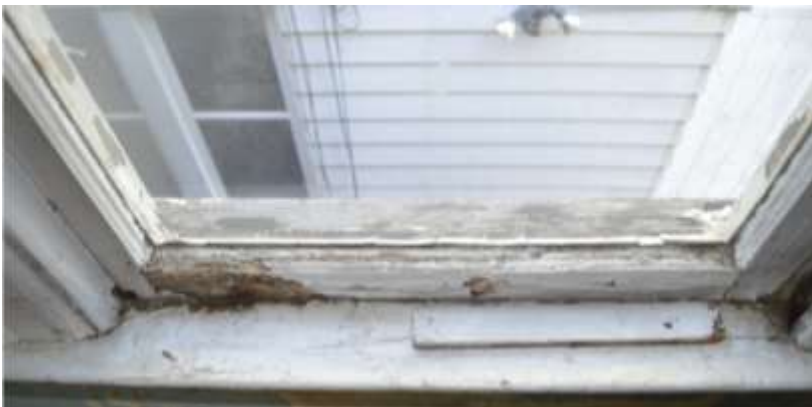
23 – Rotted sill and sash – high moisture area

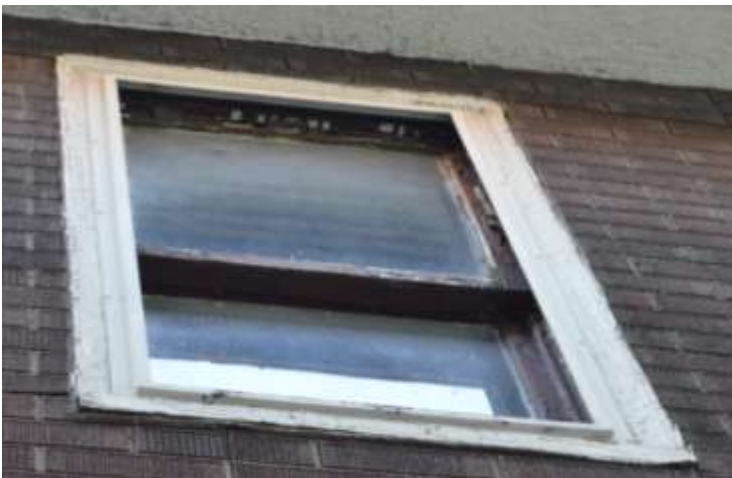
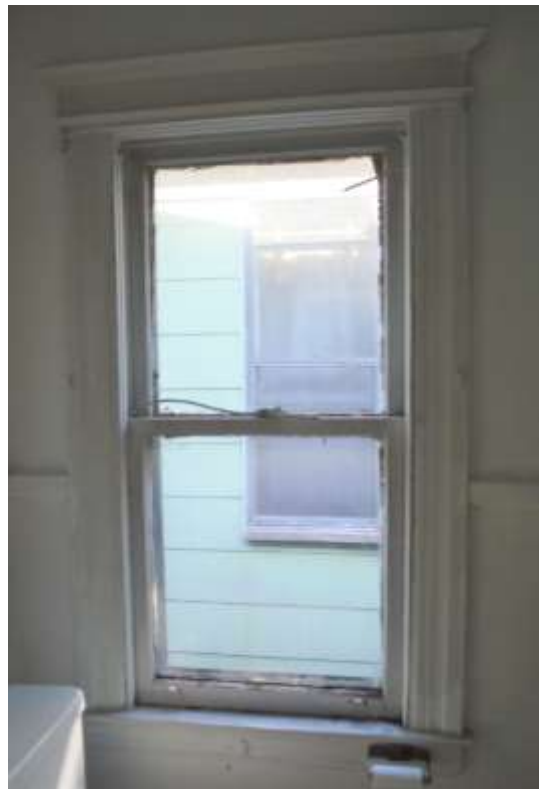
ATTIC WINDOWS – 2 OPENINGS – NOT NUMBERED – These are very deteriorated and have a high likelihood of needing replacement.

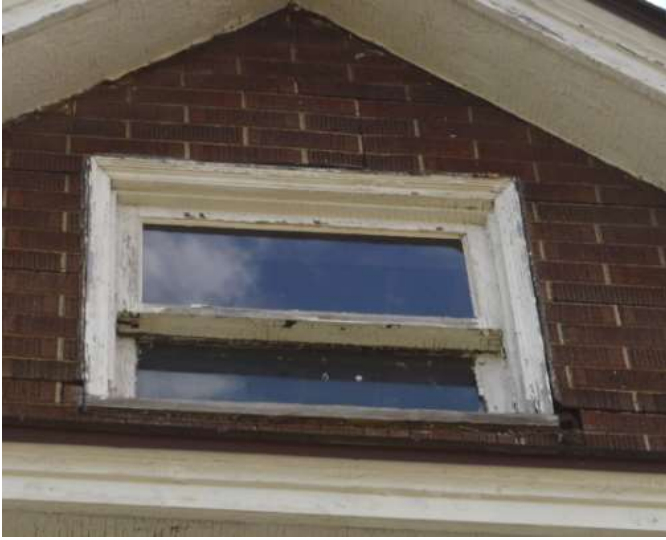
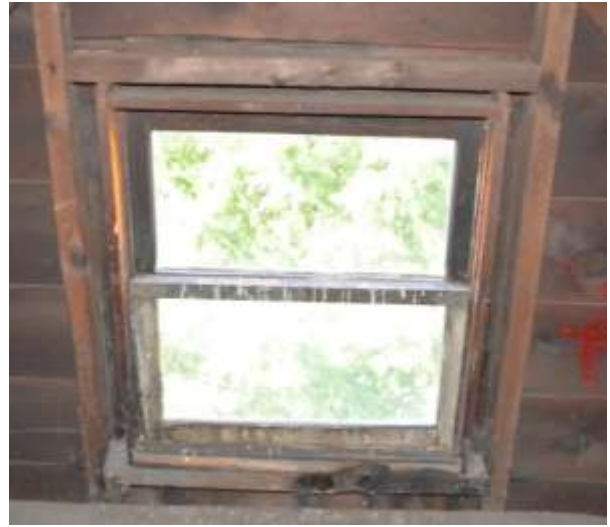
SOUTH SIDE – (no exterior photos) - rotted sill and sash, sash don't close – no interior frame
