150 Bagley, boundaries of building and associated parking lot

150 Bagley, theatre wing proposed for demolition

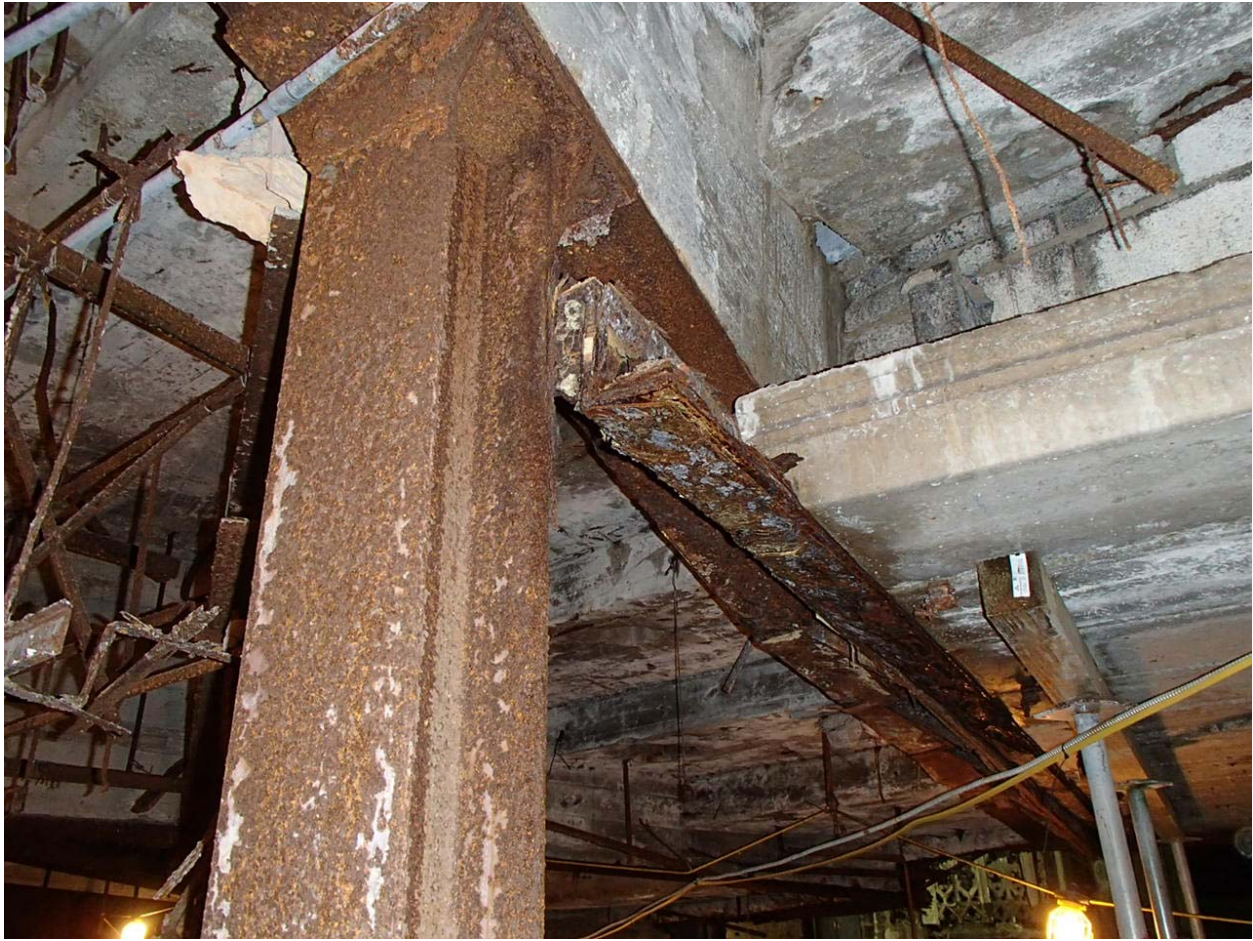
Image #1 - Rusted steel angle supporting concrete balcony floor slab. This corroded steel would need to be completely replaced.

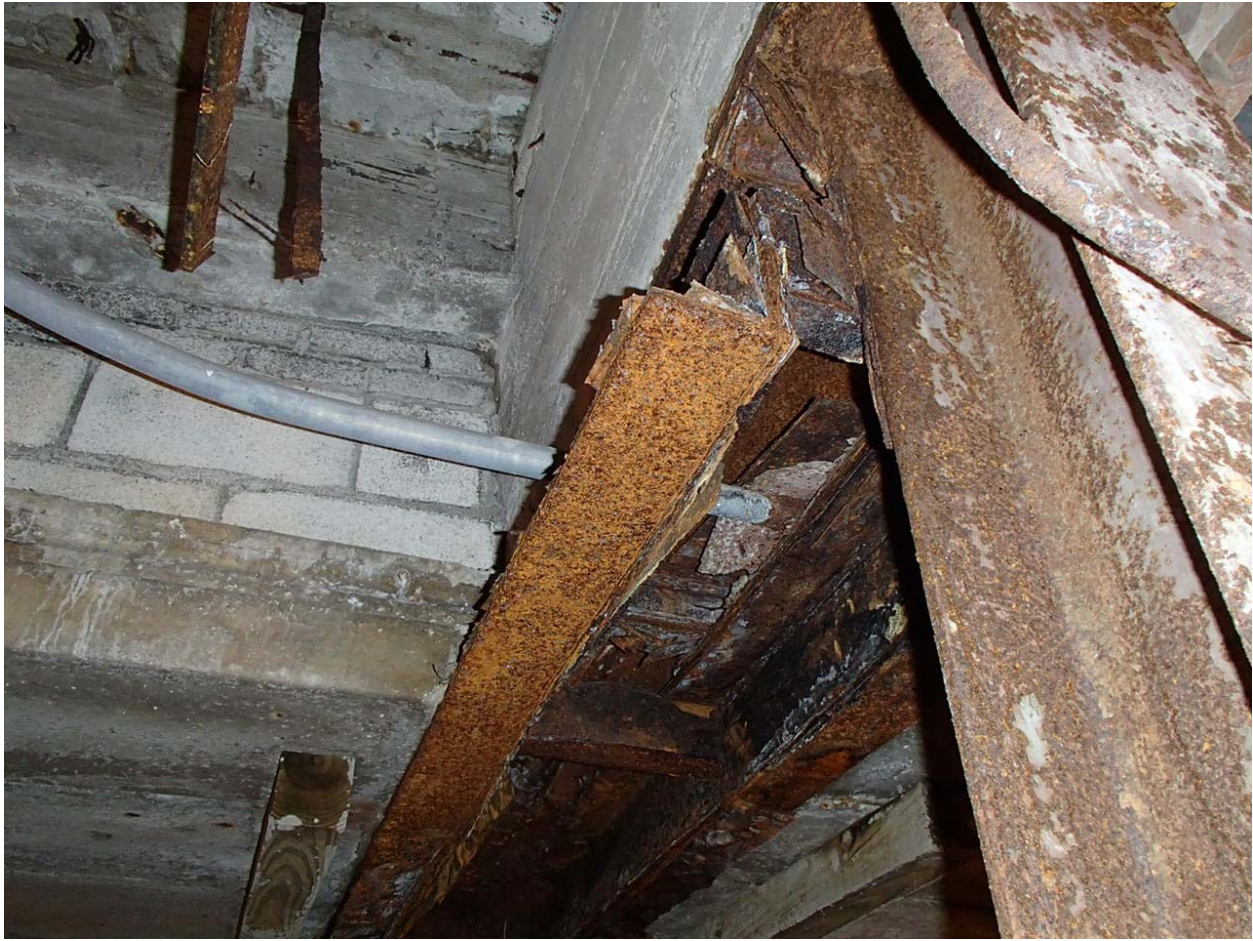
Image #2 - Rusted steel angle supporting concrete balcony floor slab. This corroded steel would need to be completely replaced.

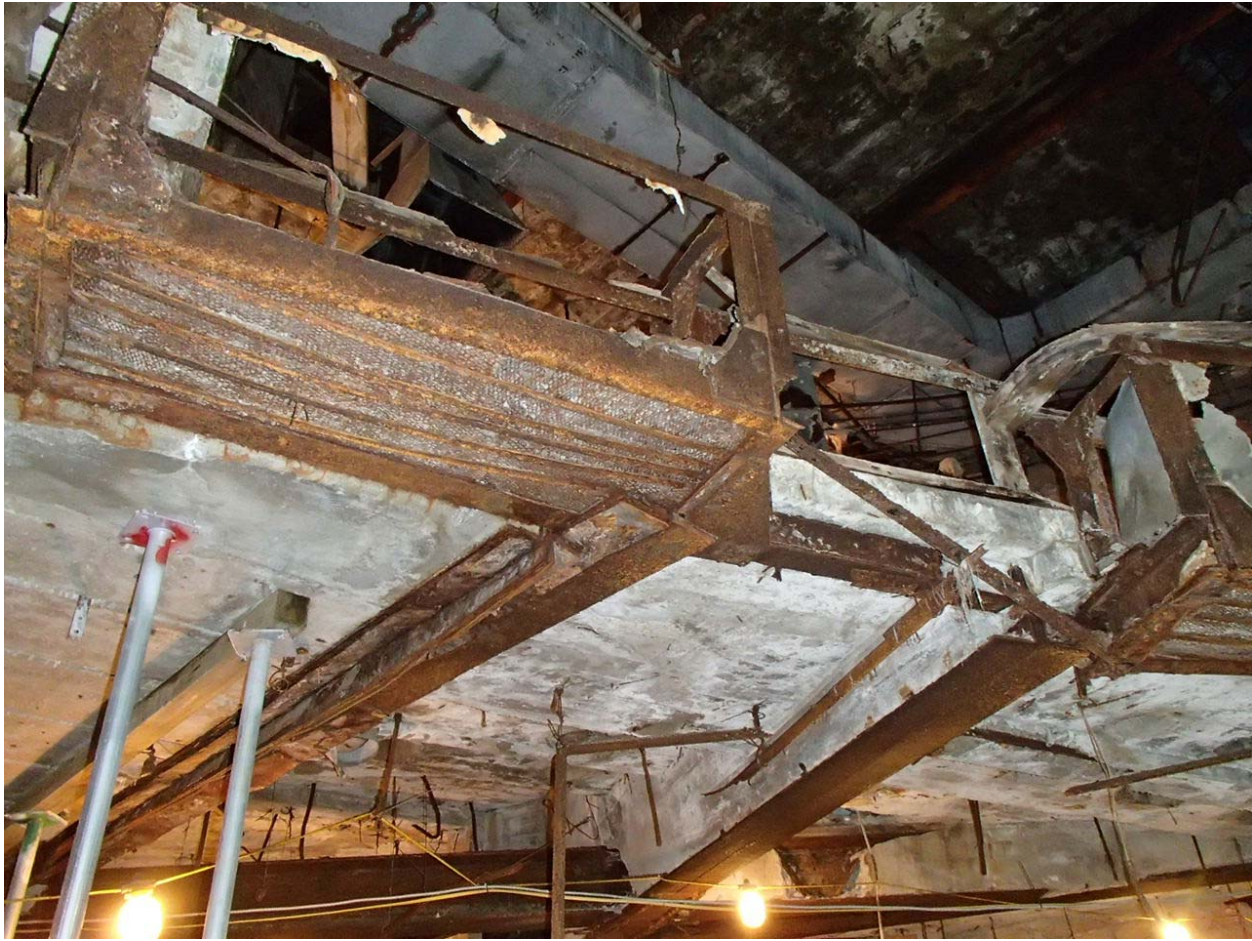
Image #3 – Rusted steel support at front edge of balcony. Much of this corroded steel would need to be completely replaced.

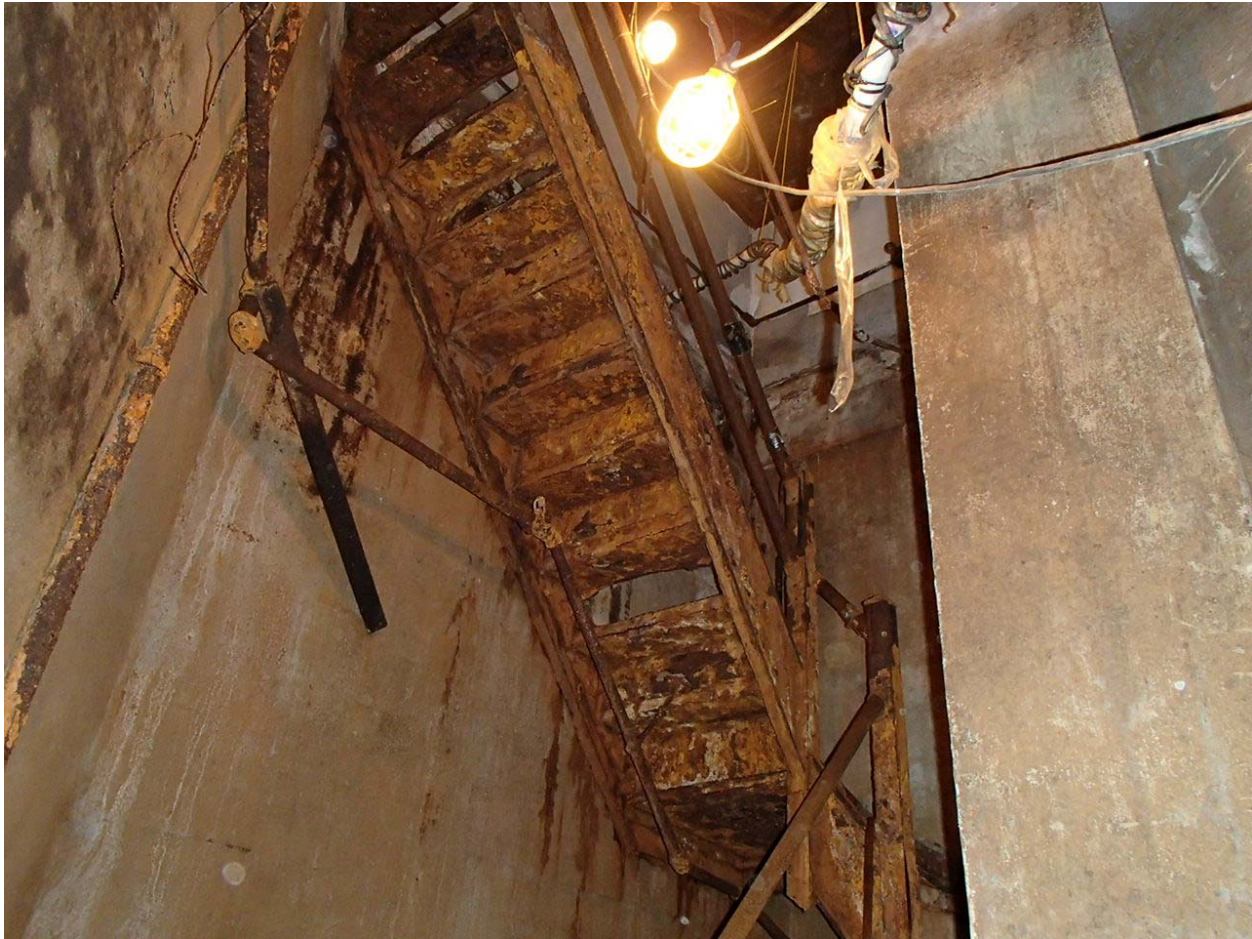
Image #4 – Stairs are very rusted with some risers rusted completely through. The condition of this utility stairs is indicative of the smaller steel members that in many cases have rusted through completely.

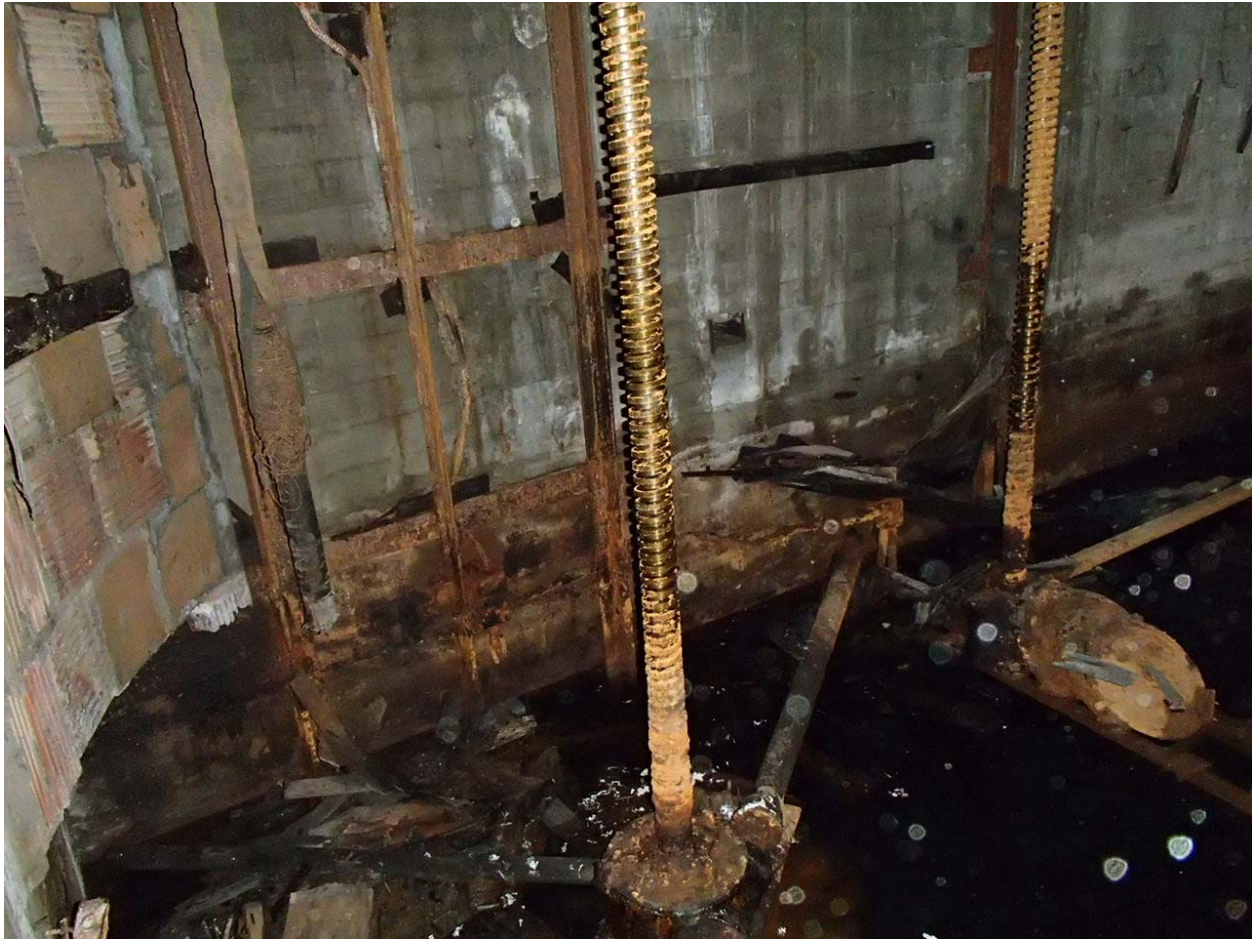
Image #5 – Screw jack mechanism for moveable stage floor. Water intrusion into the orchestra pit will need to be investigated further and mitigated.

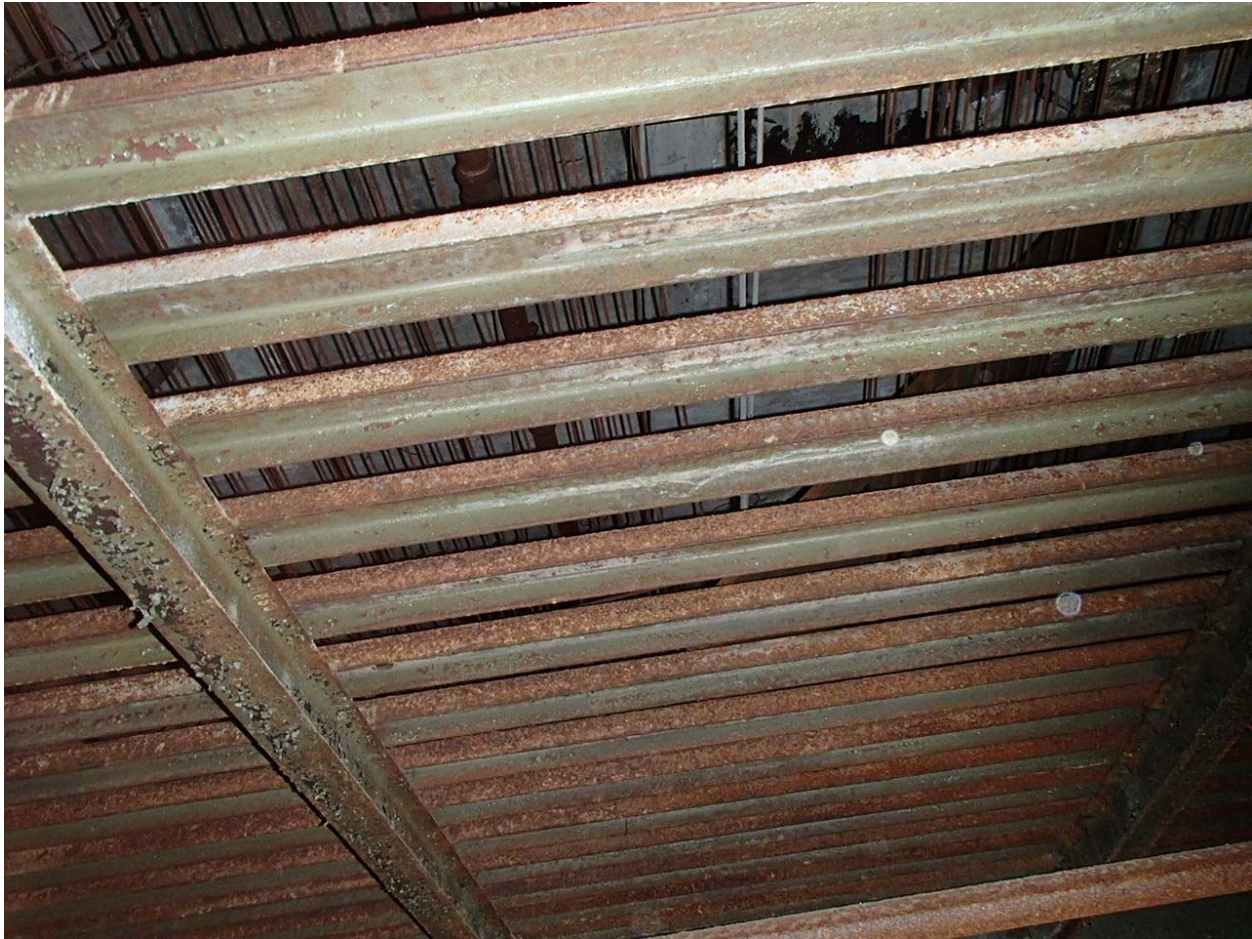
Image #7 – Grid iron floor above the stage has surface rust. This area is below the flat roof above the fly tower, which has been kept relatively water tight. The remainder of the theater space below the “egg shaped” roof was not kept water tight and has much more severe deterioration of the structure below.

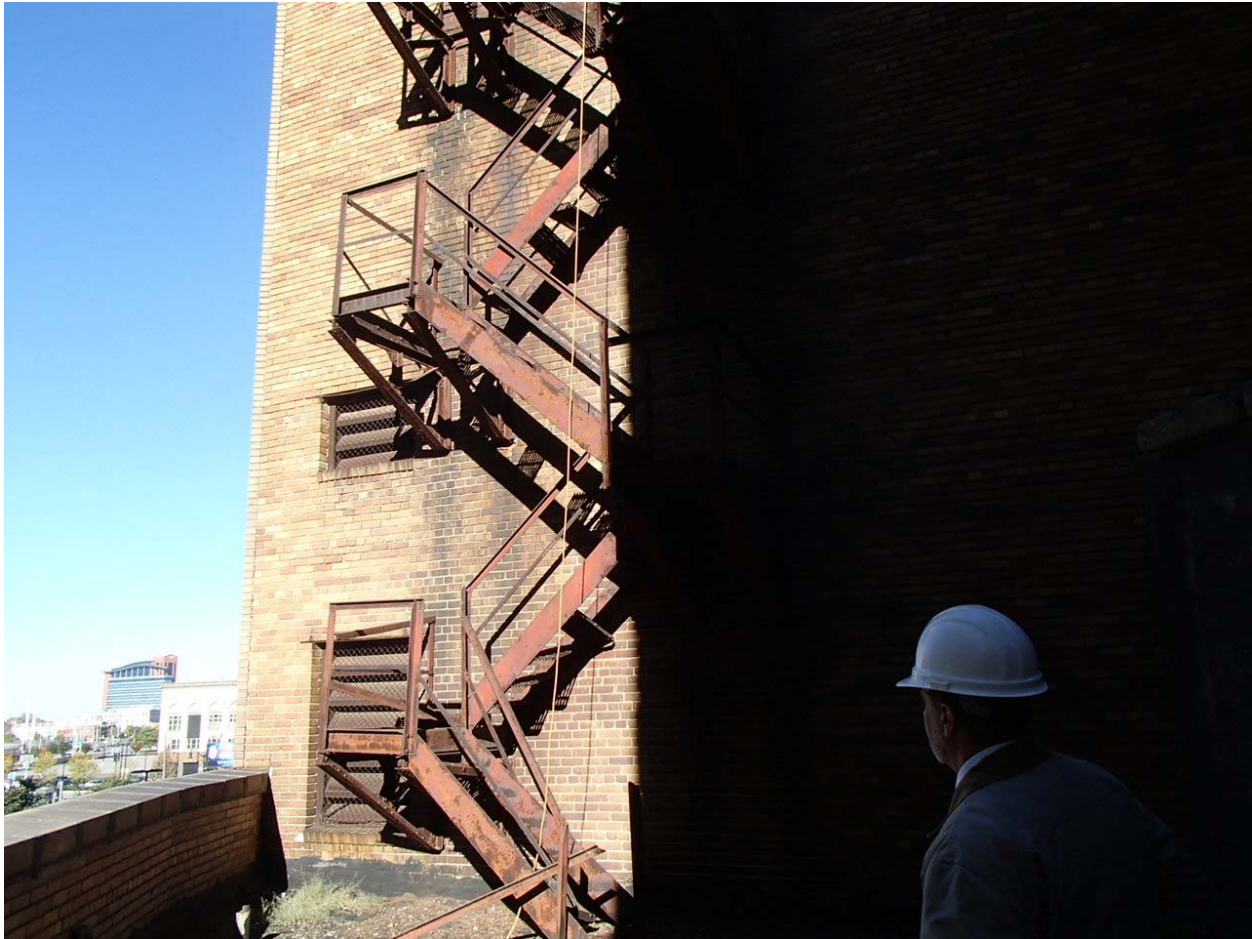
Image #9 – Exterior fire escape is unsafe as it is missing several treads.

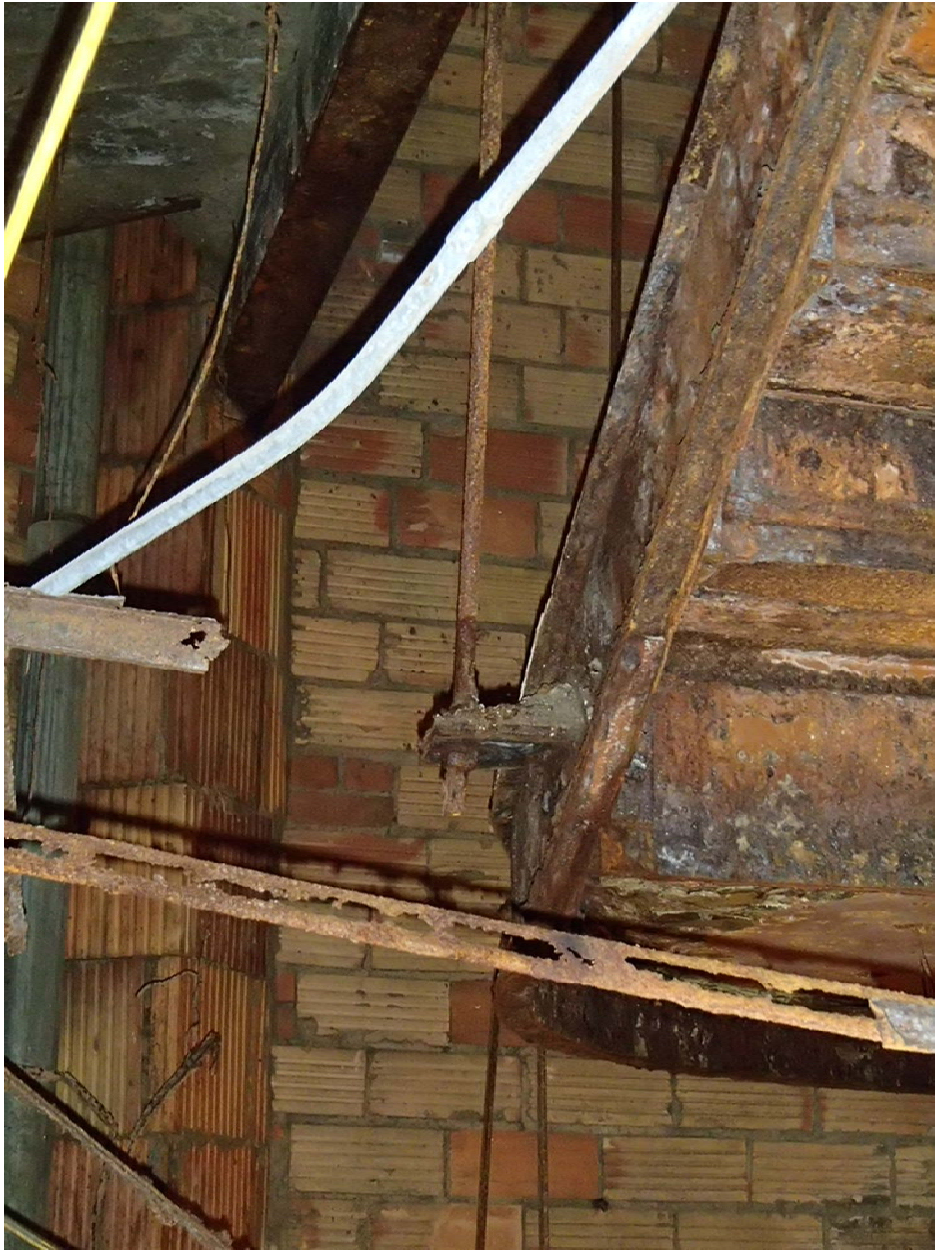
Image #10 – Interior stair stringer is supported by a hanger rod.

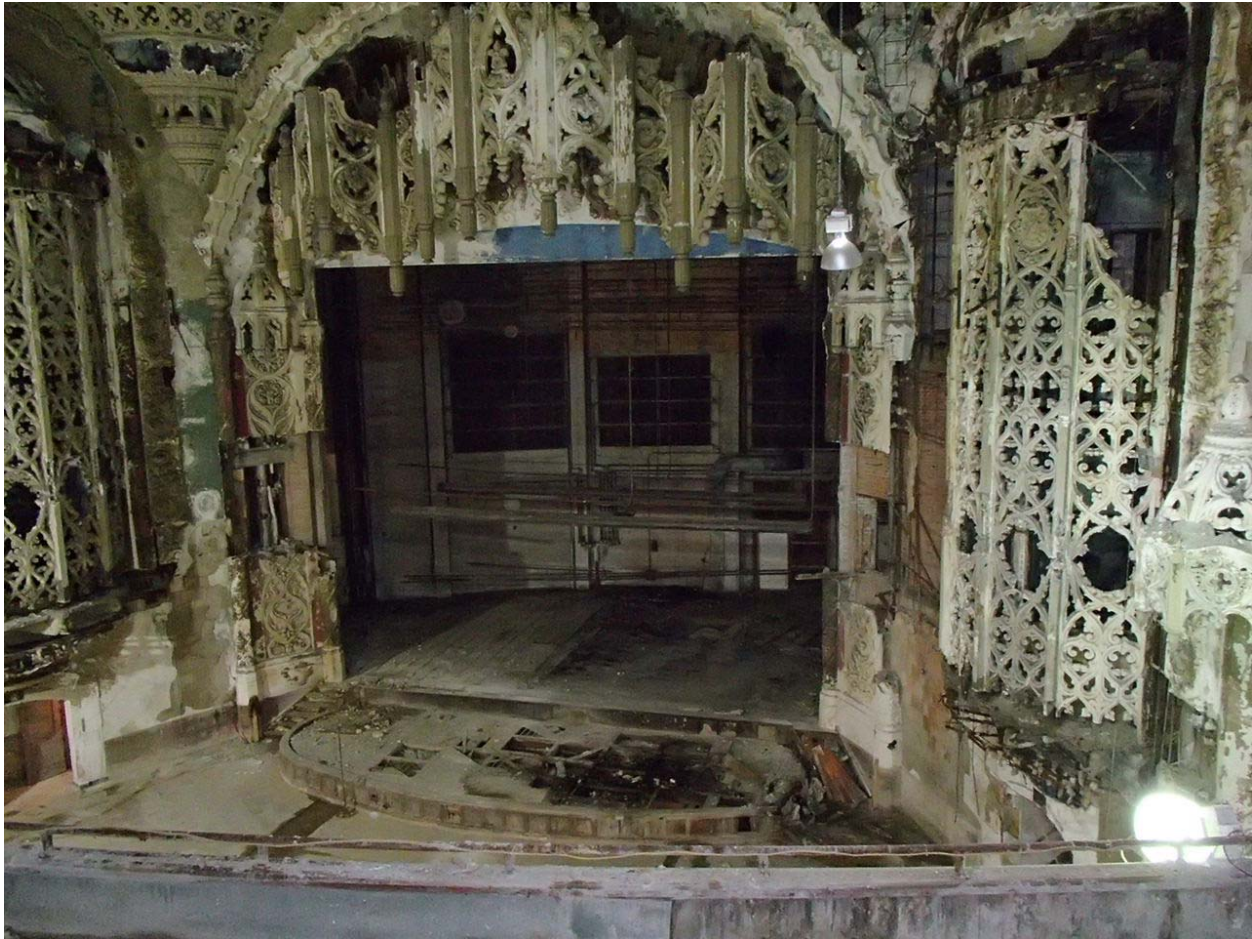
Image #11 – Portion of stage with curved front edge is a vertically operable section of floor with wood floor deck and framing spanning between steel beams. The wood framing has severely deteriorated due to water intrusion.

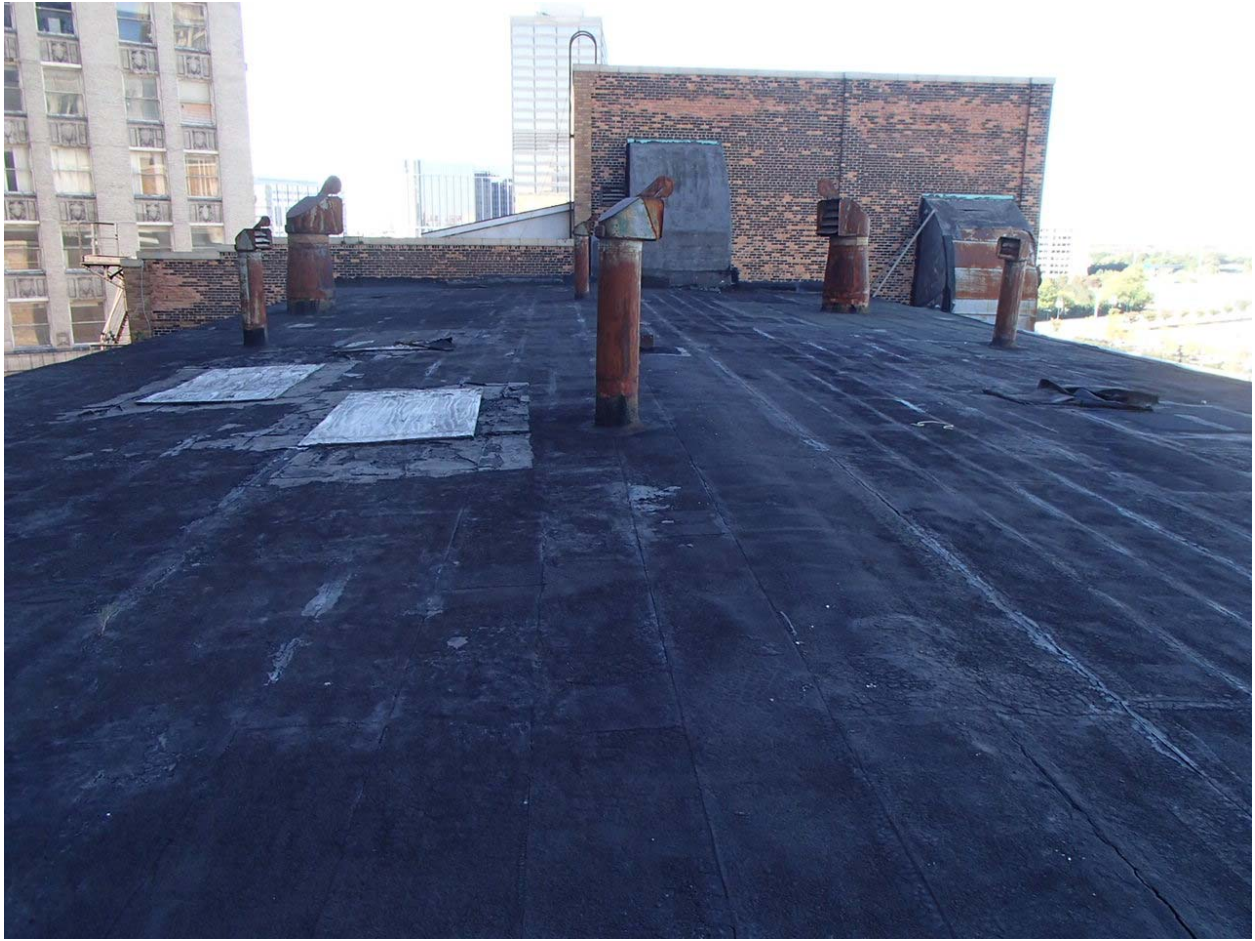
Image #12 – Main roof above theater seating area.

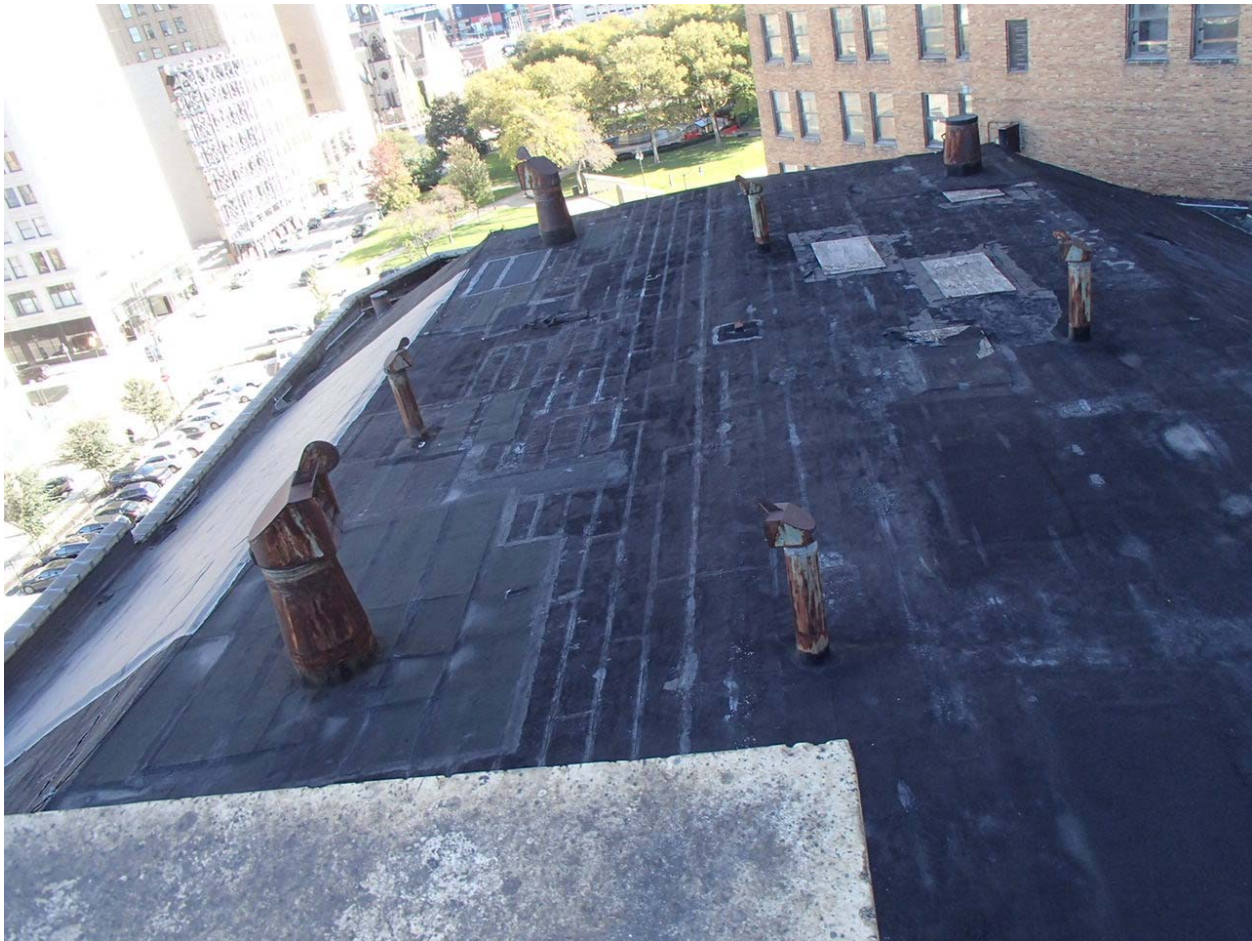
Image #13 – Main roof above theater seating area viewed from high roof above the fly loft. Gutter formed by roofing flashed to very short parapet along exterior wall has leaked water into exterior brick bearing wall below. With no railing and such a short parapet, the access to clean the drains and maintain the flashings is dangerous. The failed gutter and parapet coping and flashing has resulted in significant damage to the exterior brick wall below. We estimate 50% of the brick on the west façade will require repair and/or replacement as a result of this condition.

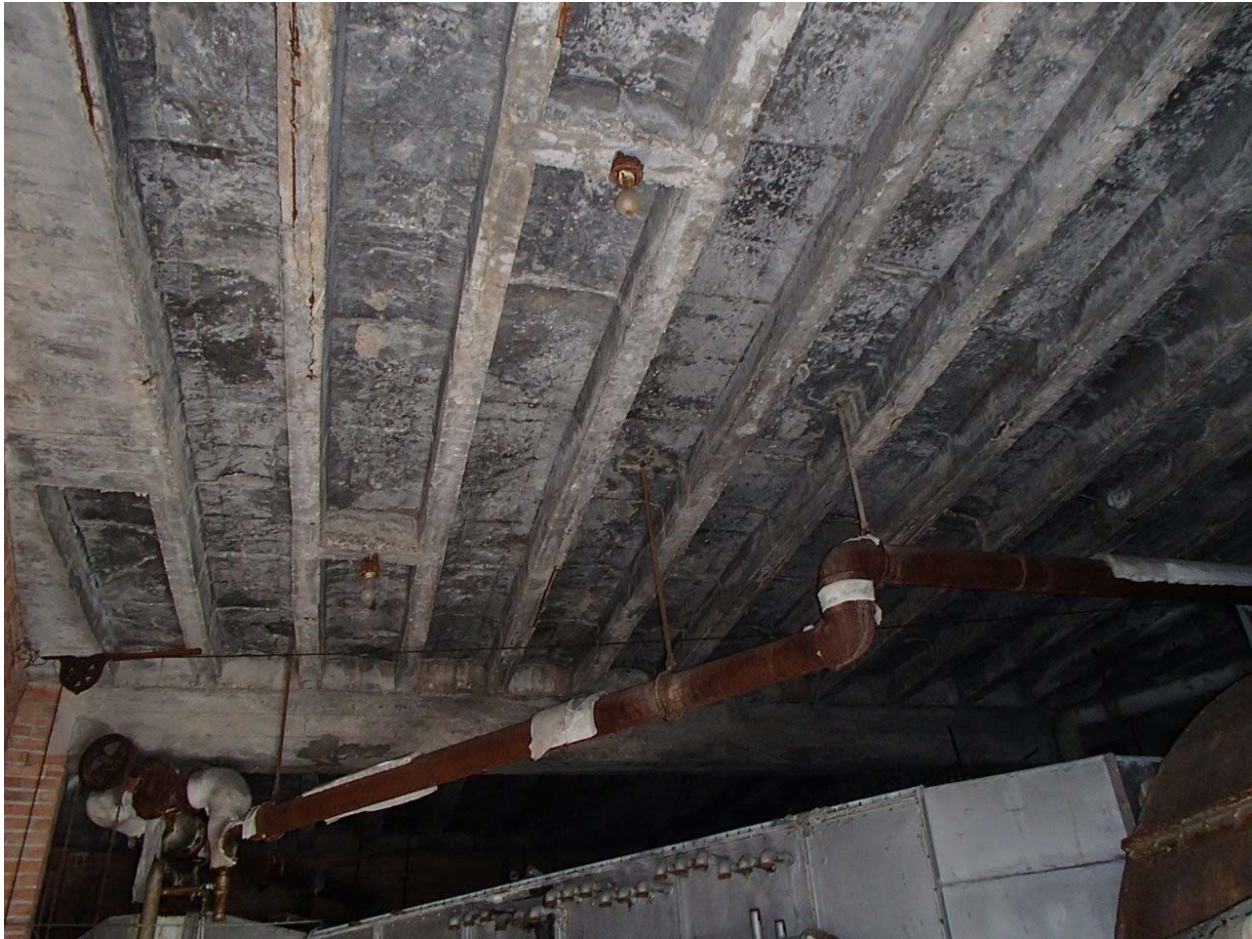
Image #14 – Underside of flat roof structure of fly tower - note there is some spalled concrete at rusted rebar locations.

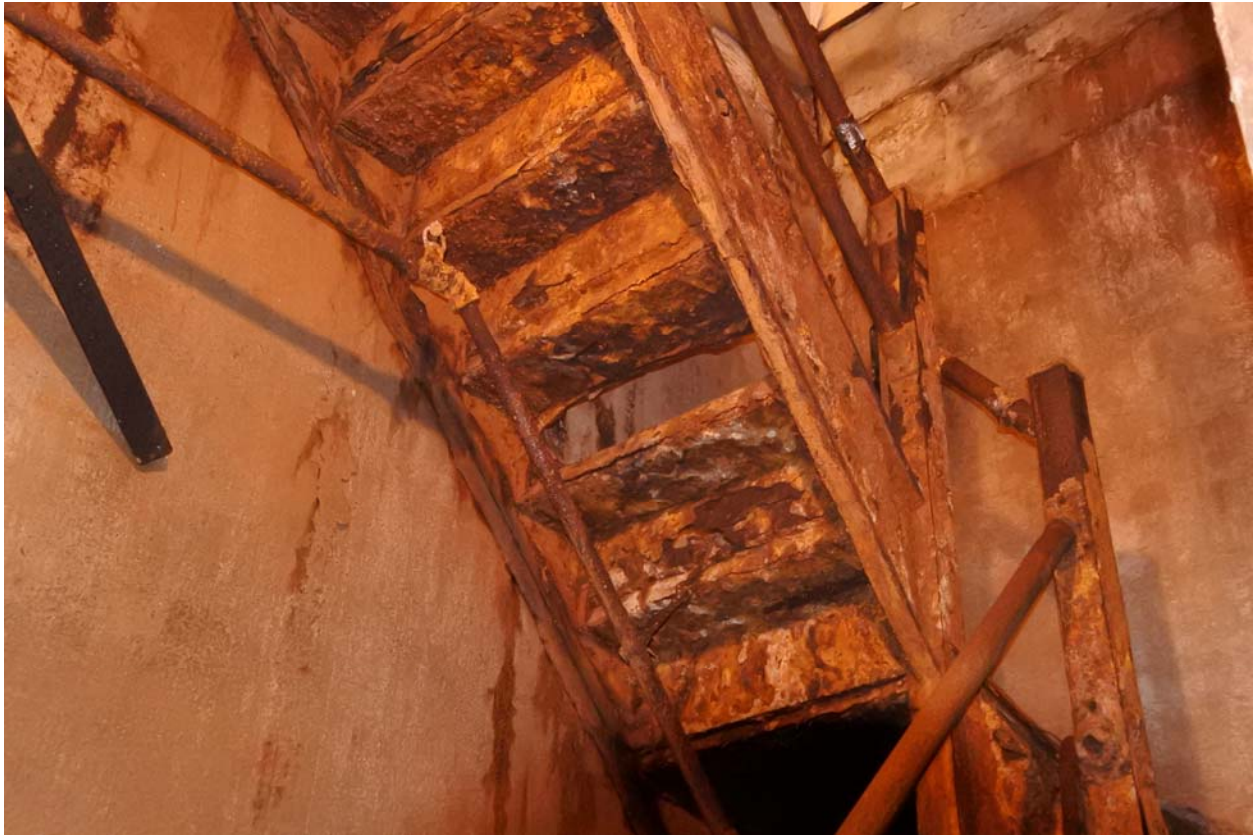
Image #16 – Rusted stairs to lower level.

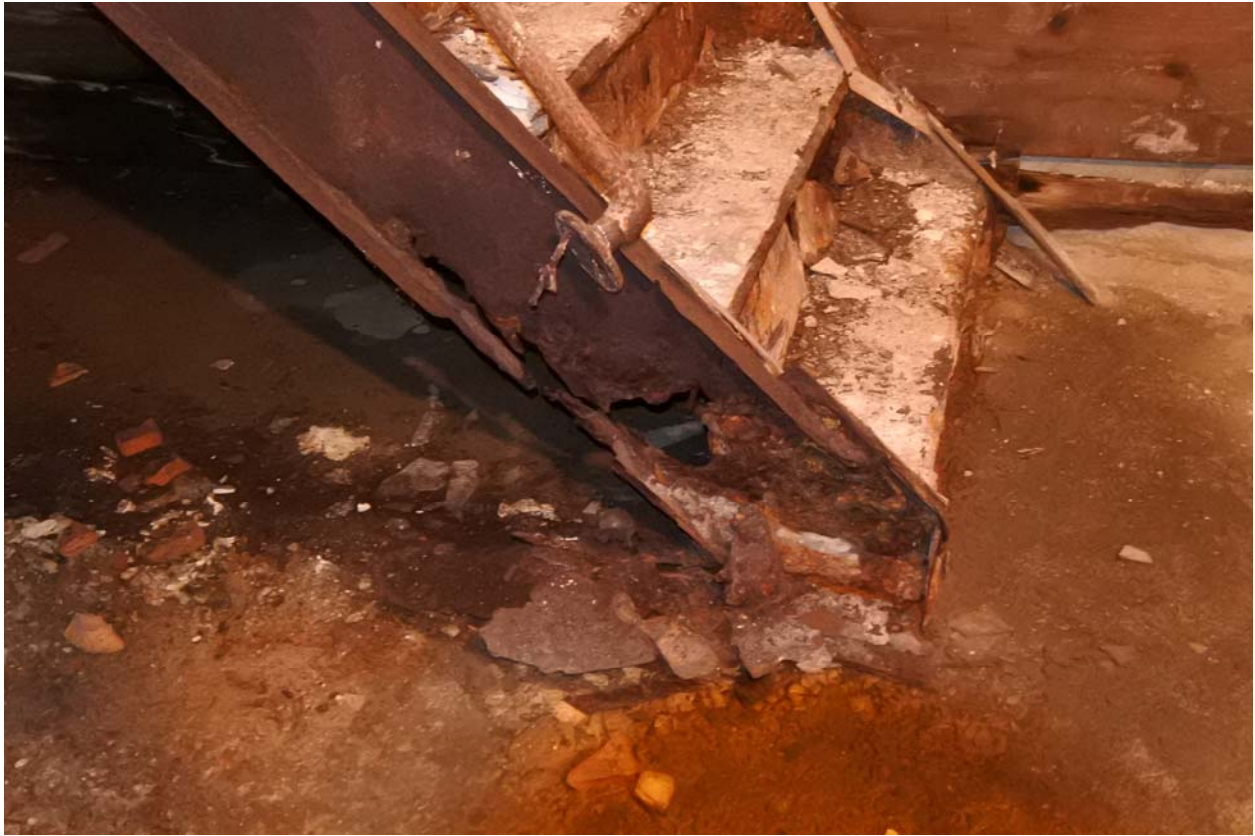
Image #17 – Rusted stairs.

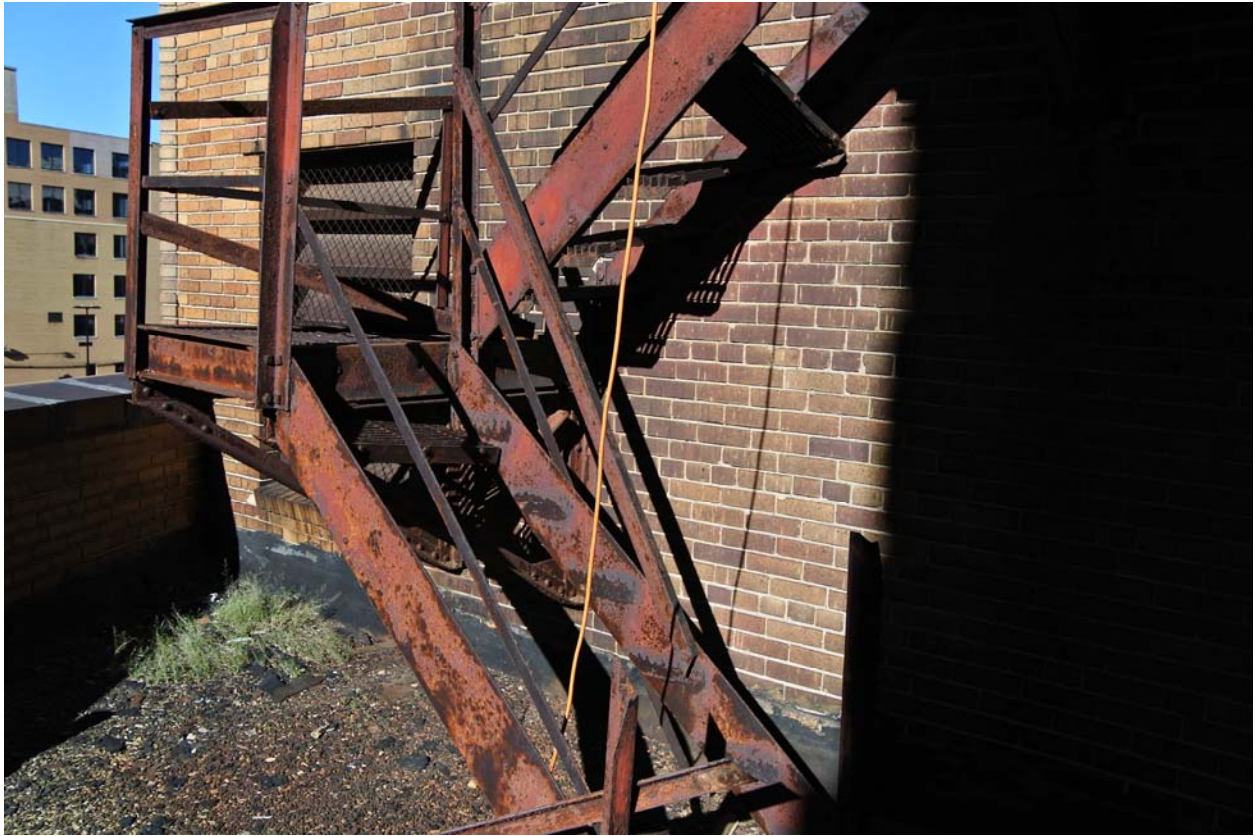
Image #18 – Rusted fire escape with missing treads.

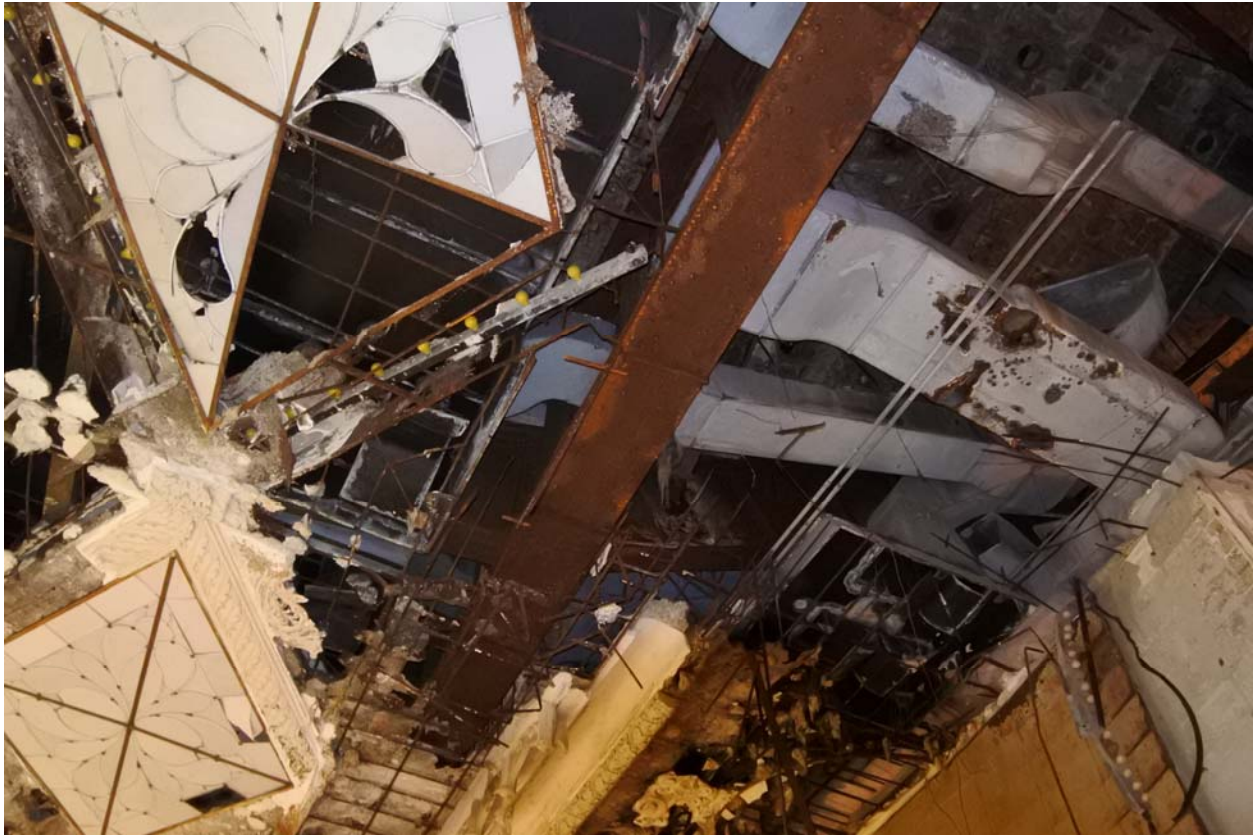
Image #19 – Underside of balcony has heavy plate girder supporting built-up steel “raker” beams that appear to have only surface rust where they are exposed. Less than half of the balcony framing could be observed due to some ceiling finishes still being in place.

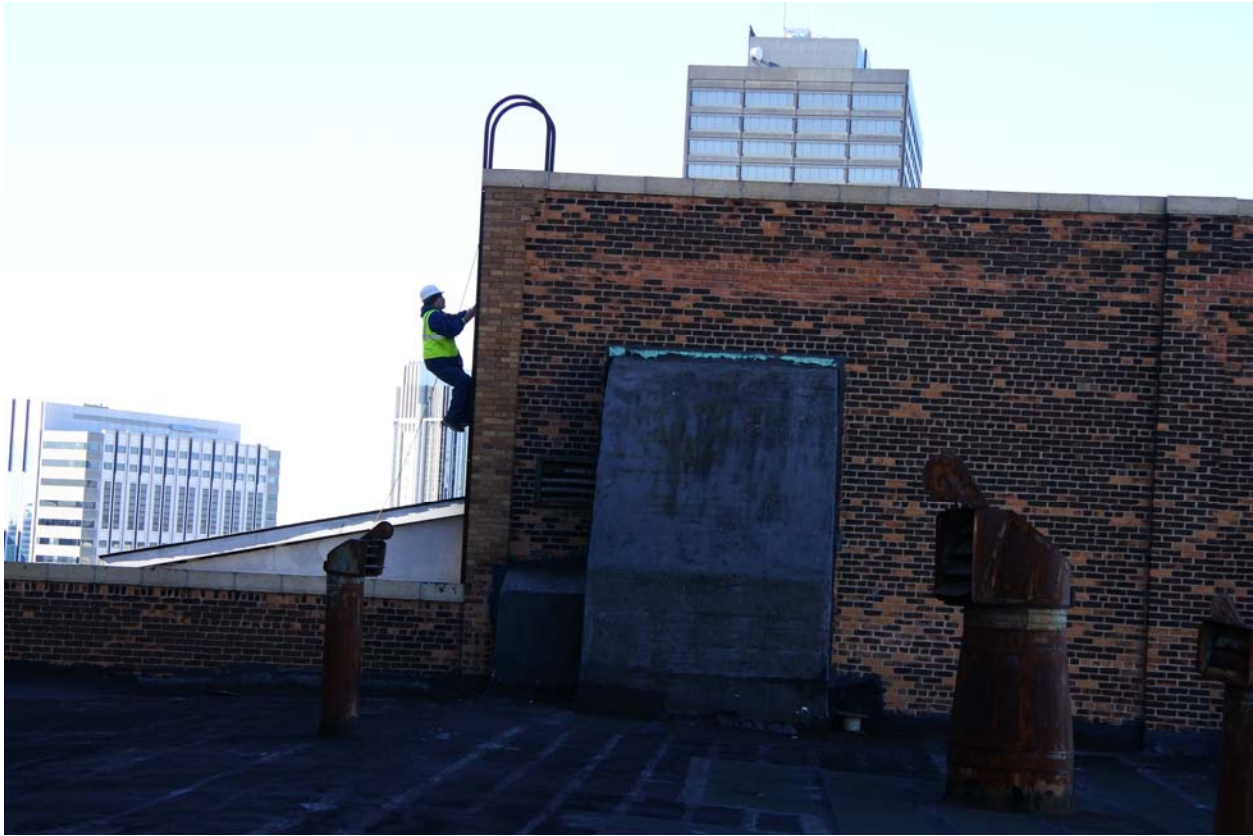
Image #20 – Nadir climbing to roof above stage.

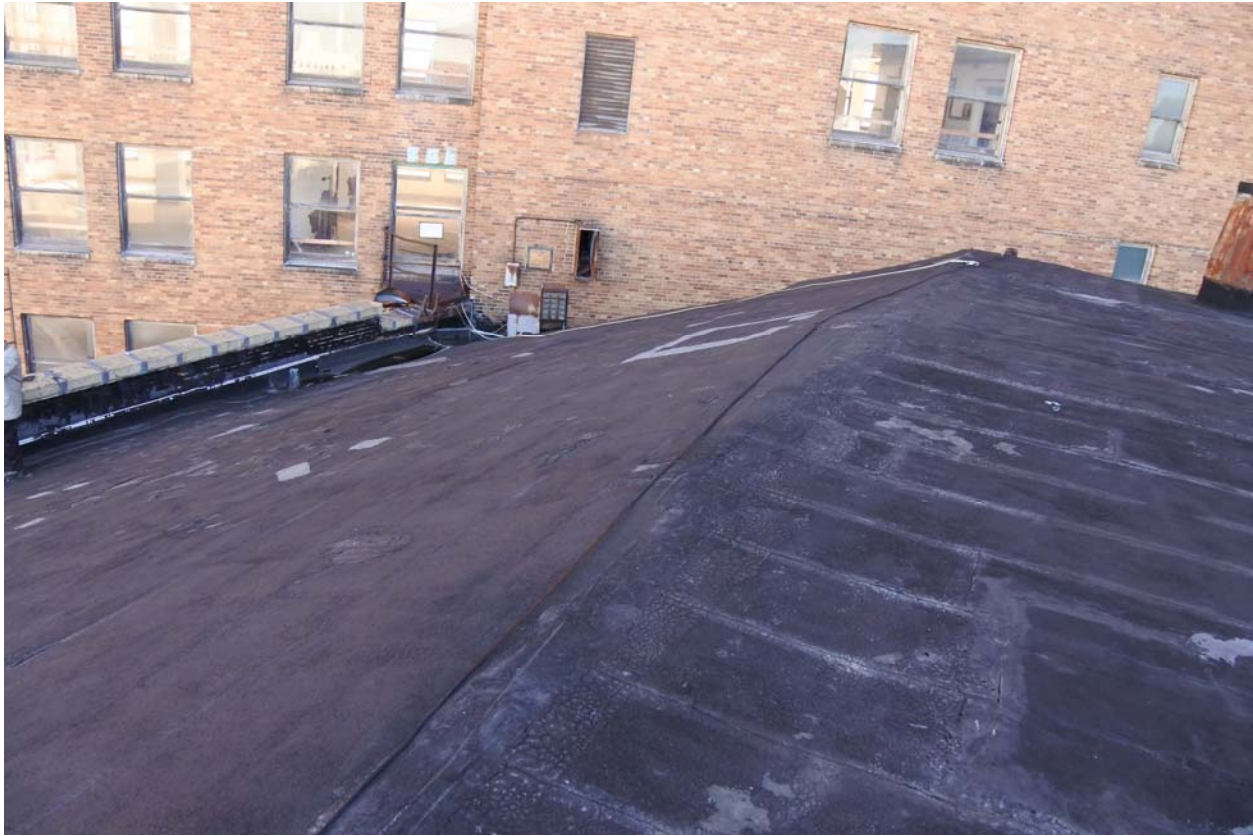
Image #21 – Typical view of main “egg shaped” roof. Structure below is steel trusses and purlins supporting a gypsum plank roof deck. Photos and written report by others done in 2007 indicate the gypsum deck is heavily water damaged, and sagging, and must be completely replaced.

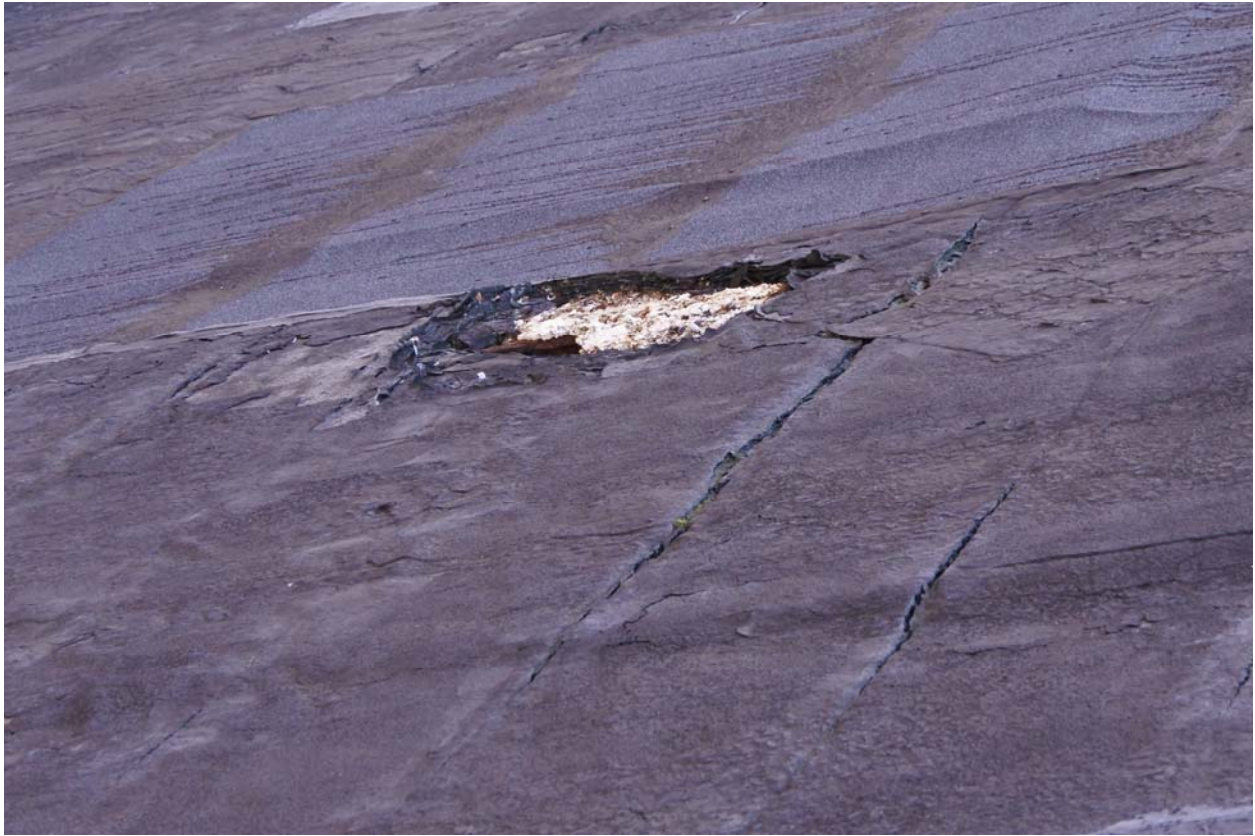
Image #22 – Roof damage

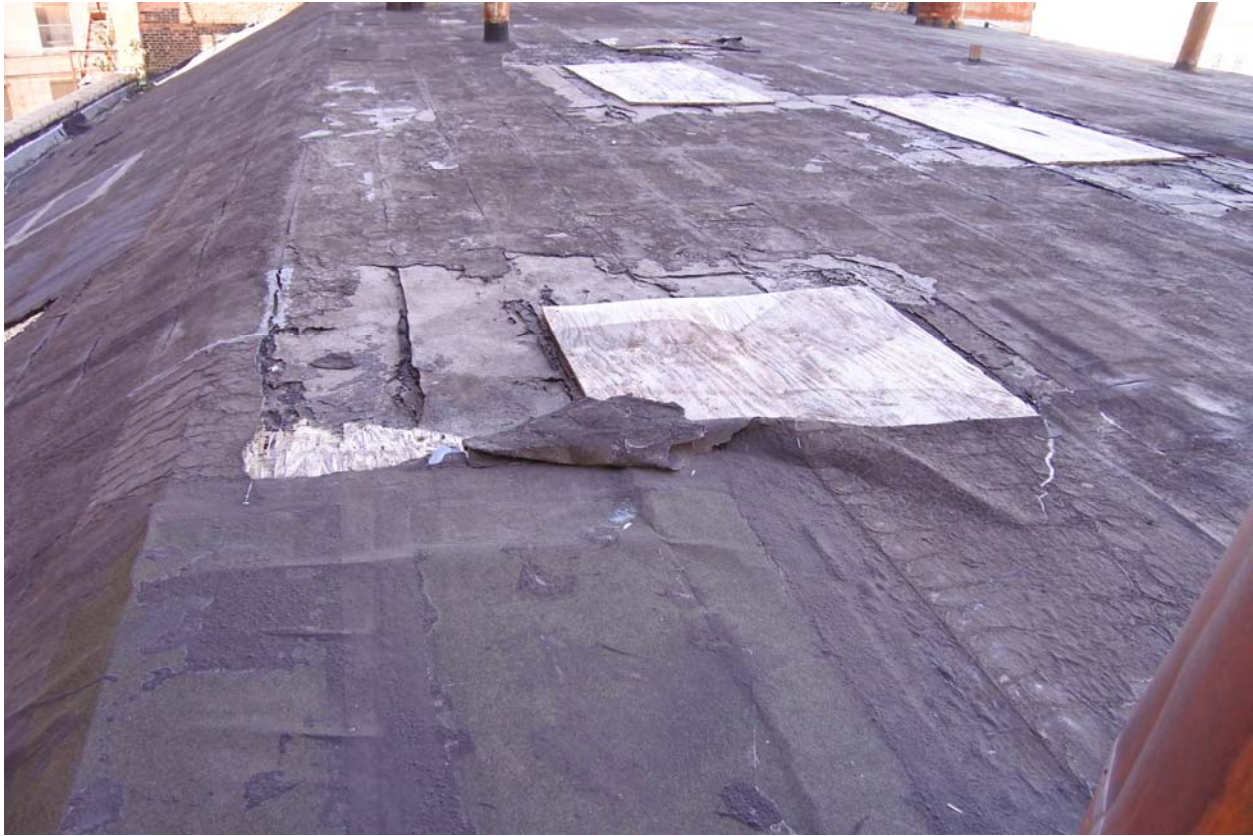
Image #23 – Roof has several plywood panels and poorly constructed patched areas.
