150 Bagley, boundaries of building and associated parking lot

150 Bagley, theatre wing proposed for demolition

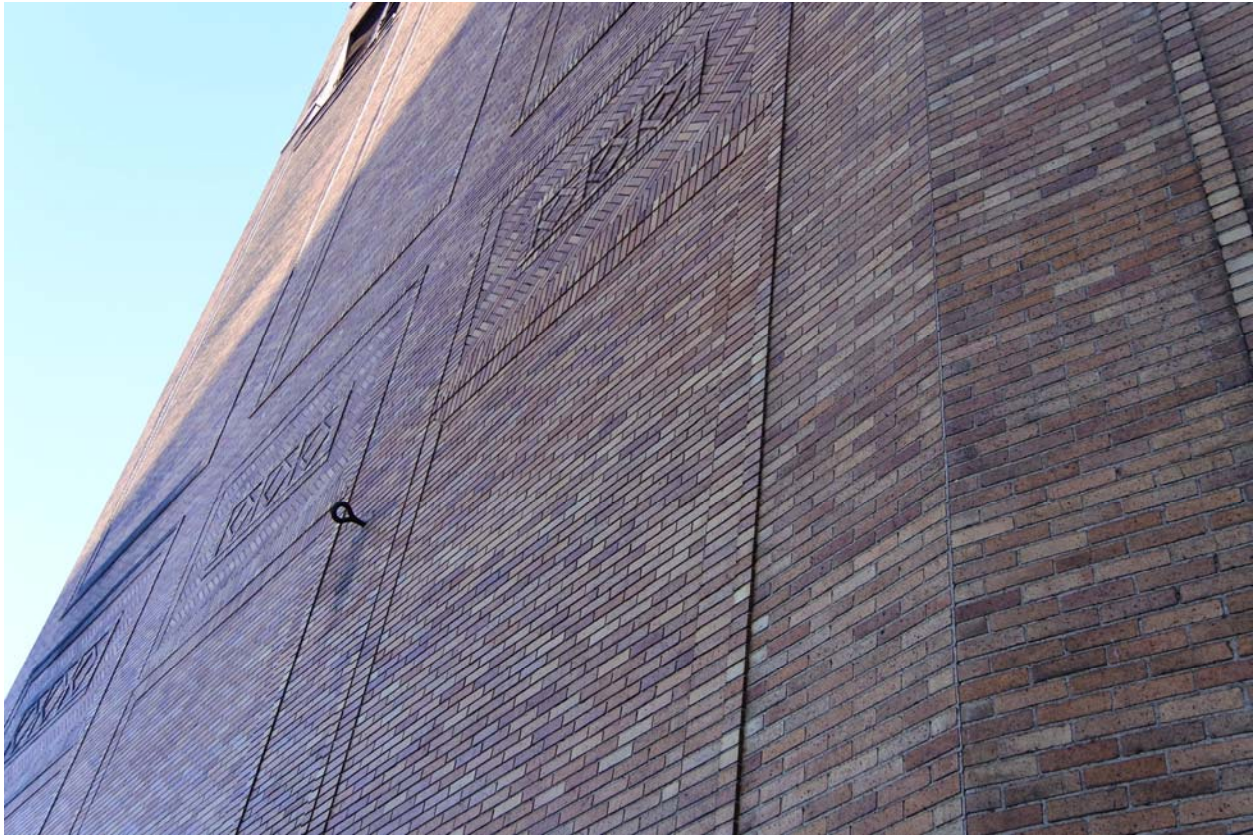
Image #24 – Photo of the lower portion of the exterior brick on Clifford Street (south elevation) is in good condition however the brick near the top of this wall is pulling away from the back-up wythe and must be re-anchored. The sidewalk here should have a protective roofed scaffold constructed until repairs can be made.

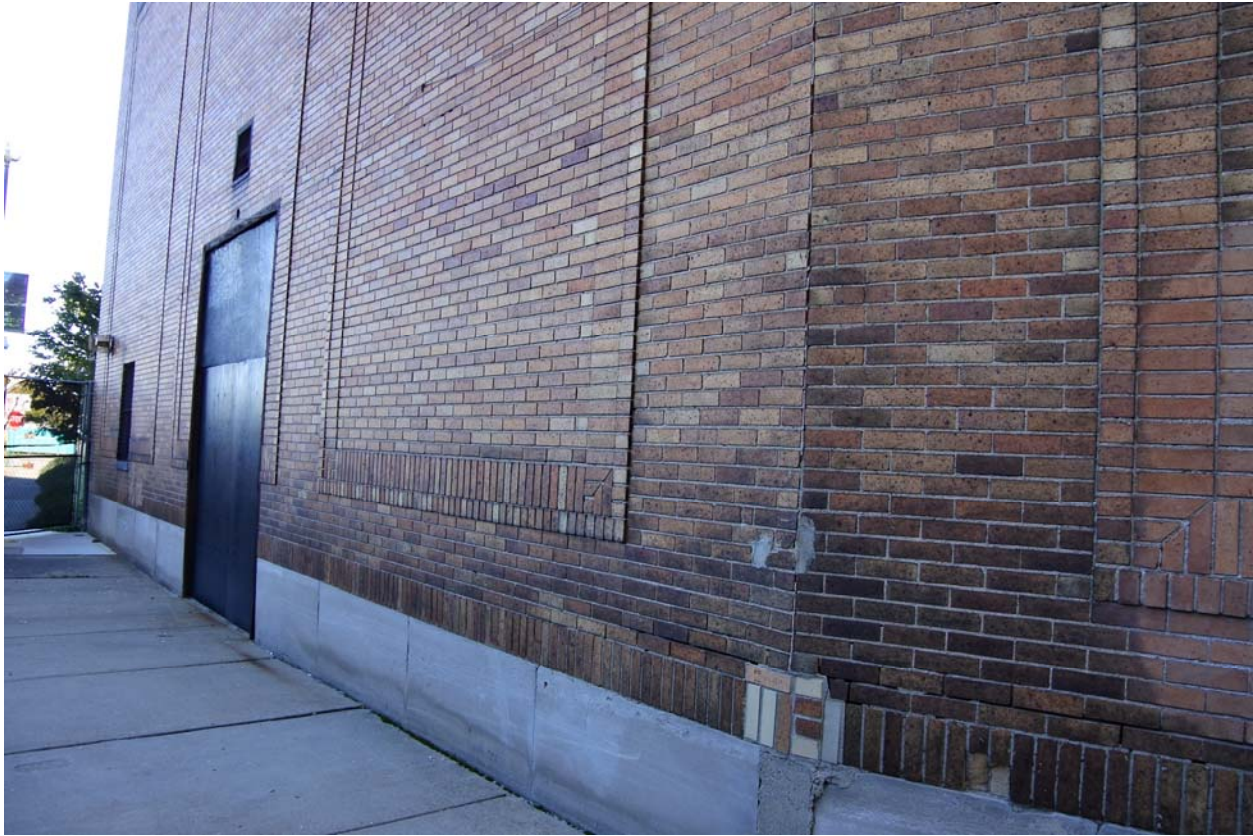
Image #25 – The exterior brick on the lower portion of the Clifford Street side appears to be in good condition with minor repairs required at the corners however the brick near the top of this wall is pulling away from the back-up wythe and must be re-anchored. The sidewalk here should have a protective roofed scaffold constructed until repairs can be made.

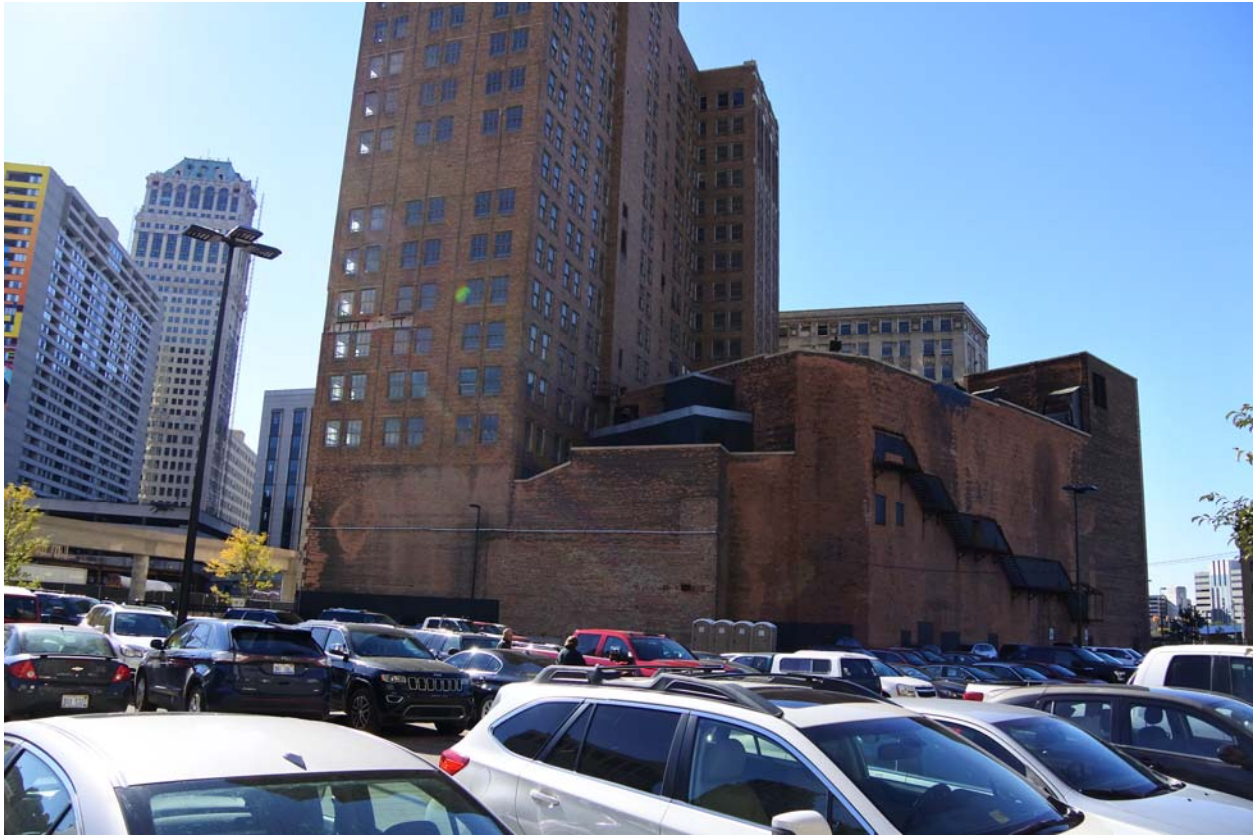
Image #26 – Exterior view from West Adams Street across parking lot. The brickwork facing the parking lot has areas of deterioration.

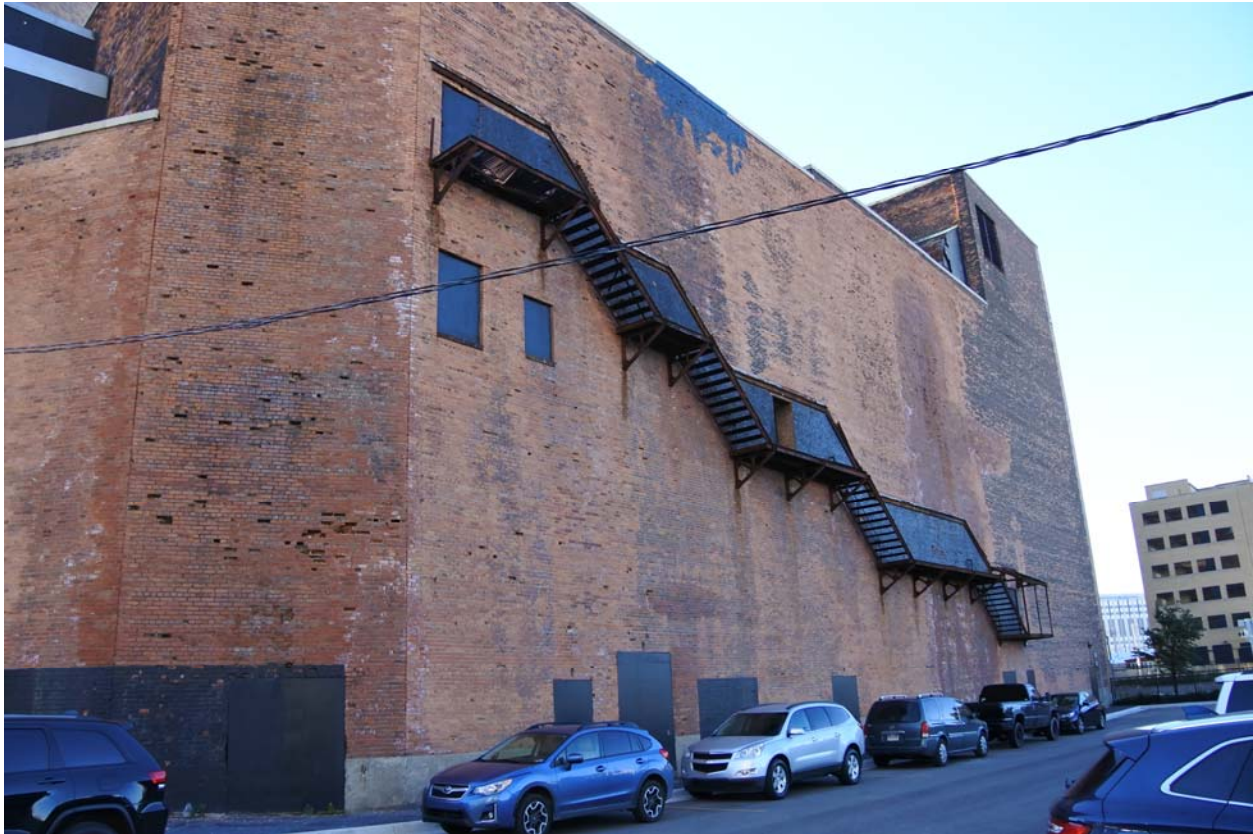
Image #27 – Exterior view from parking lot off North Adams. The exterior brick shows stains where water has leaked into the wall from failed roof flashings at parapet. There are many bricks missing throughout the full height of the wall, (especially at the corner), There is significant staining throughout indicating water intrusion, and severe damage at the top six feet of the wall below the parapet and coping. We estimate 50% of the brickwork here should be removed and replaced to properly correct the damage to the exterior walls shown here. The fire escape is also unsafe and should be removed or repaired. The parking lot along this wall should be fenced-off so cars cannot park along the wall here and potentially damaged by falling masonry.

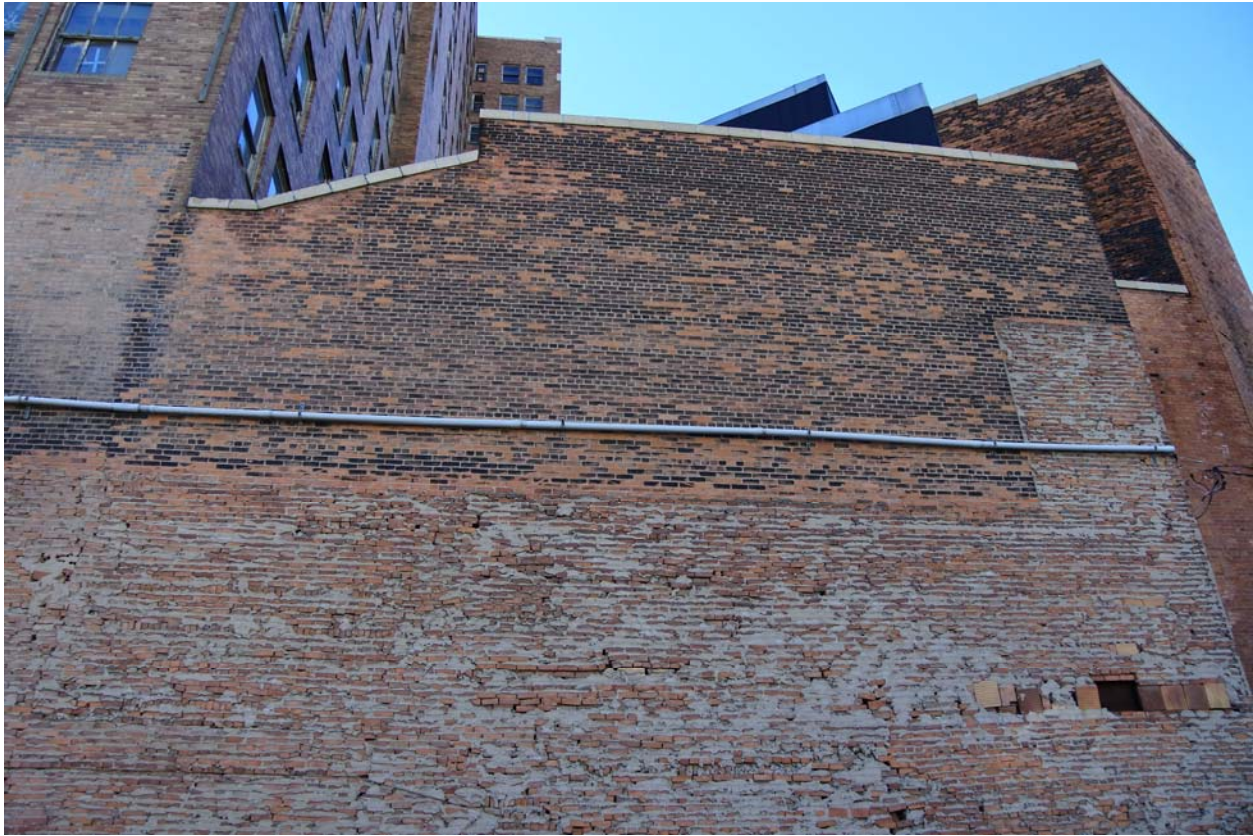
Image #28 – Area of rubble brickwork on the north elevation that was not originally an exterior wall surface. Most if not all of the north wall will either need to be parged and covered with another material, or rebuilt as a brick veneer with masonry back-up wythe.

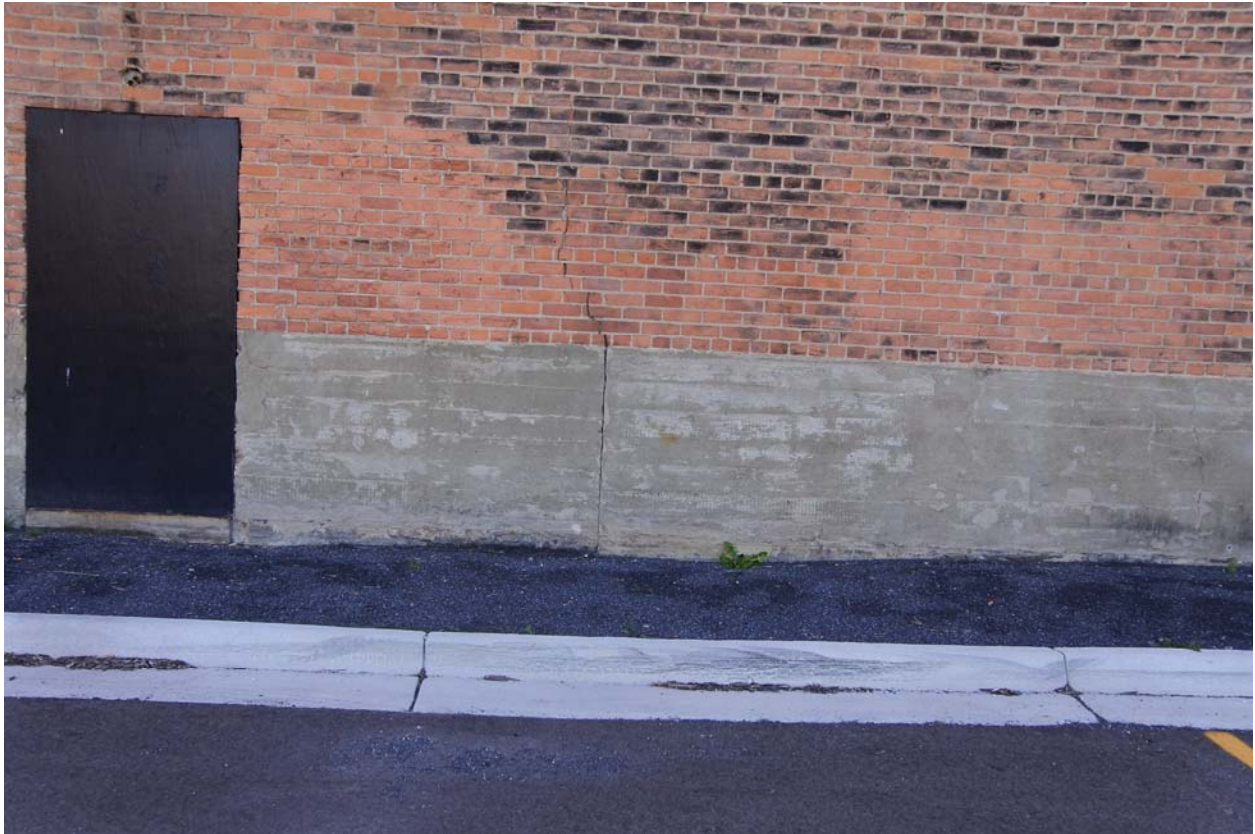
Image #30 – Cracks in exterior brick wall above joint in concrete foundation wall. The bricks above the concrete should be re-worked so that a control joint in the brick corresponds to the joints in the foundation wall.

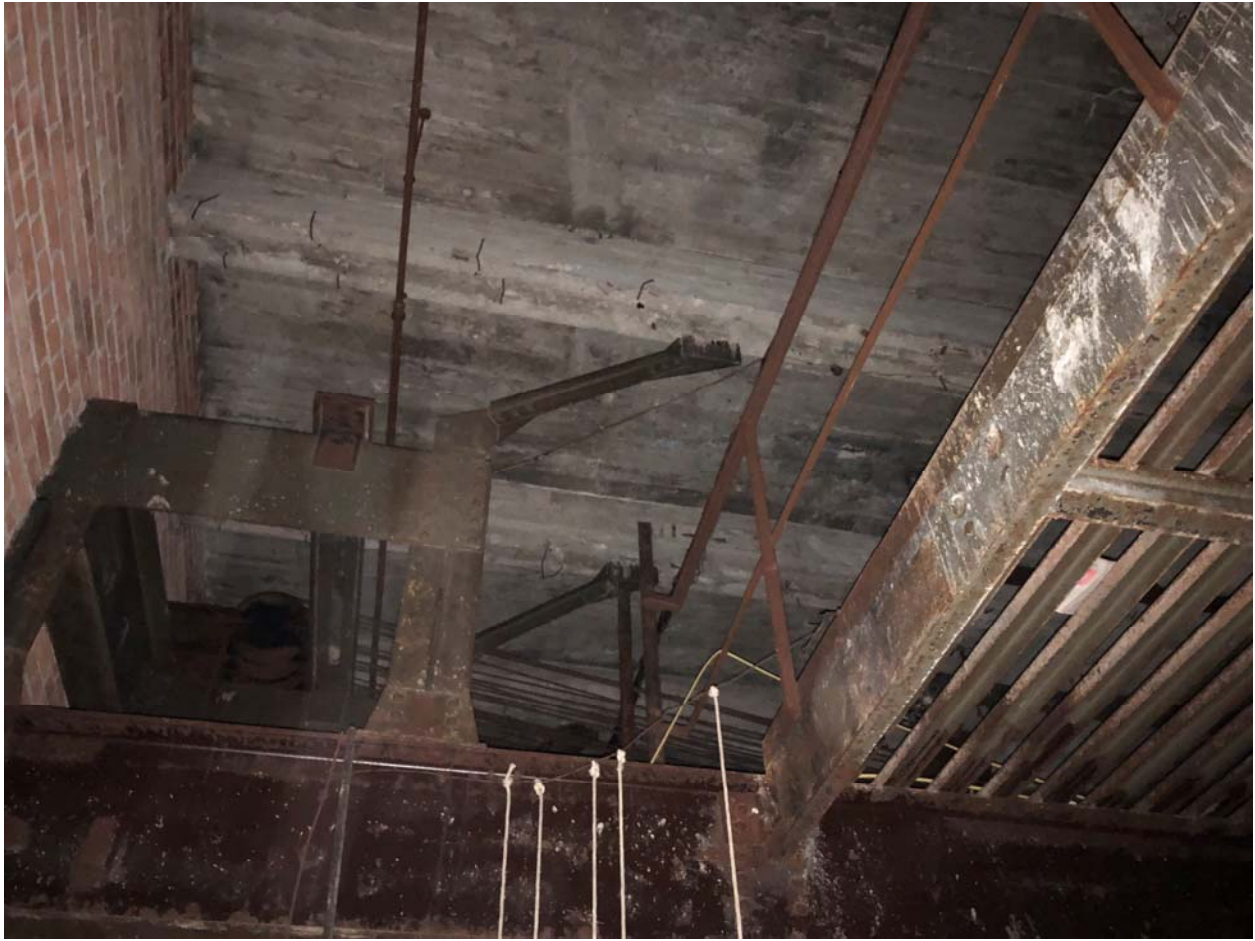
Image #31 – Concrete roof structure above fly loft.

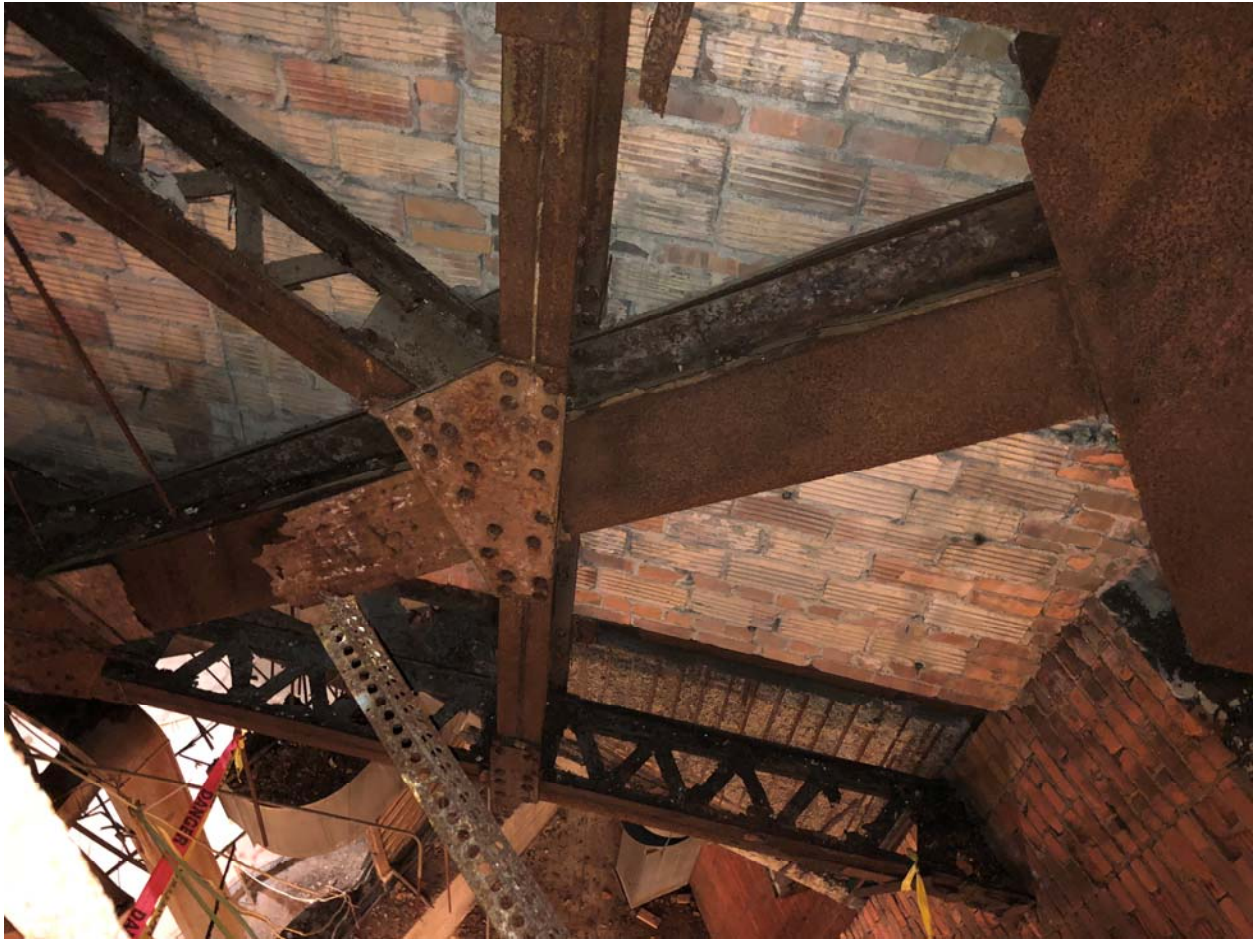
Image #32 – Condition of the larger members of the interior steel framework is fair with mostly surface rust, however the smaller steel members such as the webs of the steel trusses are severely deteriorated. This seems typical throughout the steel structure that was able to be observed.

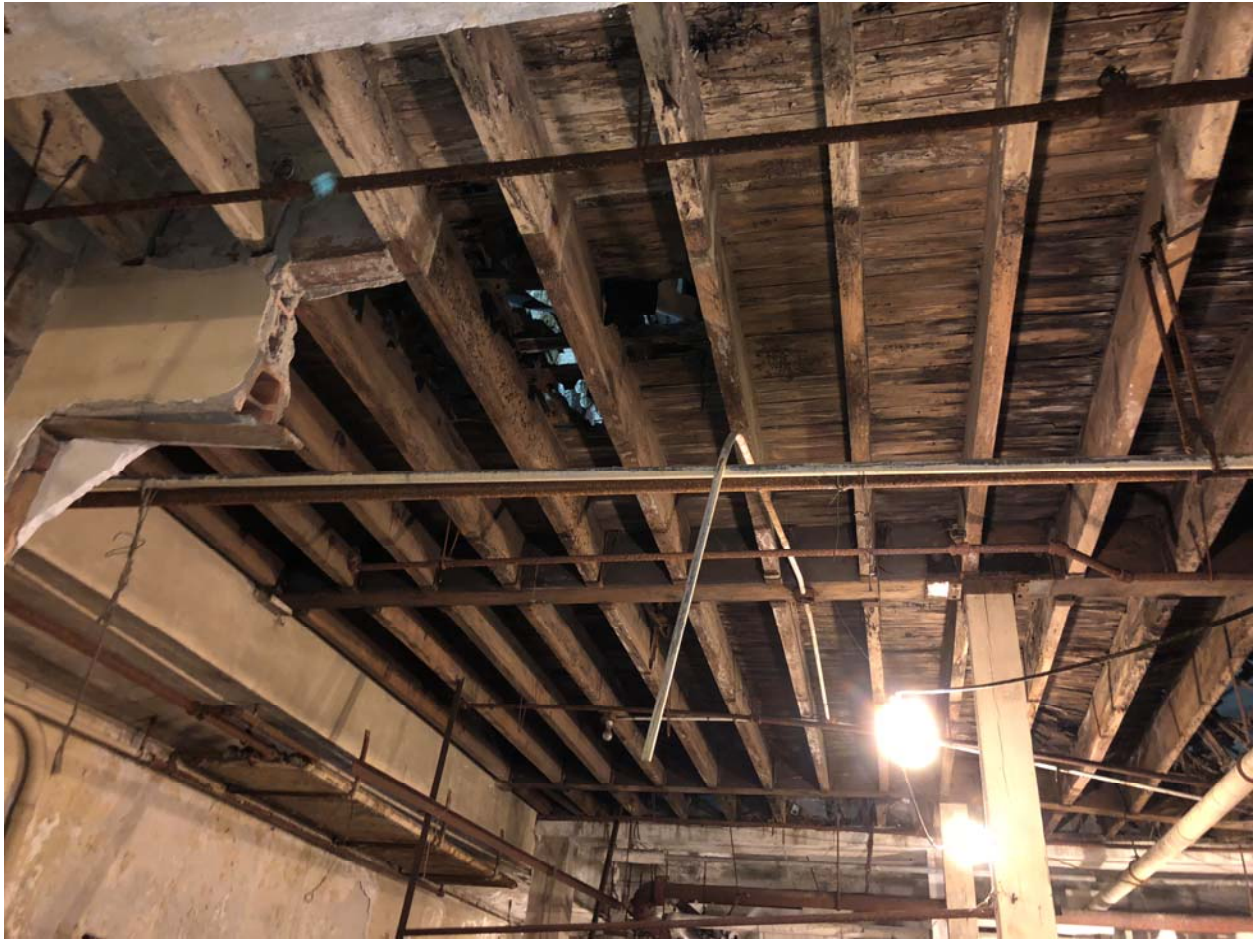
Image #34 – Underside of wood framed area of stage floor. There is much water damage to this area due to roof leakage. All of this wood framed floor must be removed and replaced.

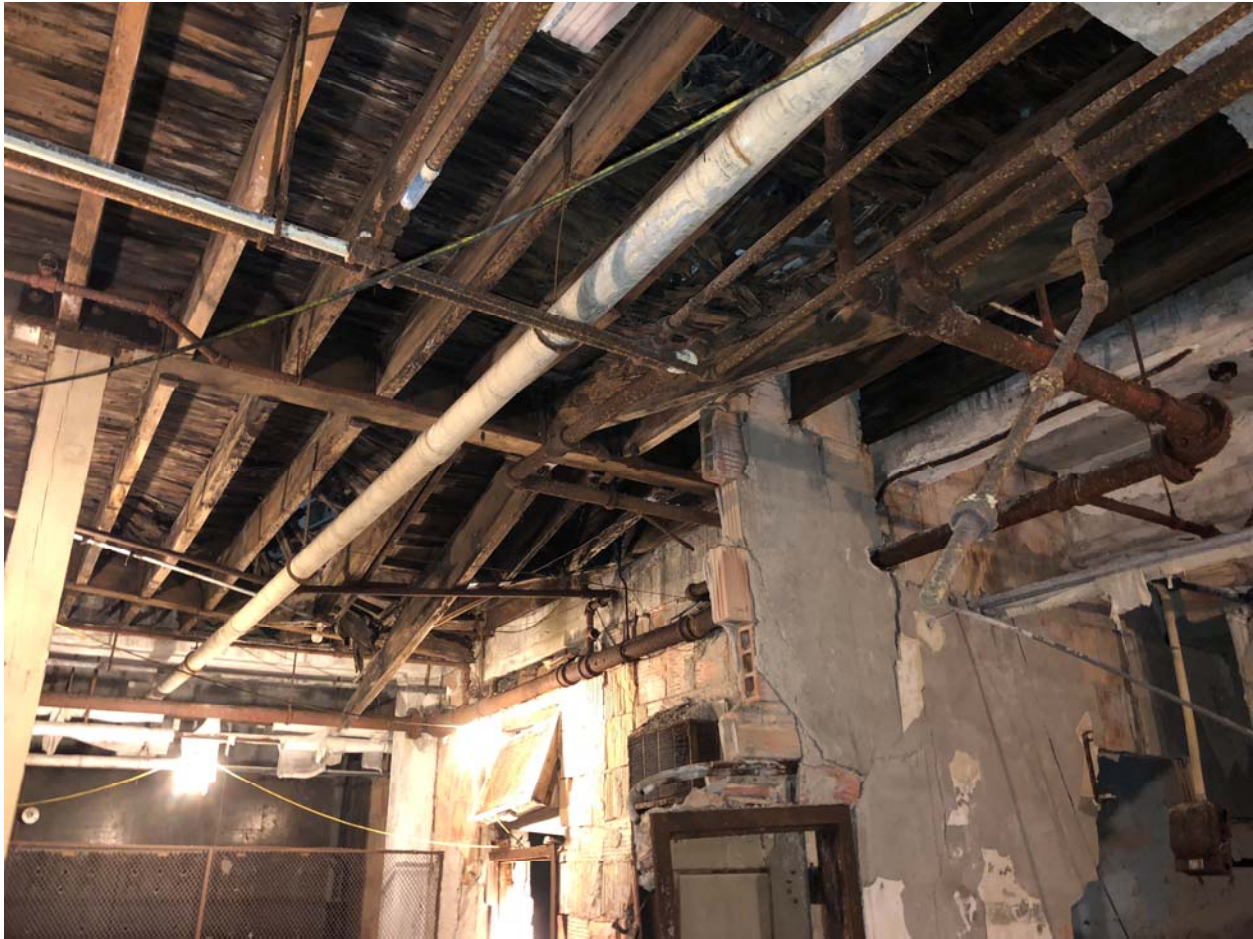
Image #35 - Underside of wood framed area of stage floor. There is much water damage to this area due to roof leakage. All of this wood framed floor must be removed and replaced.

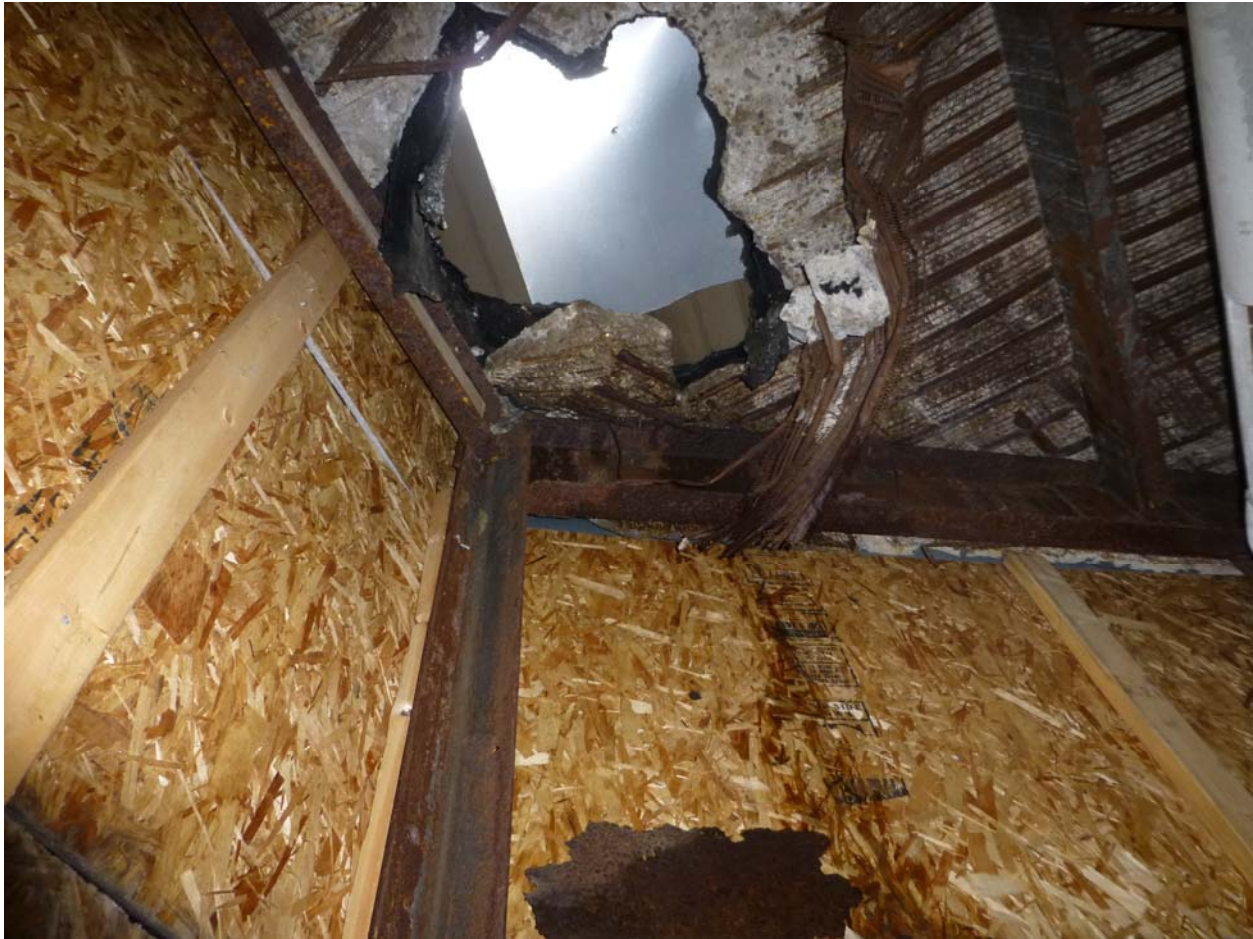
Image #36 – Photos sent by Fred Beal that were taken in June 2013 showing condition of underside of main roof above the seating area.

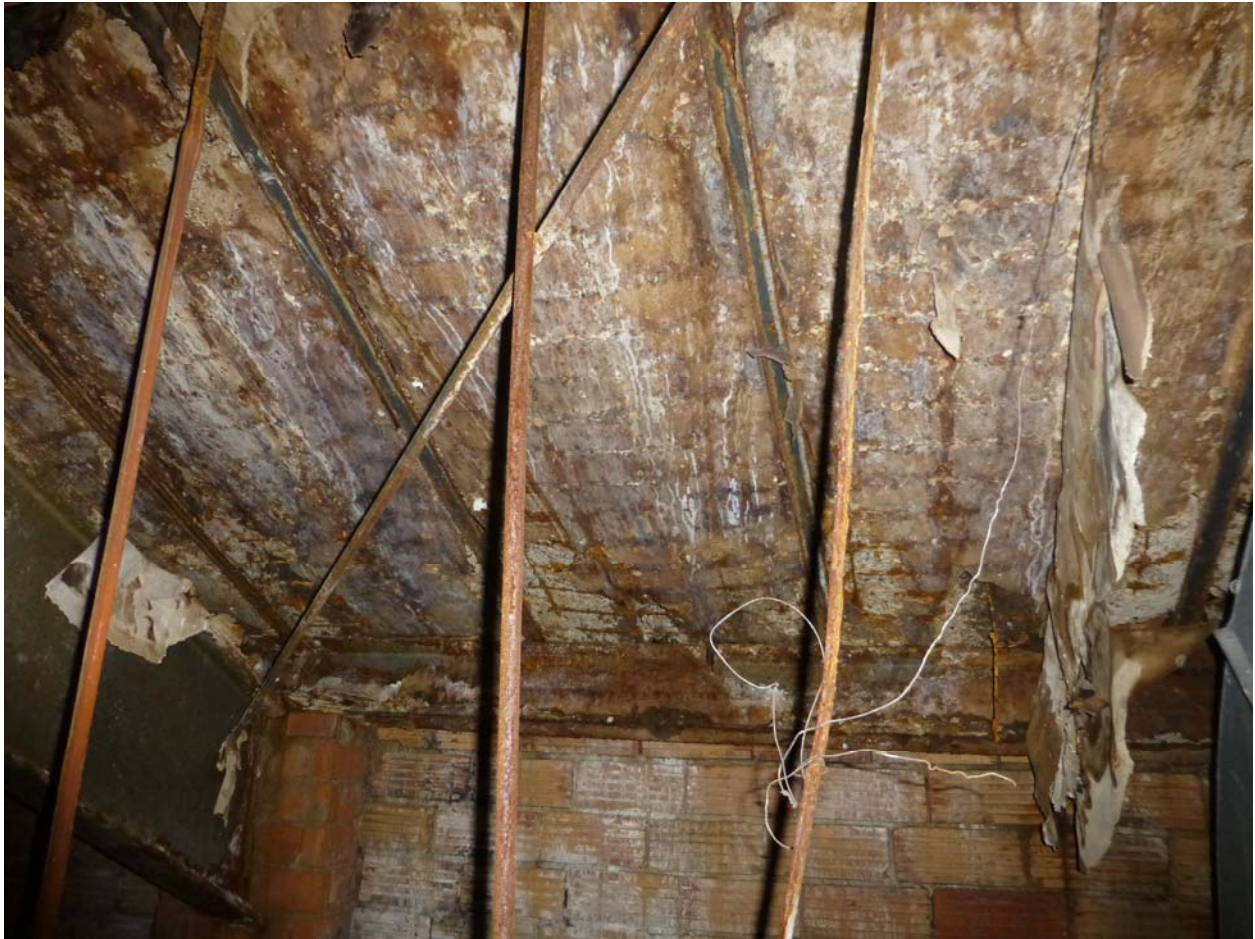
Image #37 – Photos sent by Fred Beal that were taken in June 2013 showing condition of underside of main roof above the seating area.

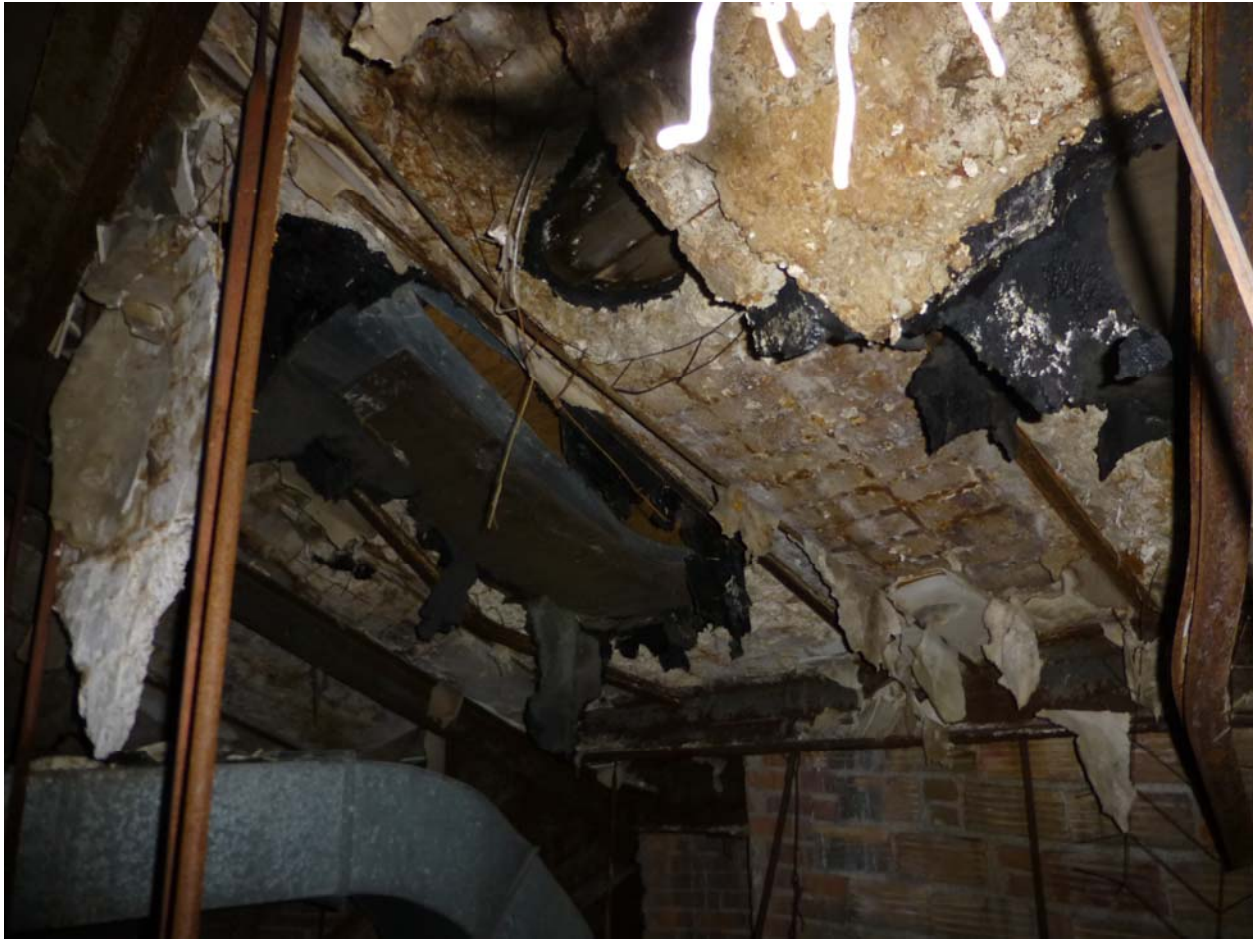
Image #38 - Photos sent by Fred Beal that were taken in June 2013 showing condition of underside of main roof above the seating area.

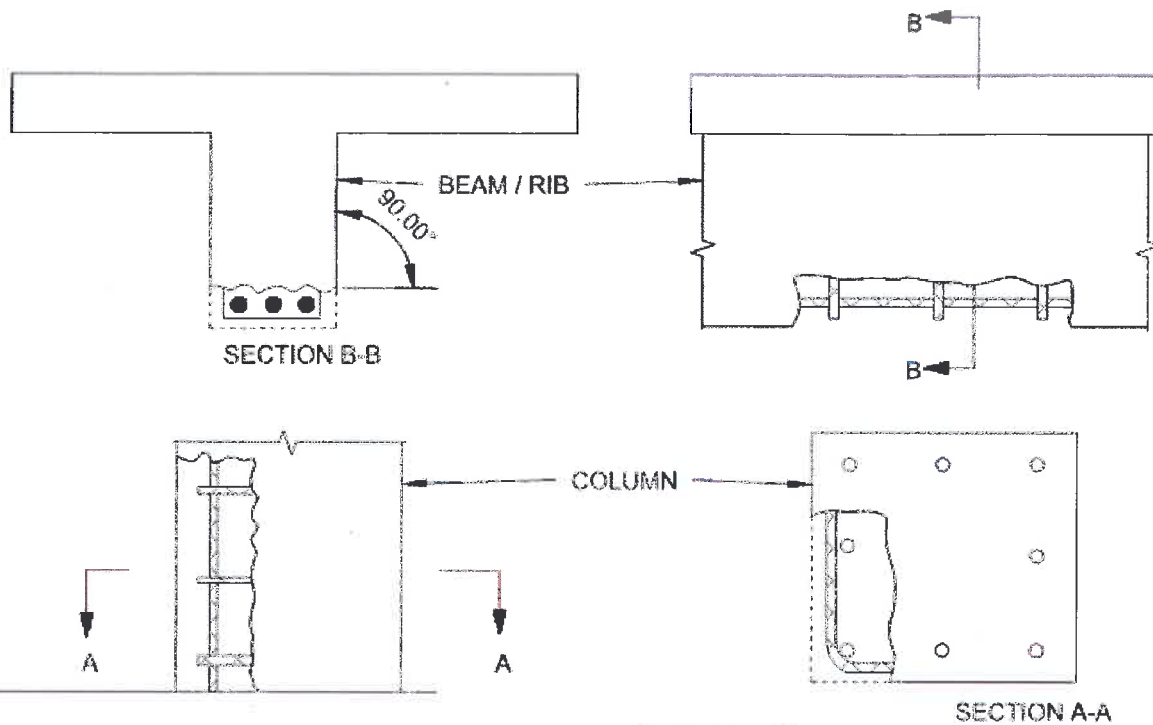
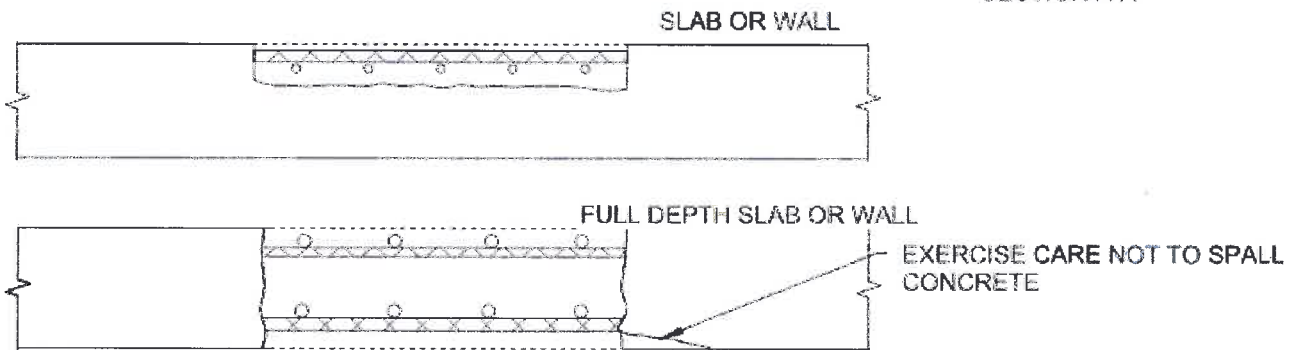
CAUTION: BEFORE STARTING REMOVALS, REVIEW EFFECT OF REMOVALS ON STRUCTURAL INTEGRITY. PROVIDE SHORING OF MEMBERS AS NECESSARY. PARTICULAR CARE SHALL BE EXERCISED AT SLAB BEAM CONNECTIONS TO COLUMNS

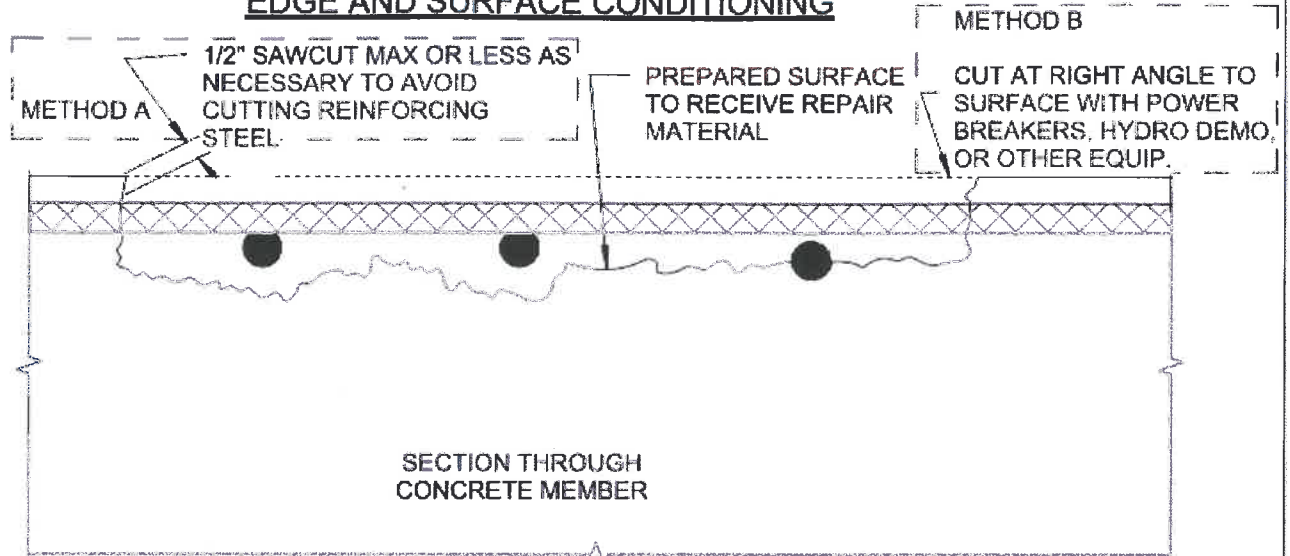
APPLICABLE TO HYDRODEMOLITION, HYDROMILLING, PNEUMATIC, HYDRAULIC AND ELECTRIC BREAKERS APPLICABLE TO HORIZONTAL, VERTICAL, AND OVERHEAD LOCATIONS

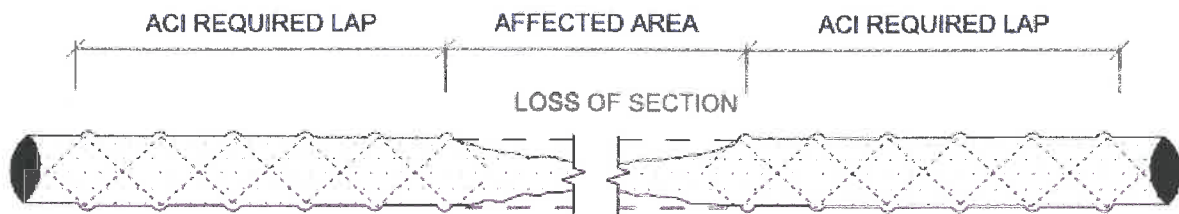
IF REBAR HAS LOST MORE THAN 25% OF ITS CROSS SECTION (20% IF 2 OR MORE CONSECUTIVE PARALLEL BARS ARE AFFECTED), THE STRUCTURAL ENGINEER SHOULD BE CONSULTED

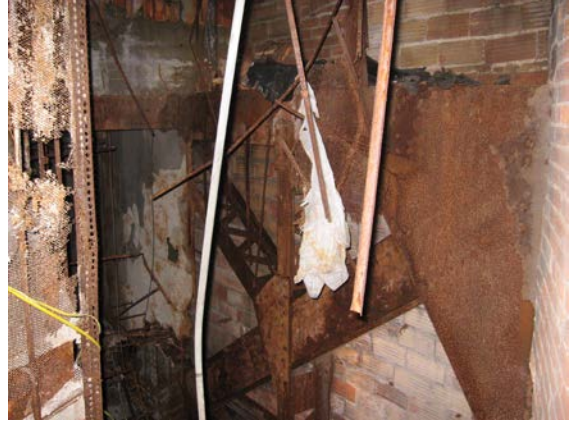
- b. There is some corrosion at the west end (parking lot side) of this large truss where water has been leaking through the roof in the past and some current minor leaks. We were not able to get up-close to this end, but from what we can see we expect the repairs to be significantly less than that required at the other end.

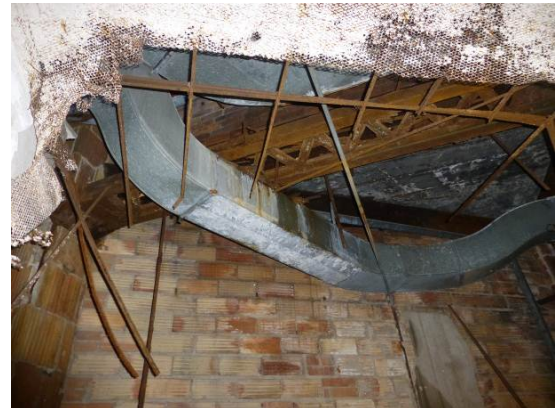
2. Mezzanine Balcony:

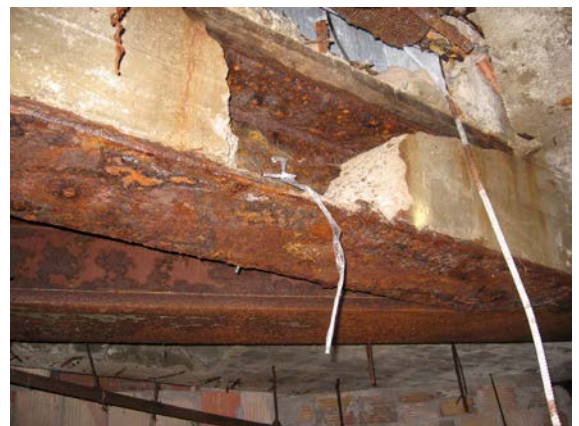
amount of section loss from corrosion that we expect will need to be repaired if the structure is returned to service in order to restore original capacity. We also expect that there will be a few more hidden conditions that will require some strengthening repair.

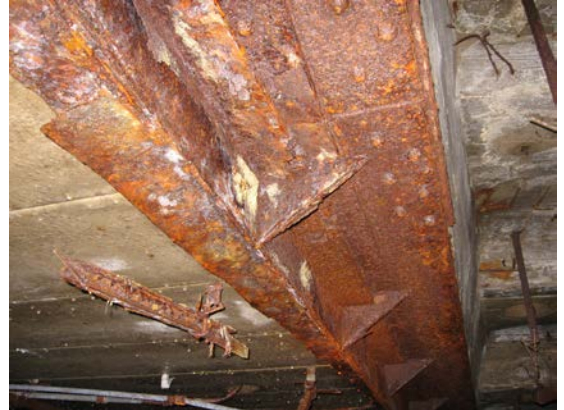
- c. The original concrete floor appears to be in good condition based on view from the underside with only a small amount of floor repair anticipated.

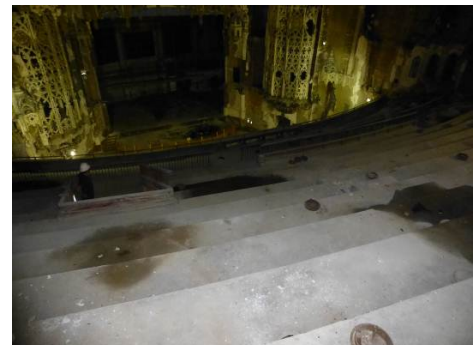
- b. The main support girders running parallel to the aisles are in good condition. These frame into a larger girder that spans the width of the theater. We were not able to do an up-close survey of this larger girder except at an end connection from the mezzanine level where there was only evidence of a minor amount of corrosion. We do not expect any strengthening repairs.

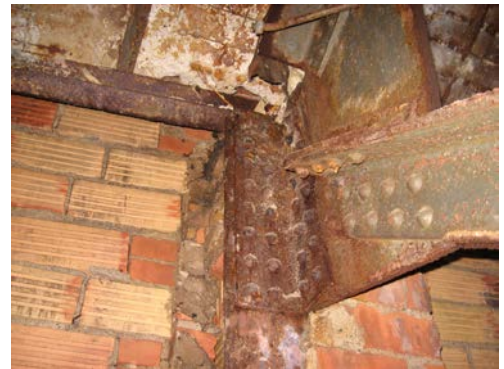
- c. In 2007, several holes in the gypsum roof slab above the theatre main seating area were patched to help stop water entry and resulting corrosion damage. Ongoing leaking observed along the perimeter were being patched during this update survey. Approximately 70% of the gypsum panels are water damaged and are bowed, and a couple panels have partially fallen and are hanging from the purlins. These occur near the back of the main seating near the catwalk access ladder along the east wall (alley wall) and need to be removed to eliminate a potential fall hazard.

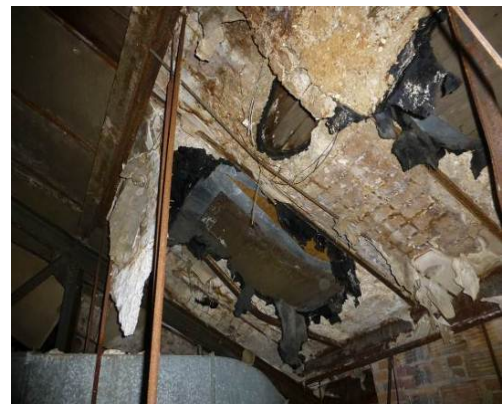
We recommend replacement of the roofing system. At that time the hangers for the cat walk can be inspected where they are embedded in the gypsum and hook over the steel purlins.

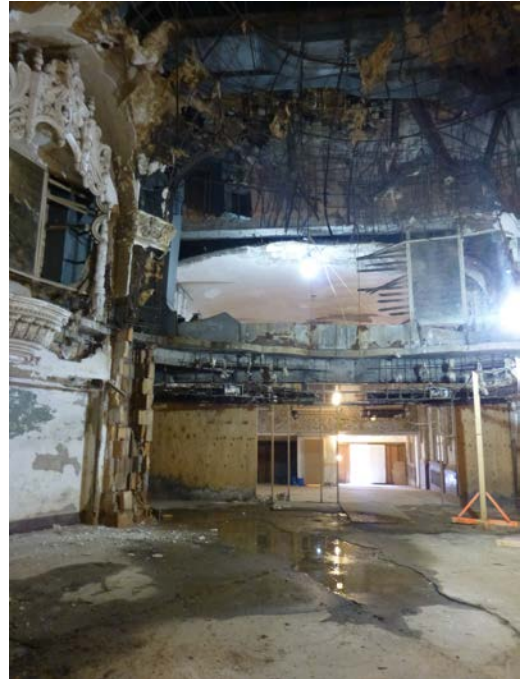
- f. Terra cotta capstones extend around the perimeter of the roofs. A few caps are missing but have been waterproofed. Installing a metal coping over the parapet would be an effective longterm solution to stop water from entering through the bed joints and cap joints.

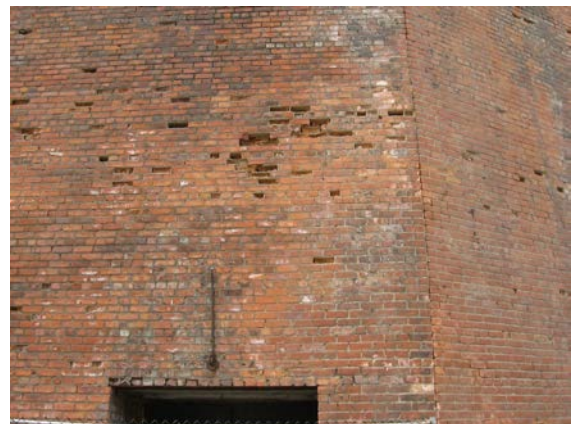
There is also a an area along the north side that has unfinished mortar joints where the wall was constructed next to an existing building that was torn down some time since original construction of the theatre. We expect that this wall is not water tight as the

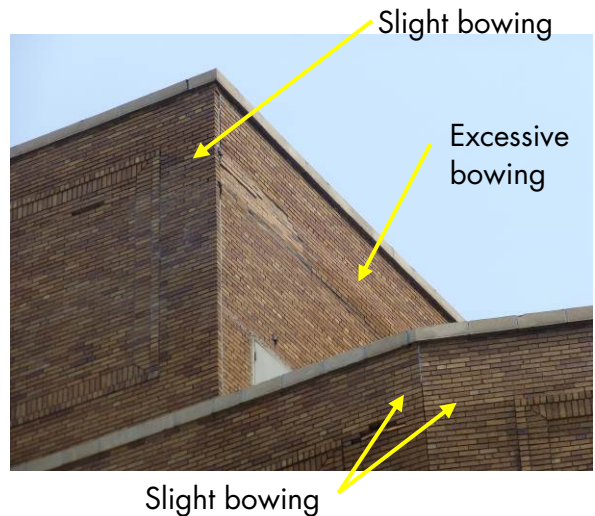
We found excessive bowing in the masonry façade along the east end of the stage roof where the stage roof slab frames into the wall. This bowing is likely due to a corroded shelf angle or corroding concrete beam, or could be related to a design or construction flaw. We recommend rebuilding this portion of the wall before it falls and damages the roof and wood framed structure below. This occurs over a roof area and is not considered a public hazard.

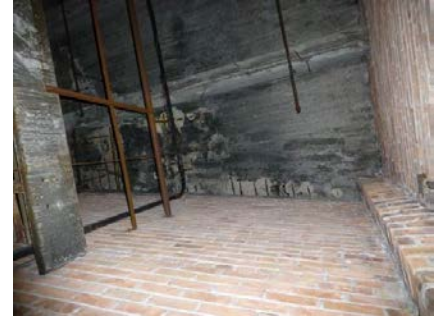
- c. In 2007, the falling fan room walls over the grand foyer were replaced with OSB panels with waterproofing along the seams. The panel are performing well, but may need some minor waterproofing where the seams have opened a little a may be letting water in.
- d. Fire escape stairs at exterior: We looked at the fire escapes occurring in the alley and parking lot sides of the theatre from the ground level using binoculars. We also looked at the fire escape along the east side and from the stage roof down to the lower roof. We noted that the metal roof structure over the fire escape along the parking lot side was removed in recent years.

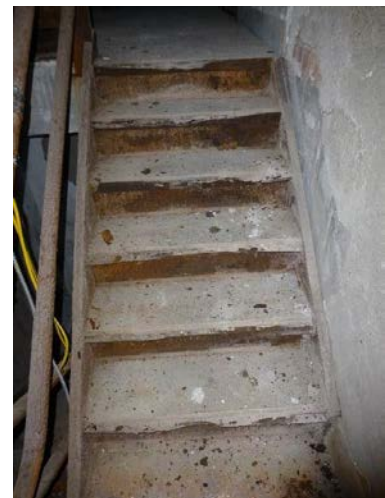
- 8. Steel Stairs: All of the interior steel stair section leading from the basement to the balconies at north end and the ones along the south end at each side of the stage are severely corroded and need replacement including some of the hanger rod connections that attach to the stair stringers. The one at the northeast corner needs to be closed due to the extent of corrosion damage. The others will need to be monitored and should not be used for heavy loads.
