**STAFF REPORT: 11-13-2019 MEETING**

**APPLICATION NUMBER: 19-6025**

**ADDRESS: 1474 SHIPHERD**

**SCOPE: WINDOW REPLACEMENT AND REMOVAL, INSTALL REAR STAIRS, REMOVE SYNTHETIC SIDING, EXTERIOR PAINTING, FRONT PORCH REPAIR, SECURITY LIGHTS, ANTENNA**

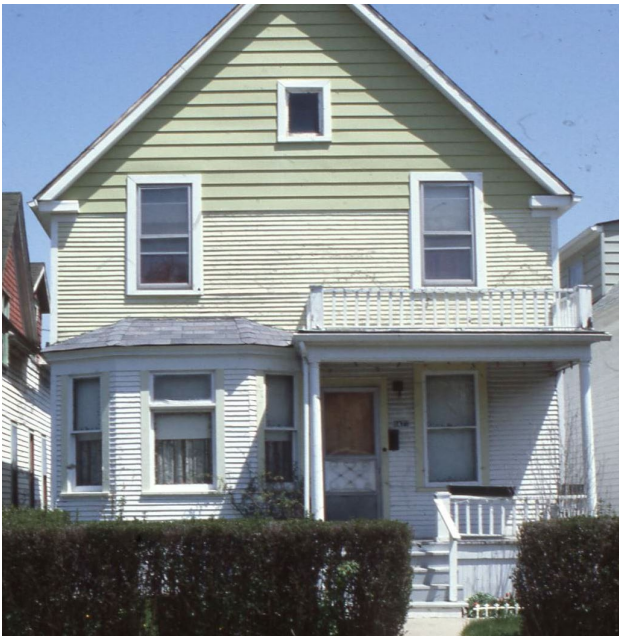
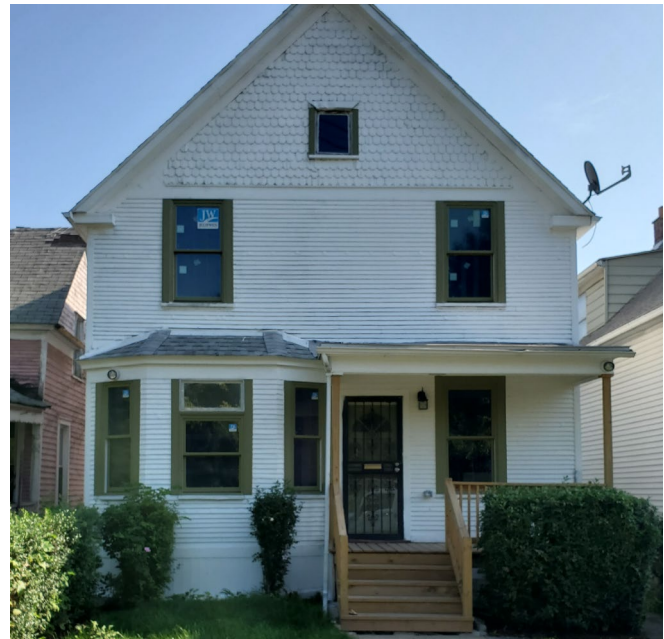
Since the August site visit, the applicant installed security lights on the front elevation. Below are comparison photographs: the left photo is from time of designation (1983); the right photo shows its current appearance.

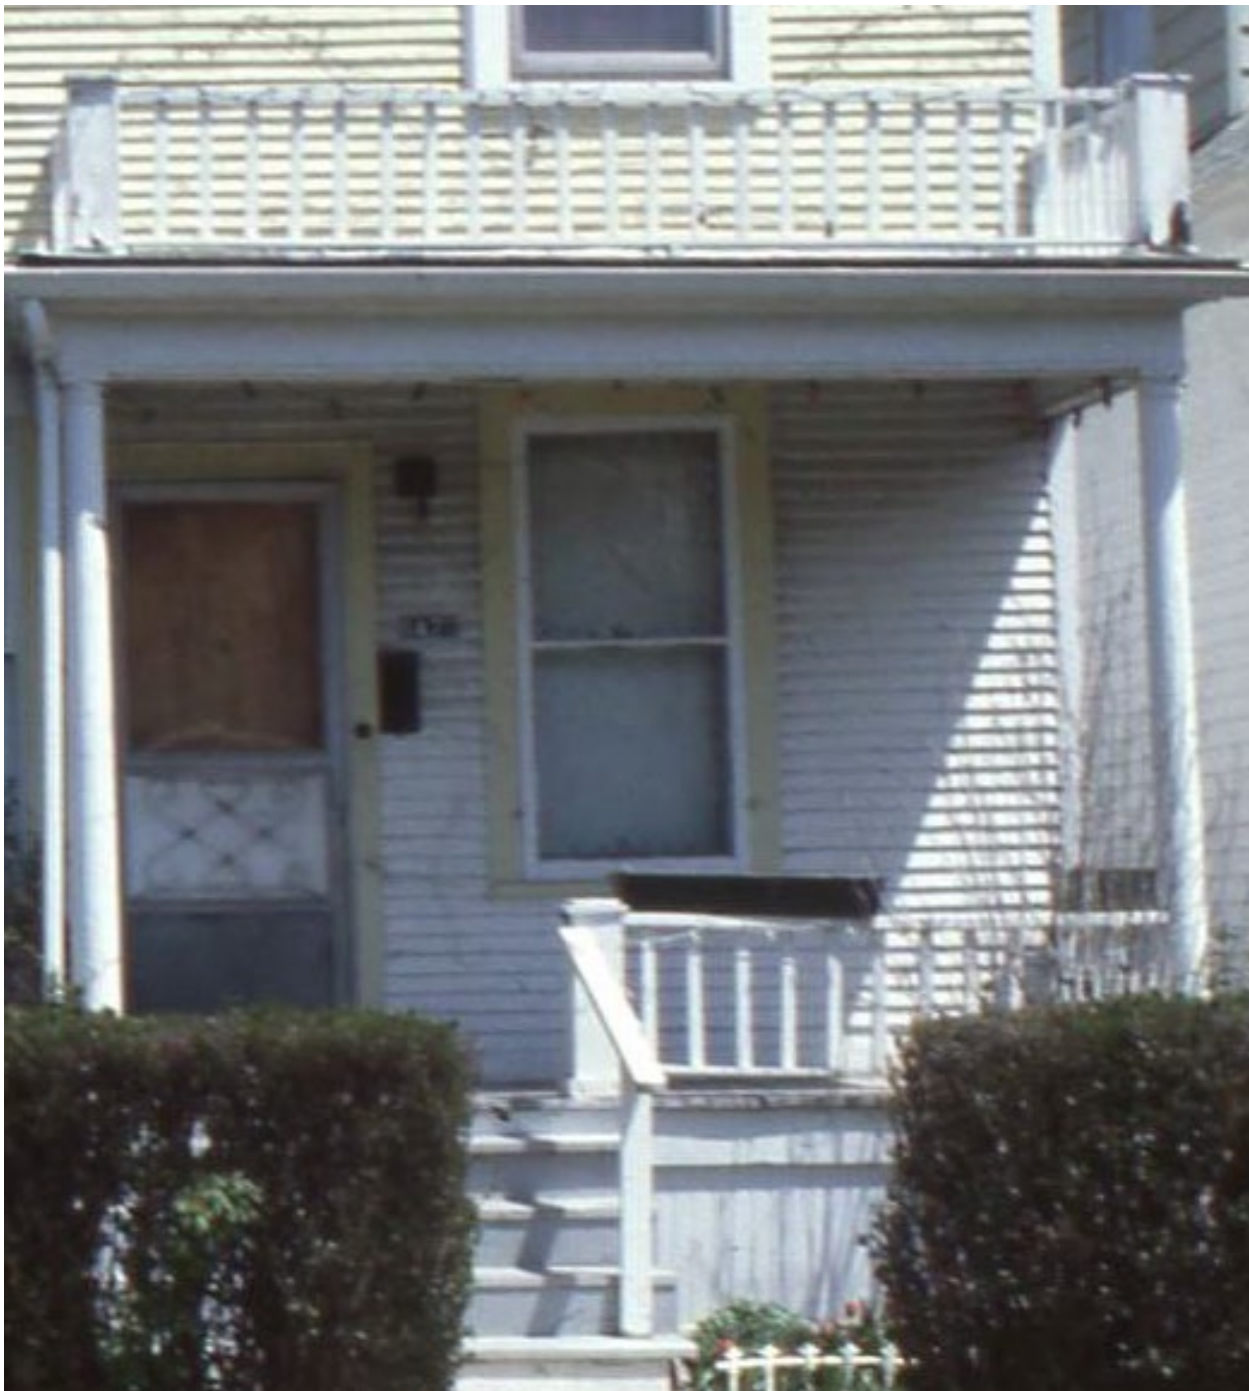
- The new porch mimics the previous porch (which was issued a COA in 2018 for only the repair of the risers and one newel post), but does not match the original porch as shown in the designation slide. The original porch offered detailing to match the vernacular design of the early 20<sup>th</sup> century house and included round porch columns with simple capitals, a square, wide newel post, and straight balusters. The original stair railing was no longer standing (if there had been one to begin with) and two single boards comprised the newel post and handrail. Additionally, a balustrade ran the perimeter of the porch roof, which included identical wide/boxy newel posts. The newly constructed porch and stair retain a contemporary deck appearance due to the railing design, thin, square posts and unfinished surfaces.

DESIGNATION SLIDE – MAY 1983. Note round wood columns & balustrade at roof and deck

- Due to the character-defining elements of the historic porch, the replacement porch should be modified so its appearance closely emulates the original porch, which can be obtained by the following:

- The replacement of the square columns with round columns (of a similar dimension/diameter) which will retain the square trim detail at the top,
- The three existing newel posts will be retained; square newel caps (matching the trim/capital on the porch columns) will be installed so the posts read as individual structural components.

- The exterior porch balusters shall be enclosed at the top rail to match the interior baluster/rail detail.
- The upper porch balustrade shall be rebuilt as depicted in the designation slide.

- All porch items will be painted to eliminate its appearance as a deck. The color will be selected by the applicant and will be submitted to staff for review.

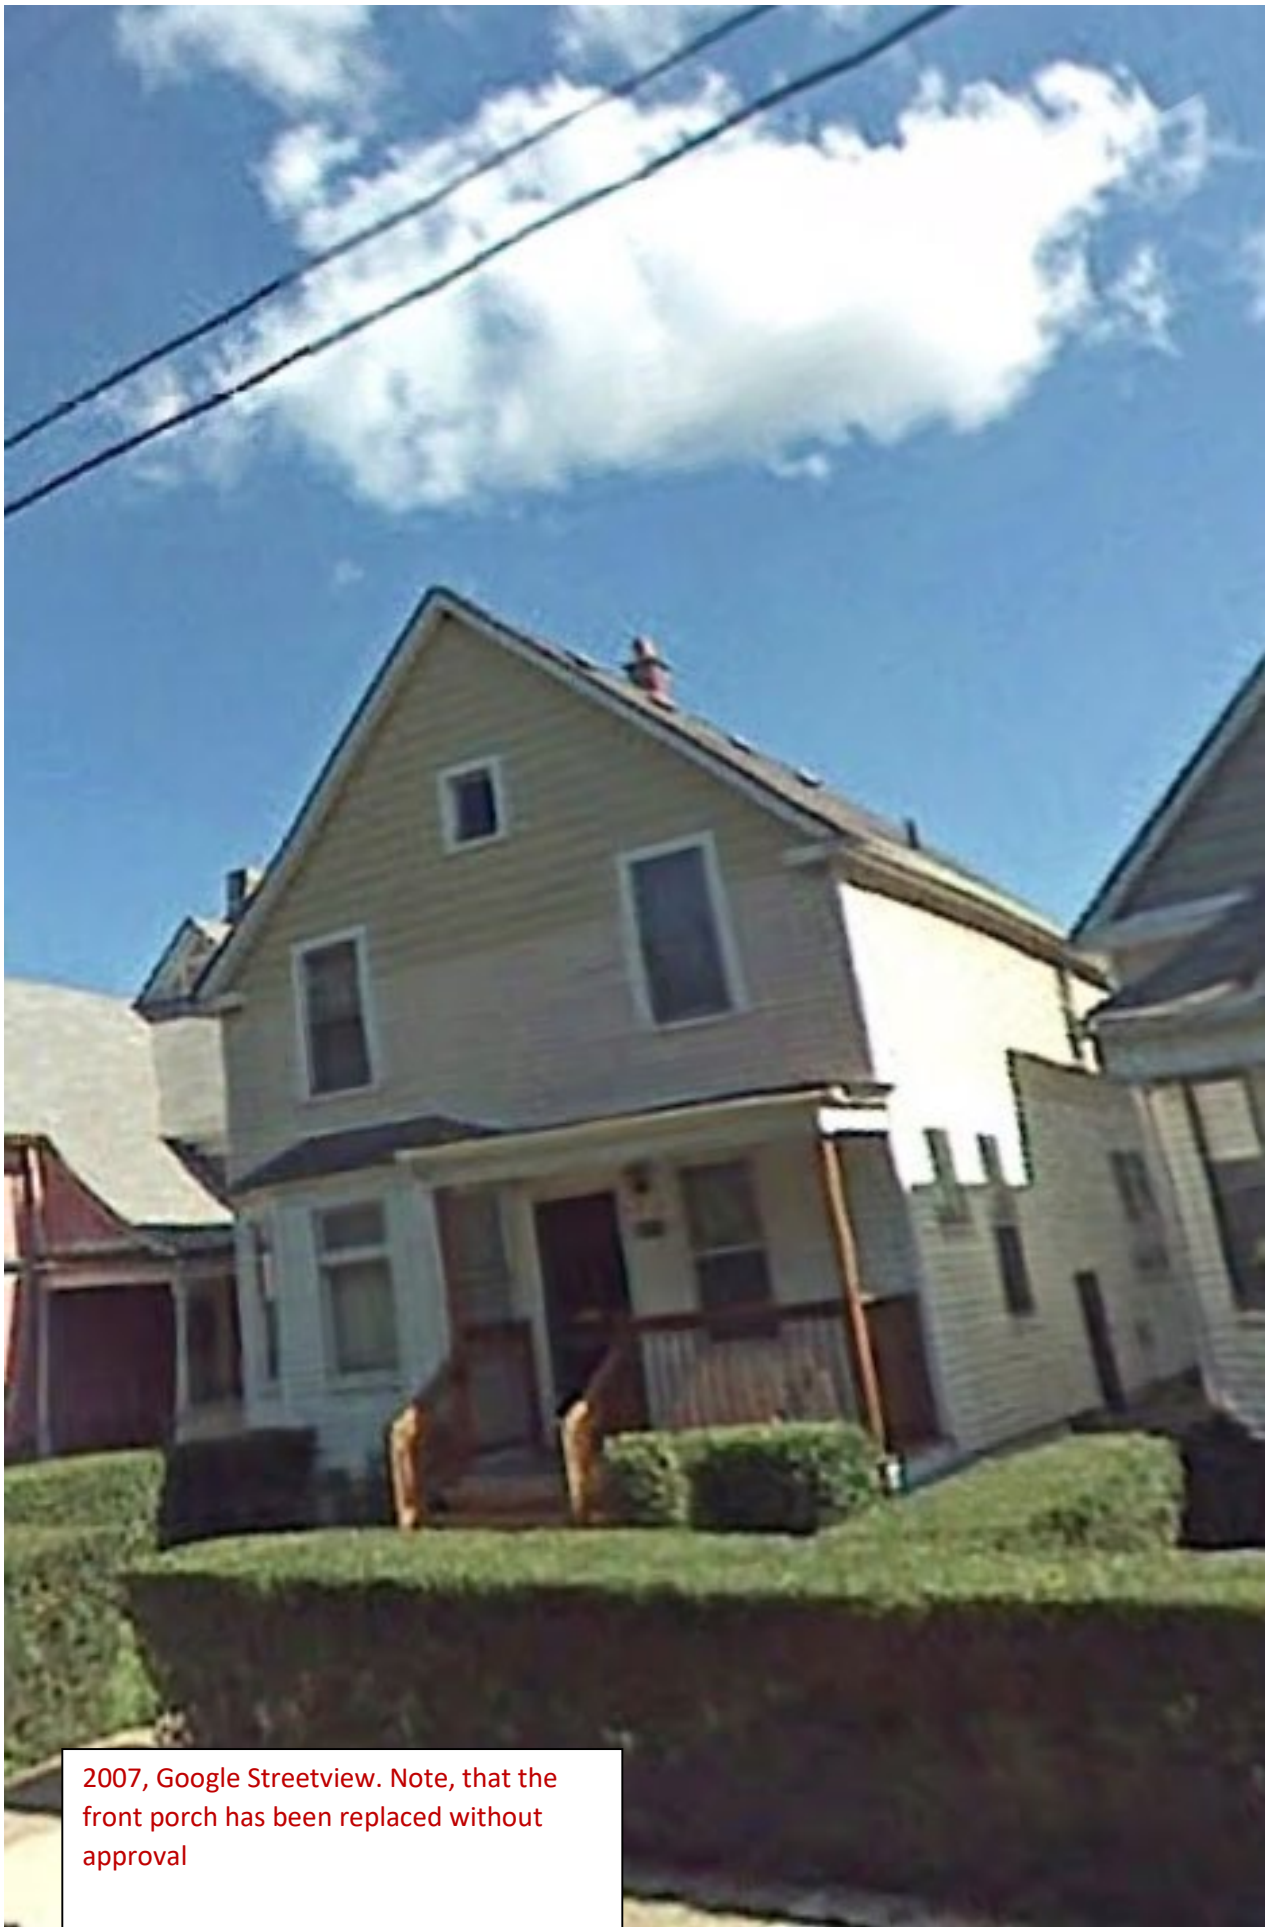
Sometime between 1983 and 2007, the original porch was replaced without a COA. Please see the below photos which depicts the illegally installed replacement porch.

2007, Google Streetview. Note, that the front porch has been replaced without approval

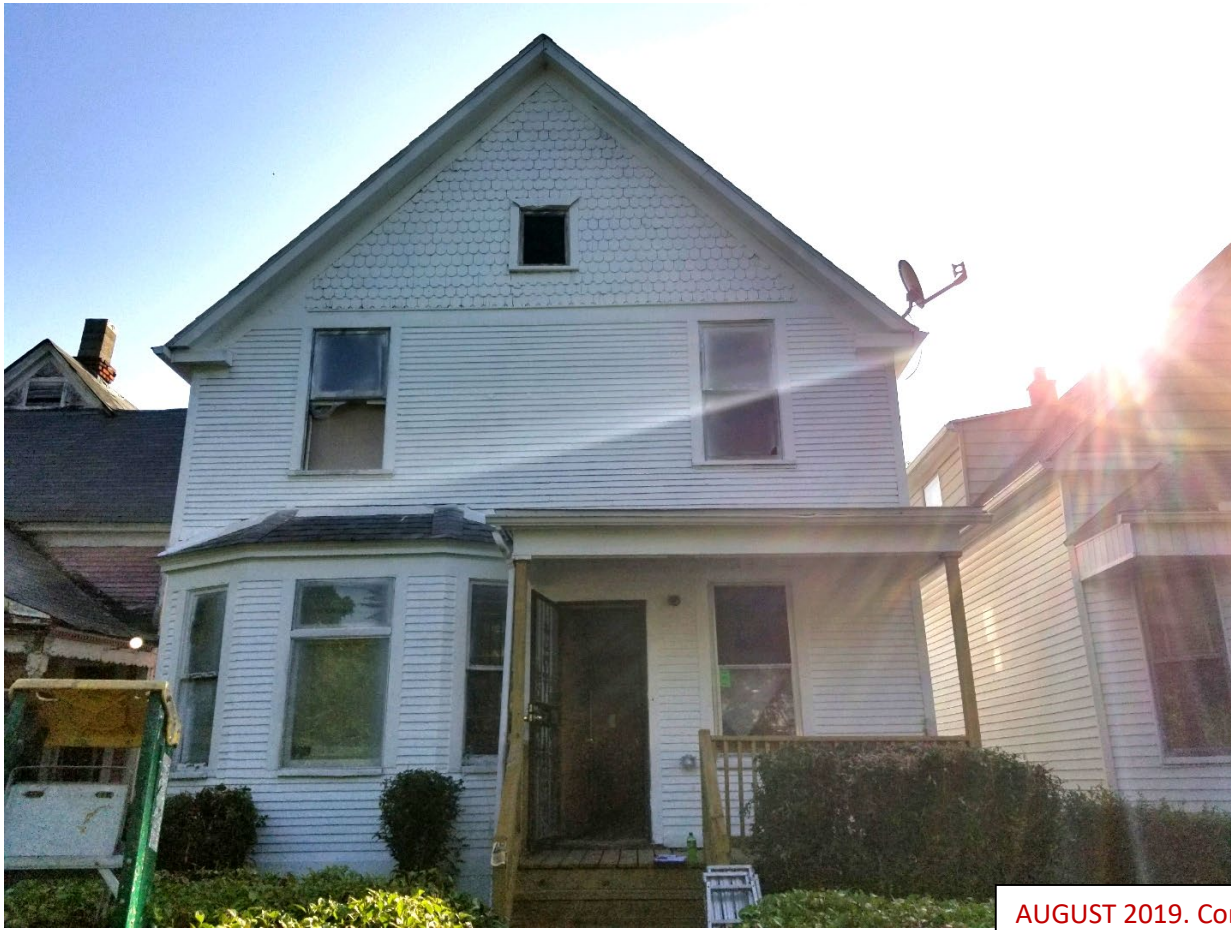
In August 2019, the applicant met with staff to discuss replacement windows. While waiting for the additional required submission information, staff conducted a site visit and noticed work had been completed without a COA and permit, including: removal of the aluminum siding, exterior painting, new wood windows/removal of a window, and the rebuilding of the front porch.

AUGUST 2019. Conditions prior to window replacement. Applicant has removed siding, painted the exterior walls, and replaced the front & rear porch (while retaining the original roof)

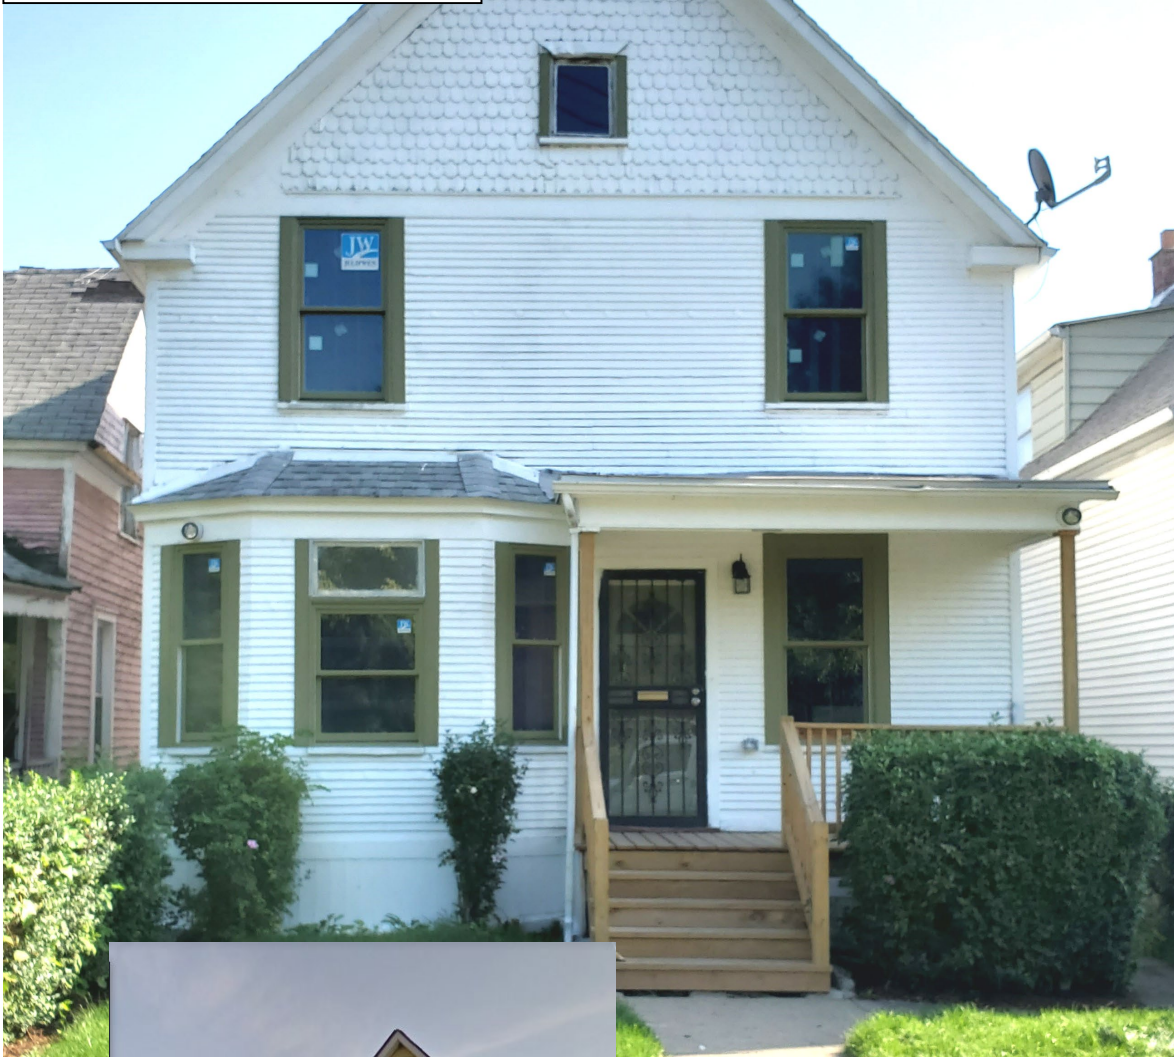
September 2019

- The painting the wood siding white does not conform to the Color System B color chart.
- The locations of the security lights are not appropriate to the historic nature of the property and should be removed. Per the Commission's "Security Bar and Lighting Guidelines", only ground lighting and porch lighting are appropriate for the front of a property.

- The antenna dish installation doesn't meet the Commission's "Antenna and Satellite Dish Guidelines" which states "Antennas shall be placed so that they are inconspicuous from the public right-of-way and do not damage or obscure character-defining features; and "Any type of dish antennas shall not be attached to the facades of residences or mounted on roofs in a manner that they are visible from the street. It is recommended dish-type antennas be placed on other buildings, such as garages or on the surrounding grounds, where their presence can be screened from the street by landscaping".

SEPTEMBER 2019. Windows have been replaced and rear enclosed porch window opening infilled. Security lights were also installed. Satellite dish/antenna appeared after 2011, per Google streetview.

- The minimal size and design of the security lights are appropriate, however their locations are not and will be relocated to meet the Commission's guidelines. (Locations to be submitted for staff review.)

- The dish-type antenna will be removed and relocated to a spot that meets the Commission's guidelines. (Location to be submitted for staff review.)
- The newel posts on the rear stairs will receive newel caps (matching those selected for the front stair newel posts), the length of the spindles shall be shortened to not extend past the bottom rails, and the stairs and railings will be painted or stained in a historically appropriate color (possibly matching the color selected for the front porch and stairs).
