STAFF REPORT: 10-9-2019 MEETING
APPLICATION NUMBER: 19-6490
ADDRESS: 791 SEMINOLE
HISTORIC DISTRICT: INDIAN VILLAGE
APPLICANT: YURI DADO
DATE OF COMPLETE APPLICATION: 11/13/2019
DATE OF STAFF SITE VISIT: 12/4/2019

PREPARED BY: J. ROSS

SCOPE: INSTALL NEW WINDOWS

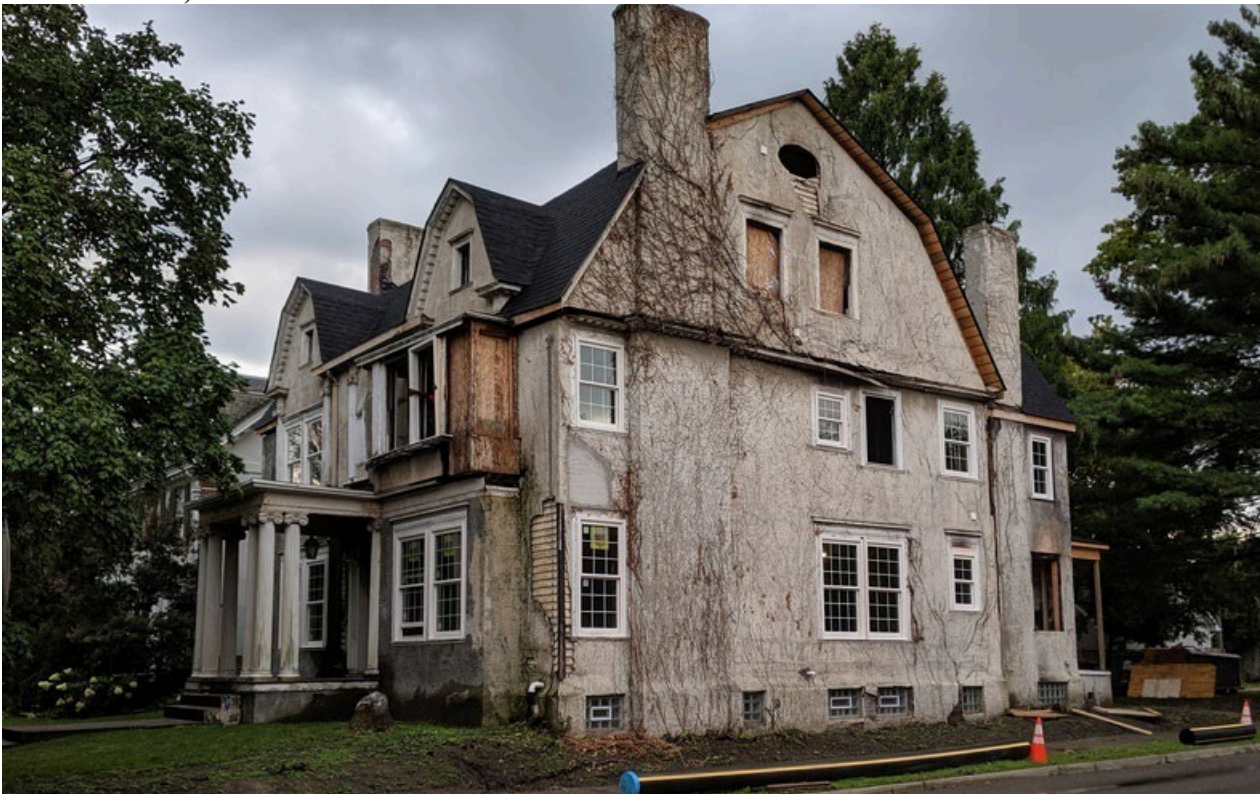
791 Seminole, current conditions

The building located at 791 Seminole, sits at a prominent location, at the northeast corner of Seminole Street and E. Lafayette Street, within the Indian Village historic district. The 2 ½ story, Dutch Colonial Revival-style home displays a gambrel-roof main mass with a rear, lower intersecting gambrel-roof wing. Asphalt shingles were recently added to the roof surface. Decorative detailing includes dentils at the soffit, the fluted Ionic columns at the first-story front porch, and the Ionic pilasters at the second story story's brick mould. Exterior walls are primarily clad with stucco, although large portions of the stucco at the south, north, and west elevations have been removed and replaced with unpainted/unfished plywood/oriented strand board (OSB). Unpainted OSB is also visible at the fascia and soffit. Windows are currently wood, double-hung units with grids between the glass. Note that a number of the windows have been improperly installed/are smaller than their respective openings and plywood has been installed to enclose the gap. A hipped-roof garage with cedar-shake clad exterior wall is to the rear of the home.

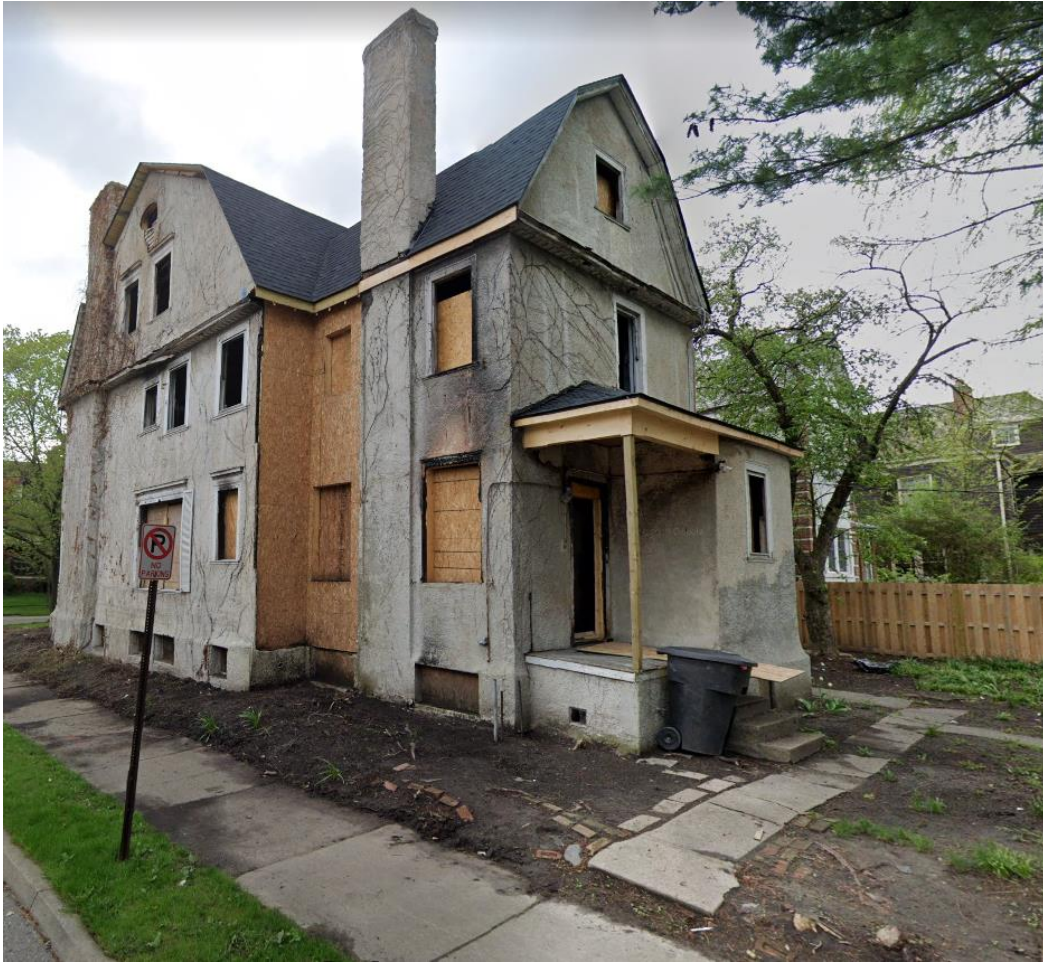
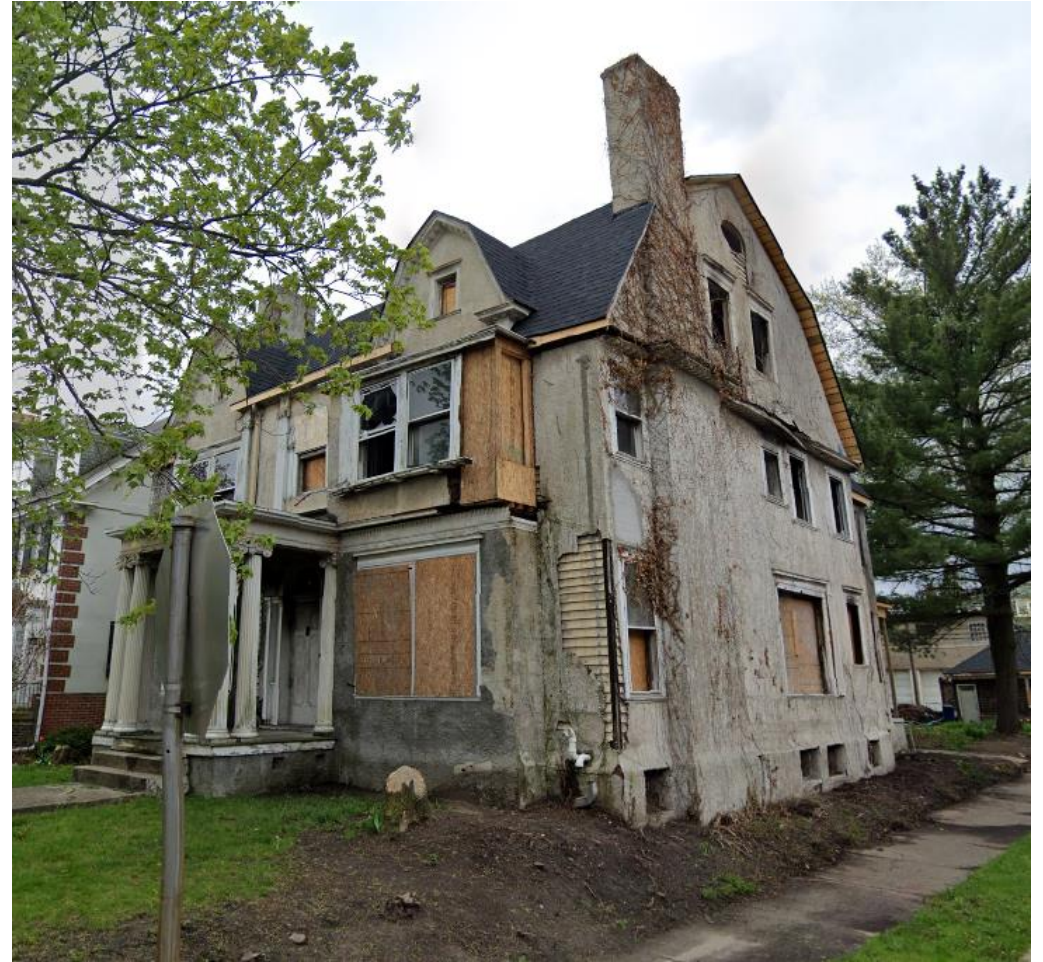
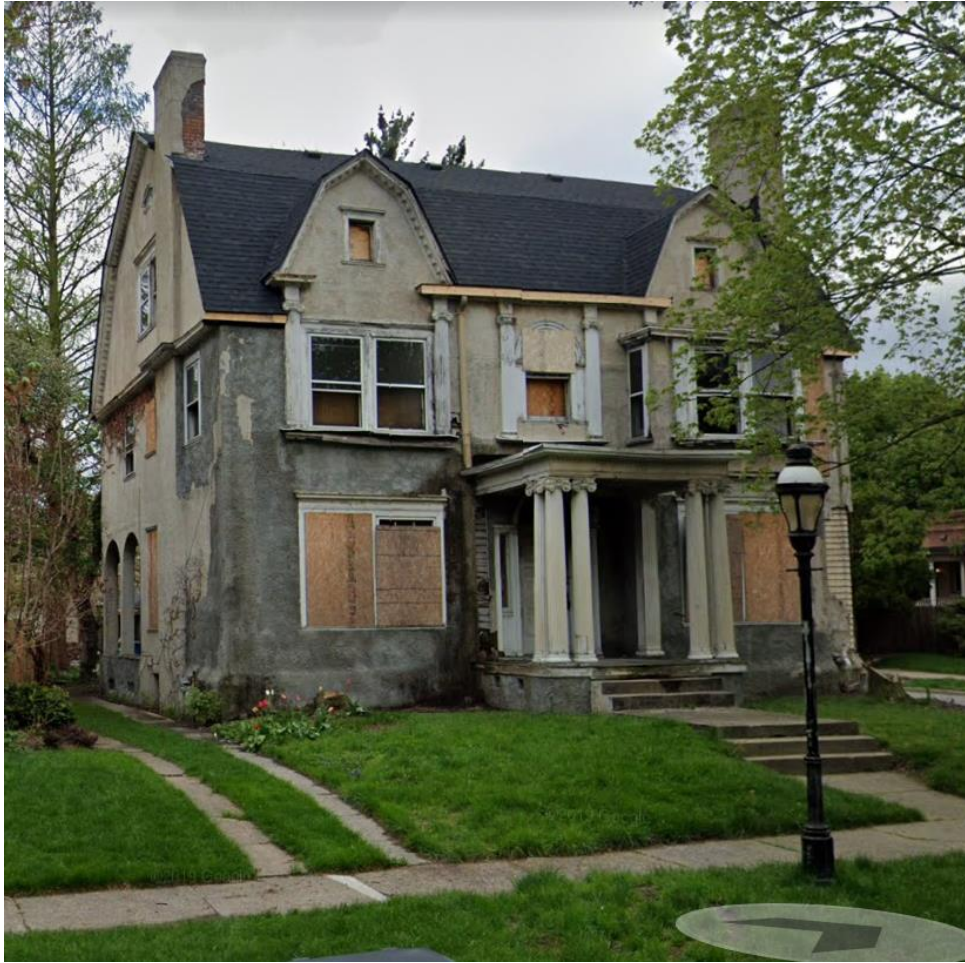
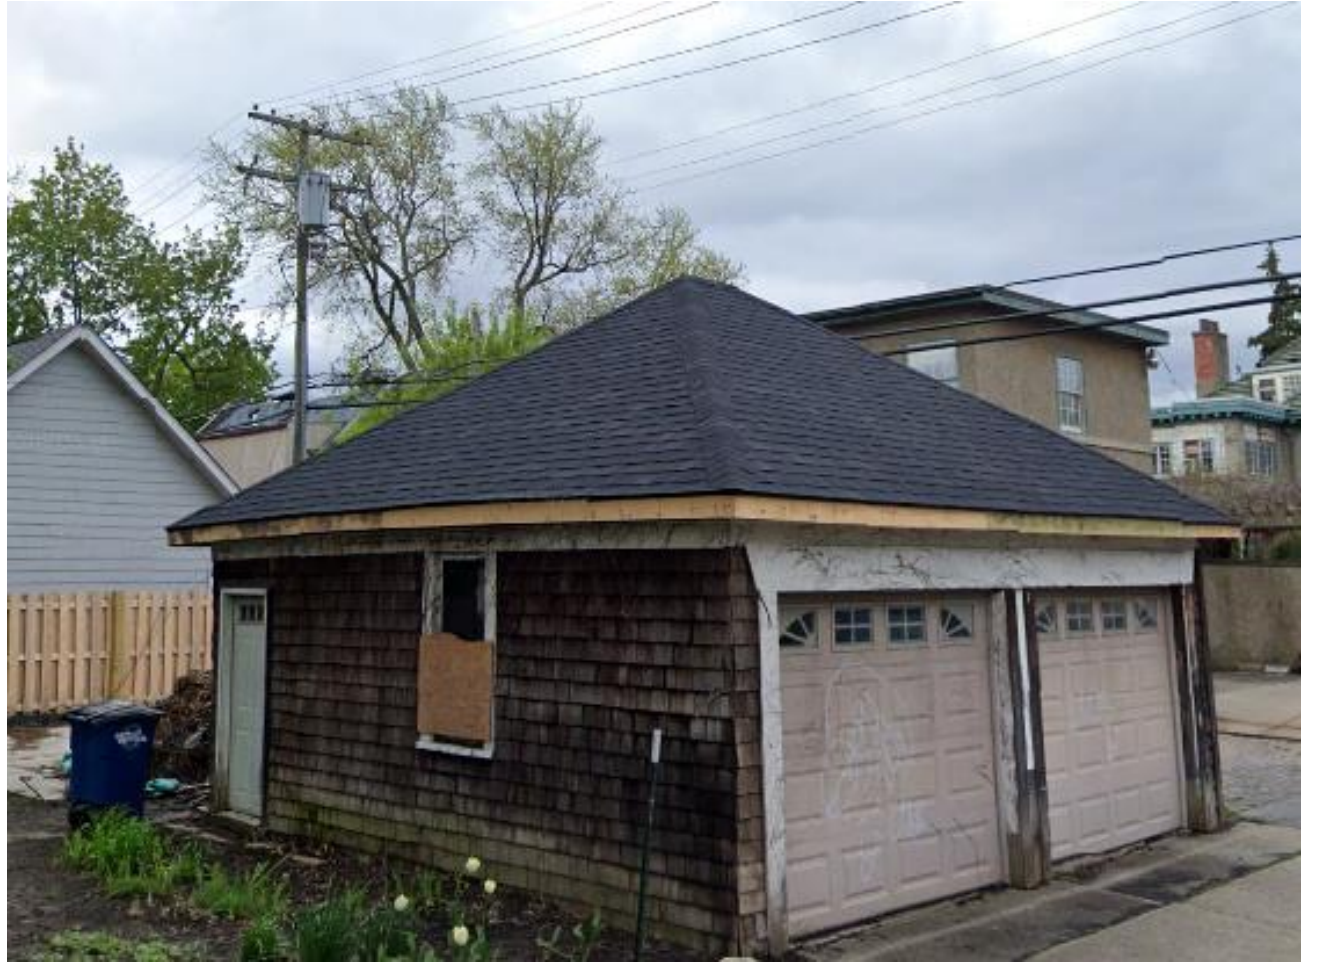
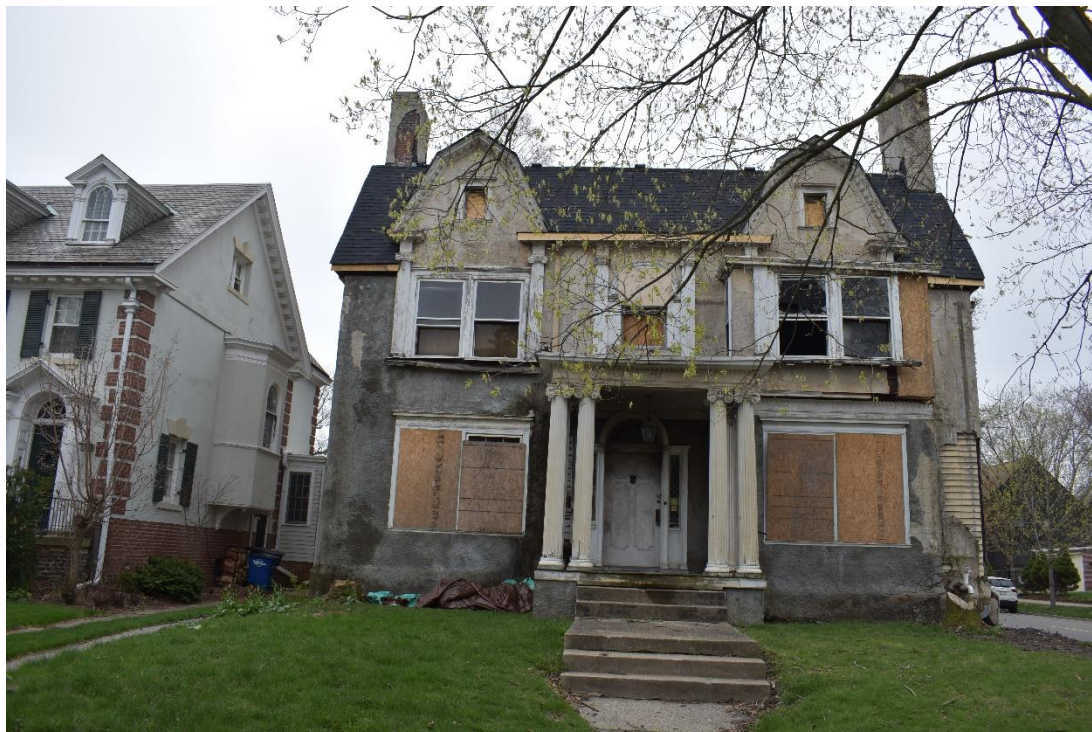
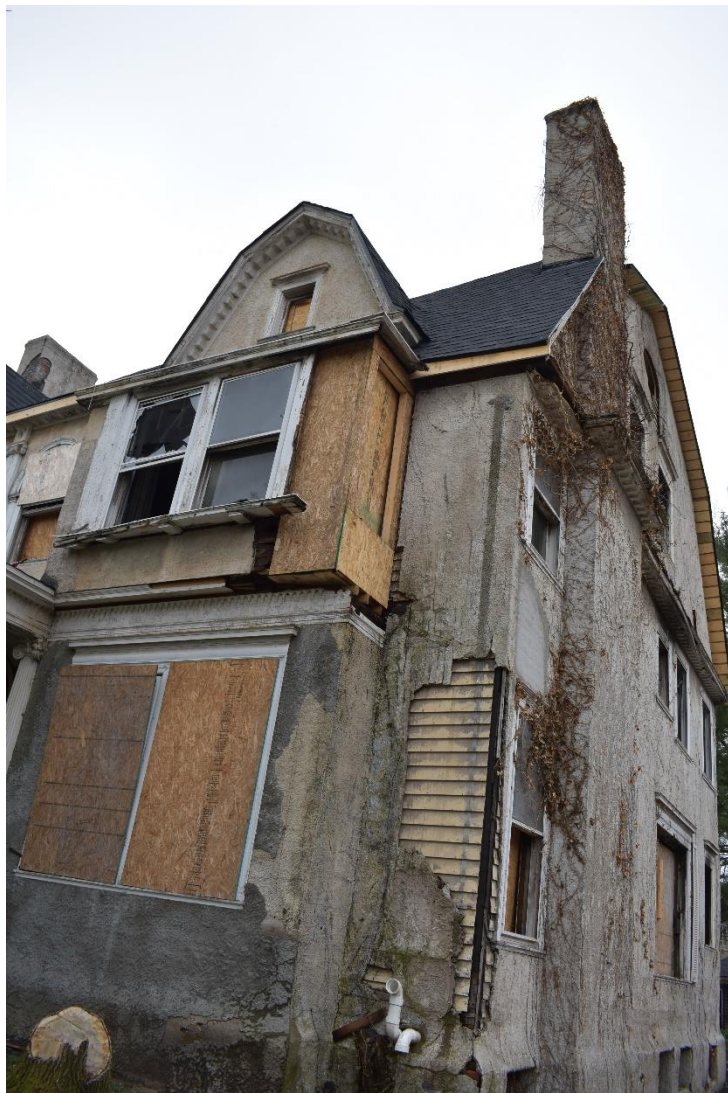
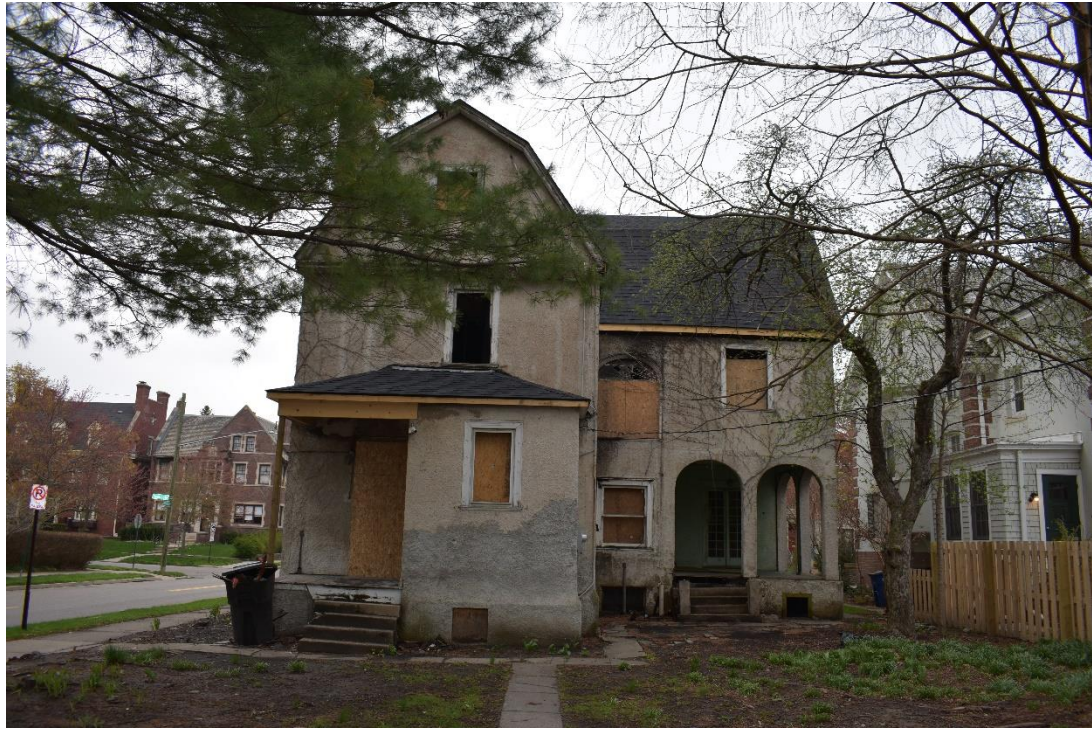
Photos of building after 4-2019 unapproved work

- On 4/30/2019, staff forwarded a report to BSEED that the following work had been completed without HDC approval OR permit:
 - The installation of unfinished plywood fascia boards The addition of the plywood/OSB siding at the front, rear, and side elevations

- Rebuilding of the rear porch
 - The installation of a plywood board at the rear garage fascia
- On 4/30/2019, HDC staff contacted one of the property owners (Yuri Dado) and discussed the ongoing violations at the property. Specifically, staff offered to help them through the process, but noted that they should stop by asap so that HDC staff could get them the approval they needed in order to undertake any exterior work outside of the approved and permitted asphalt shingle installation.

- The fascia at the home and garage roofs shall be and restored to their historic appearance using new wood to match the historic in detailing, dimension, and profile

- All existing plywood from the home's exterior walls shall be removed and new stucco added to match the historic appearance
- Replace all existing non-historic wood windows and replace with new wood windows, to match the original in dimension, profile, operation and light configuration. The new windows must be true divided light or simulated divided lite (grid applied to the exterior surface of the glass).
