STAFF REPORT: 10-9-2019 MEETING
APPLICATION NUMBER: 19-6490
ADDRESS: 791 SEMINOLE
HISTORIC DISTRICT: INDIAN VILLAGE
APPLICANT: YURI DADO
DATE OF COMPLETE APPLICATION: 11/13/2019
DATE OF STAFF SITE VISIT: 12/4/2019

PREPARED BY: J. ROSS

SCOPE: INSTALL NEW WINDOWS

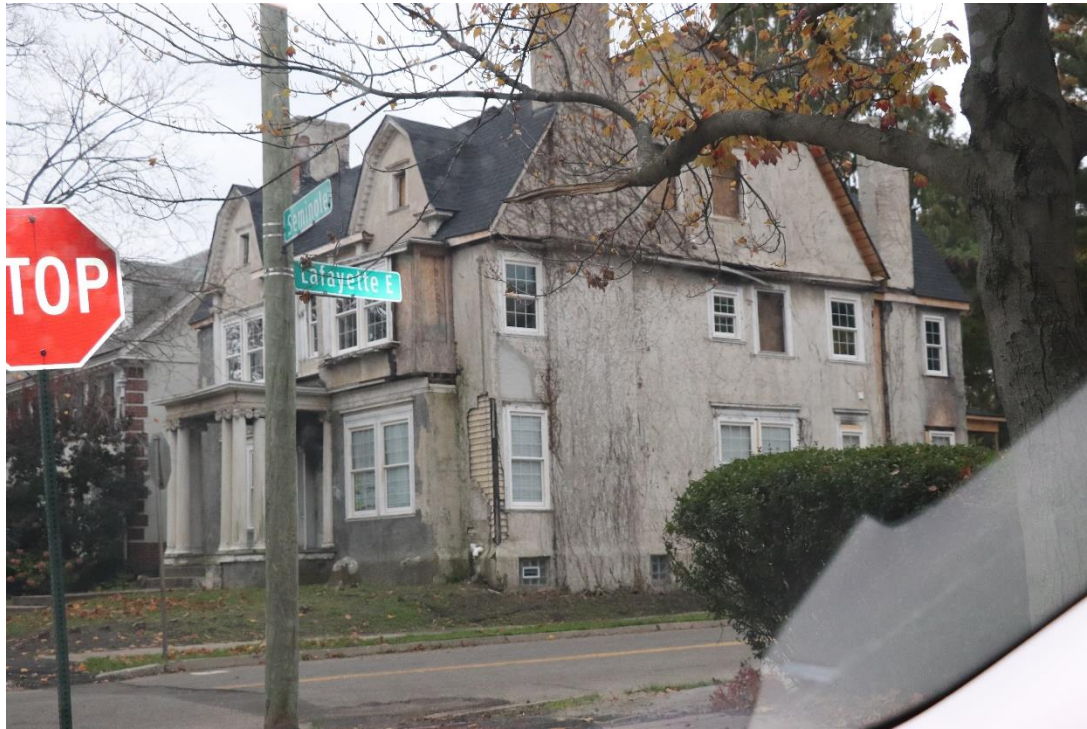
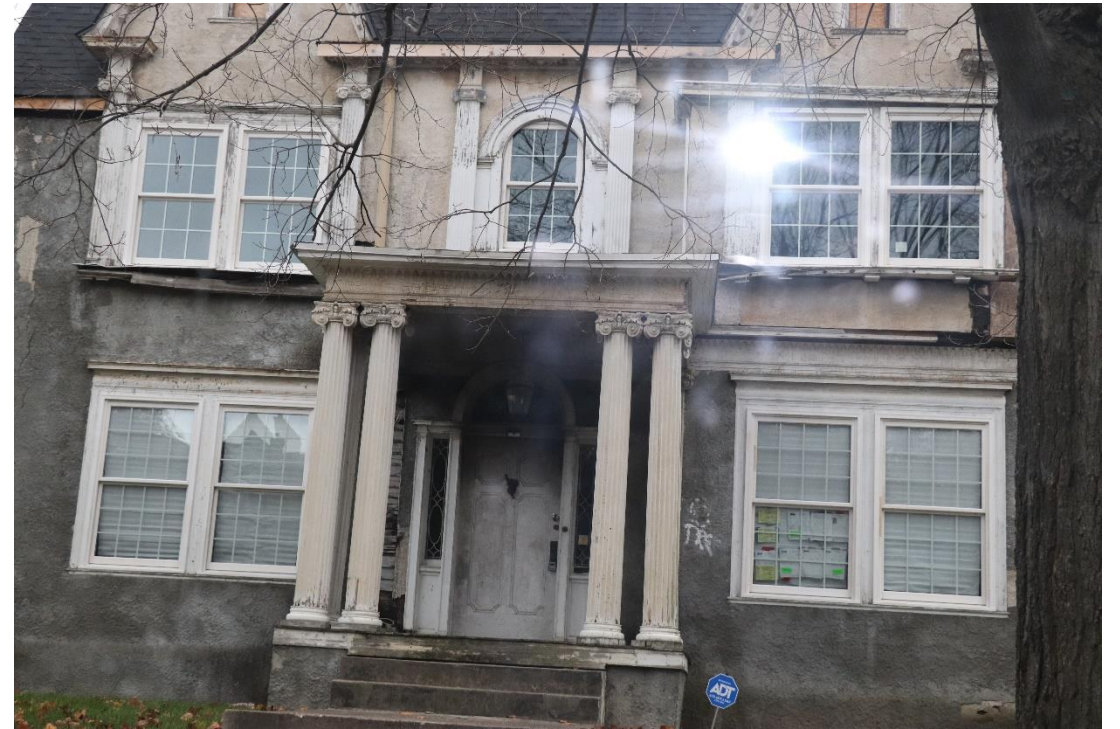
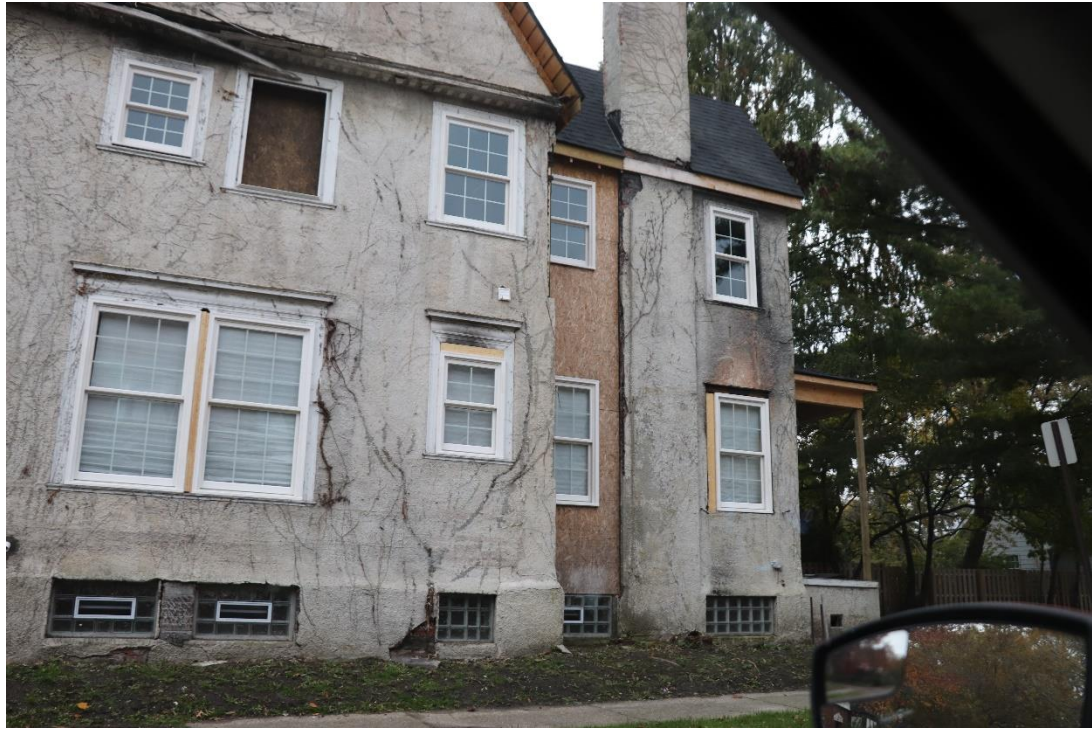
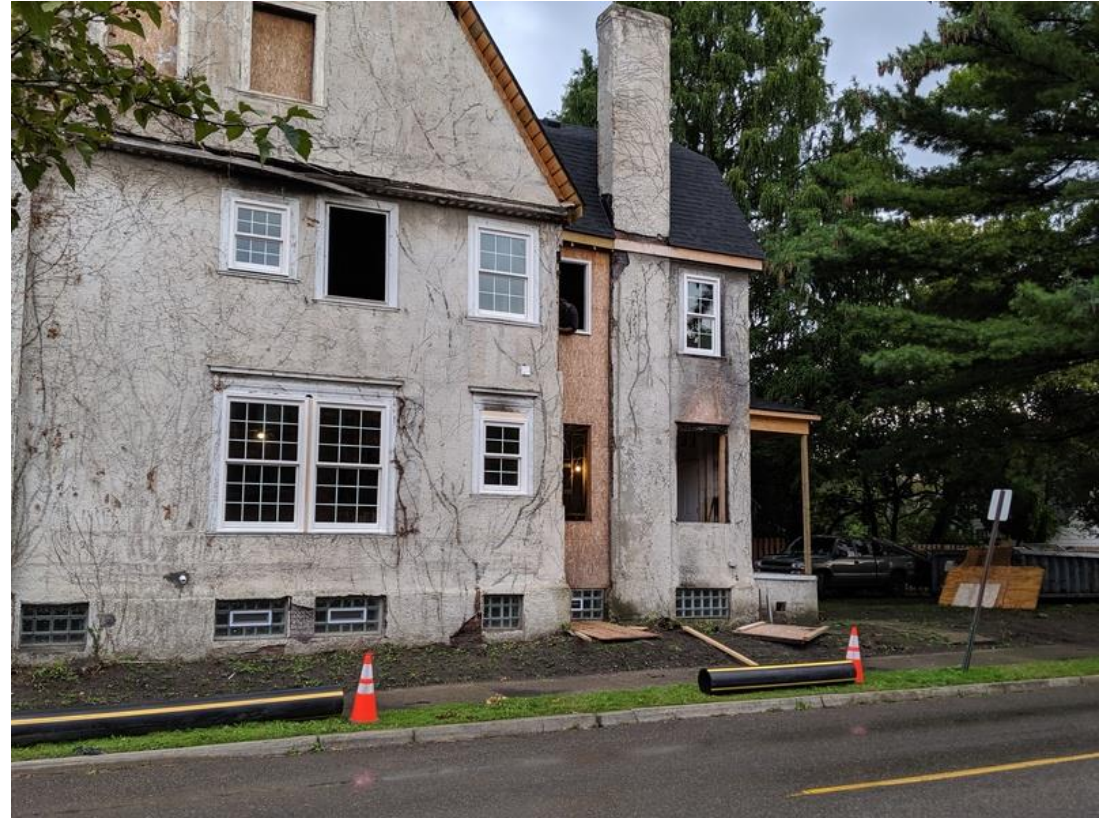
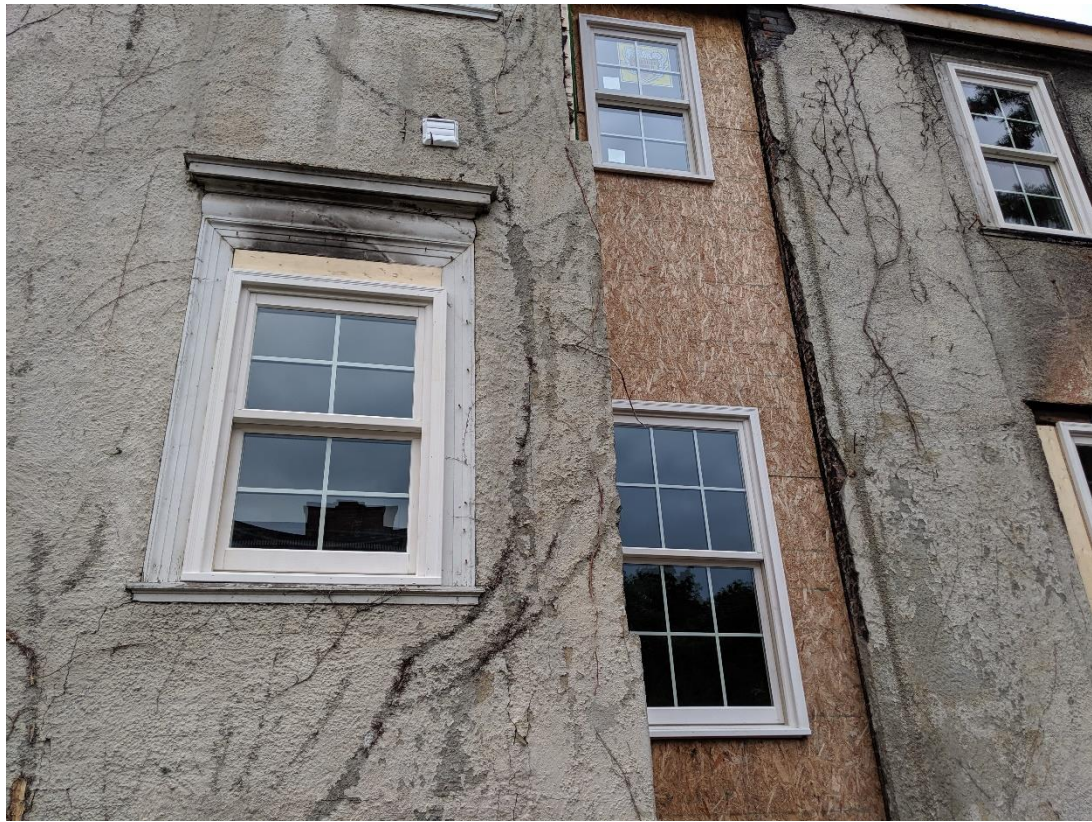
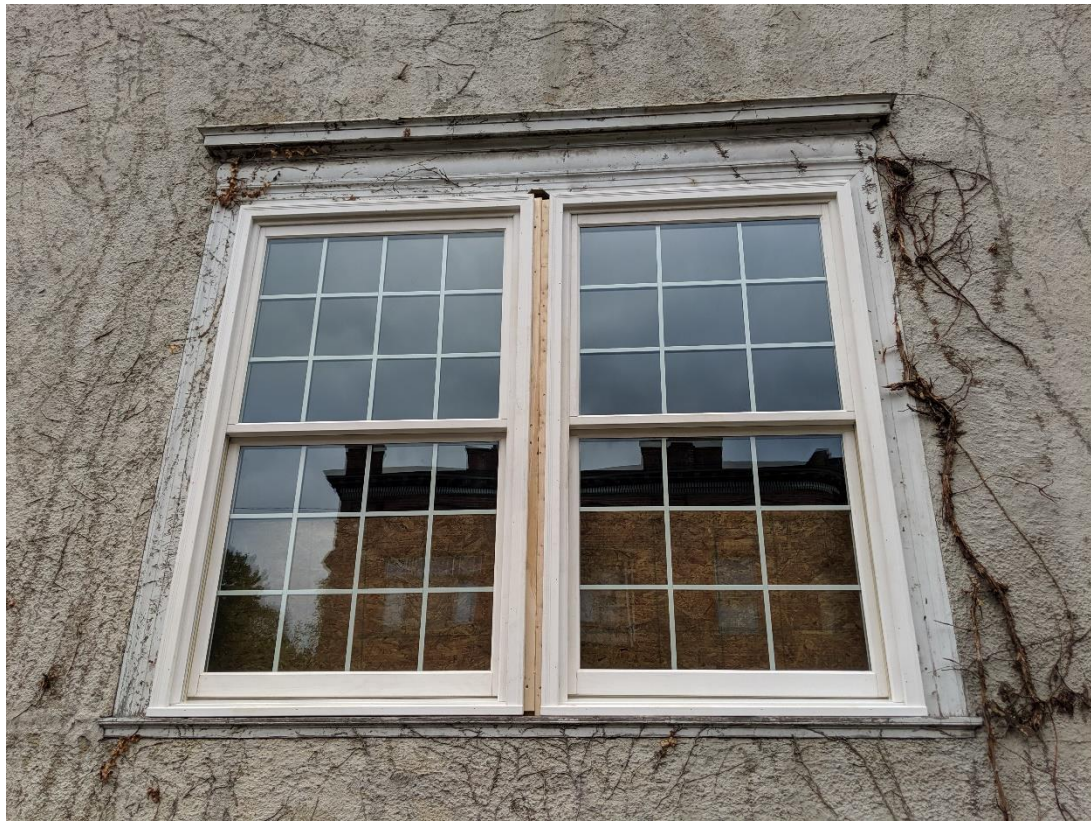
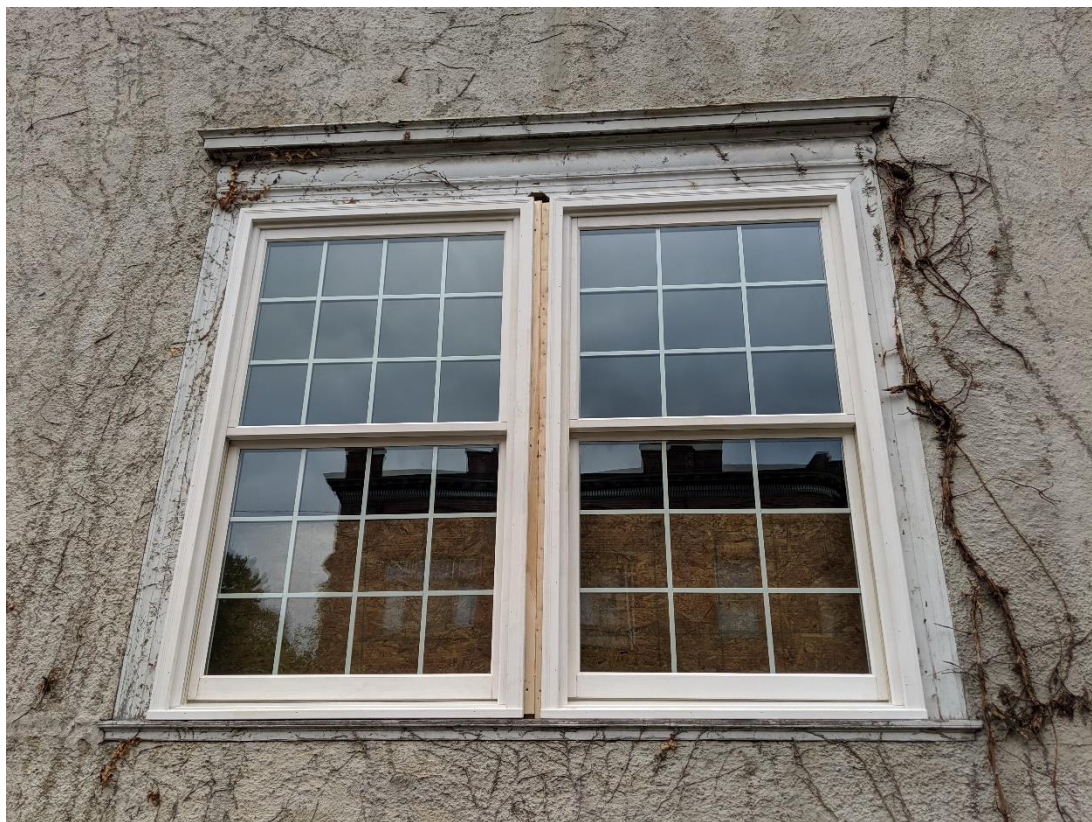
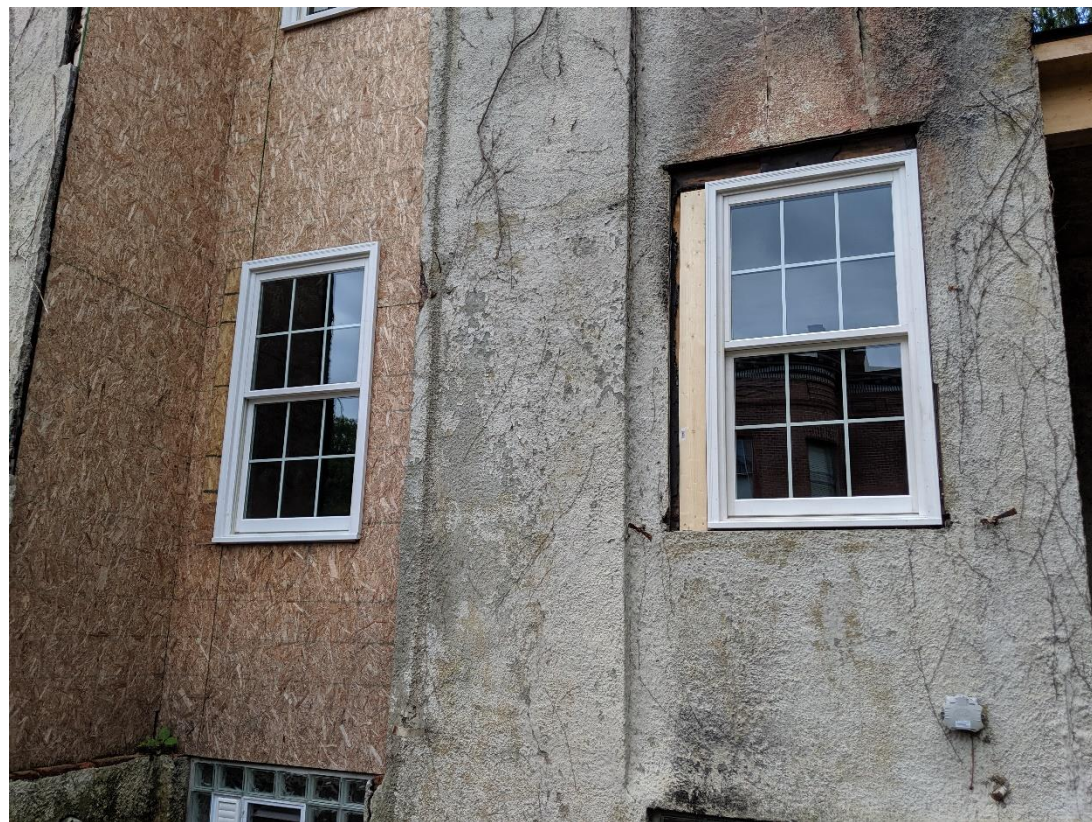
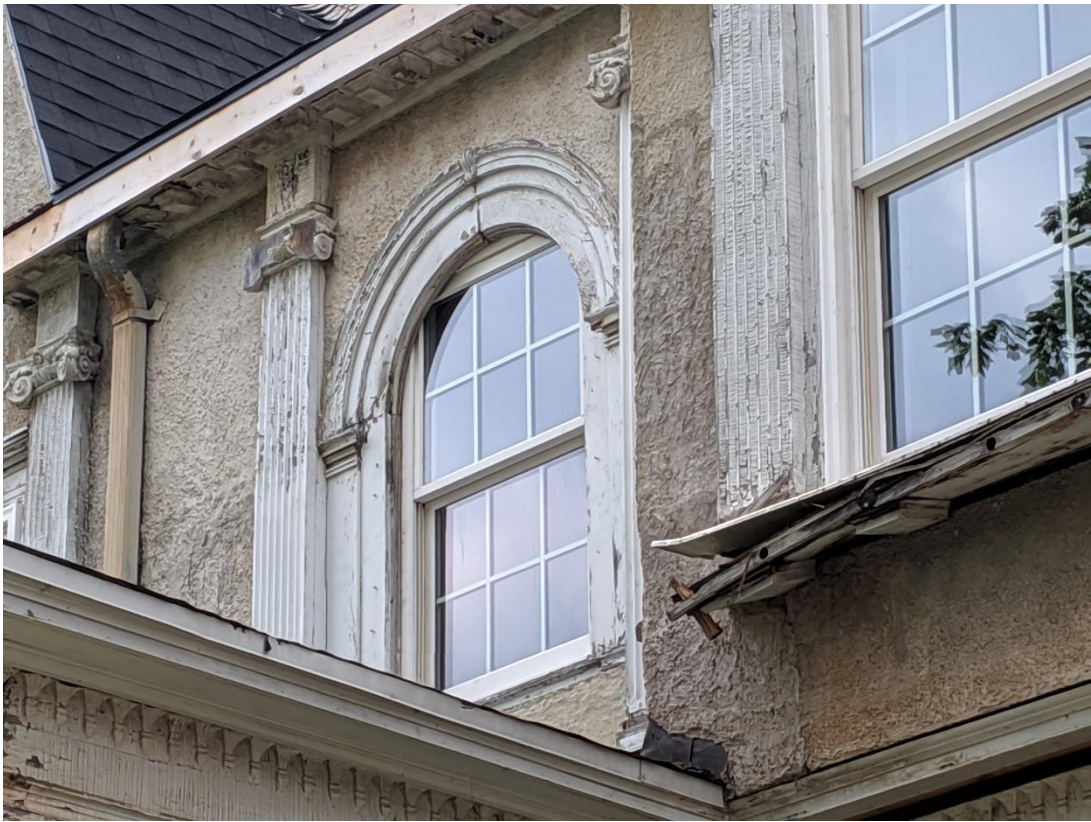
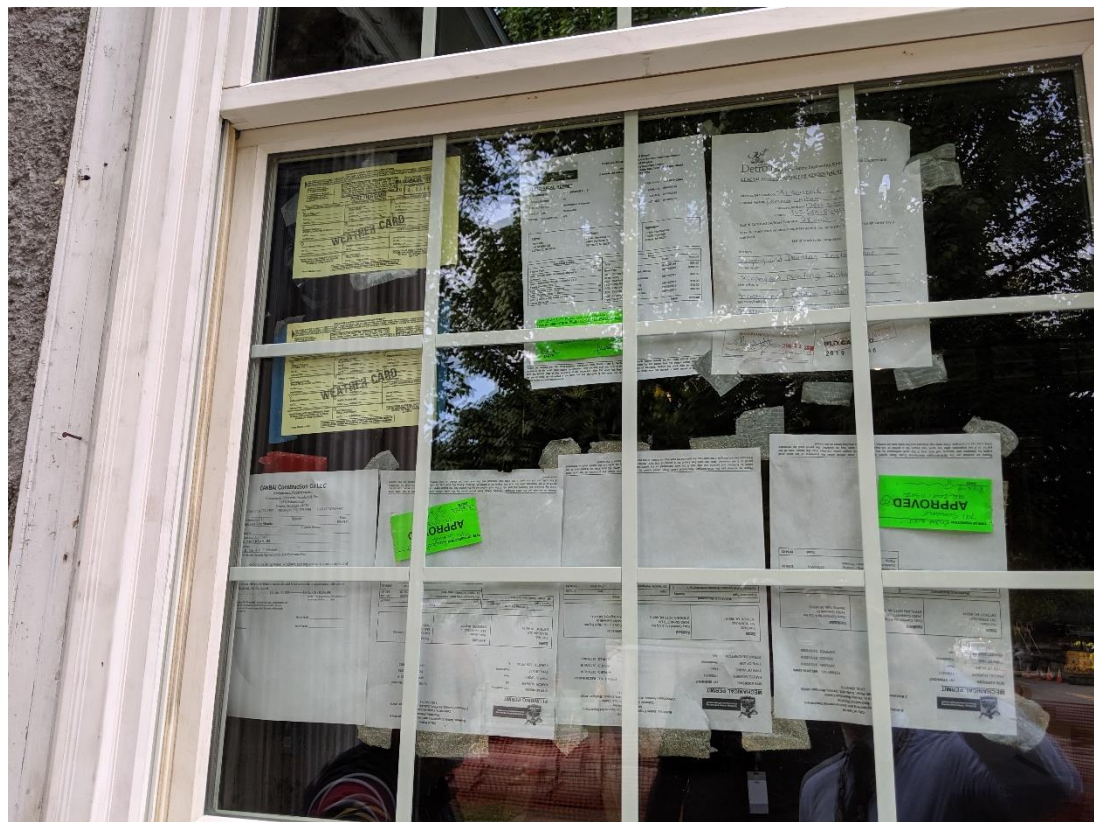
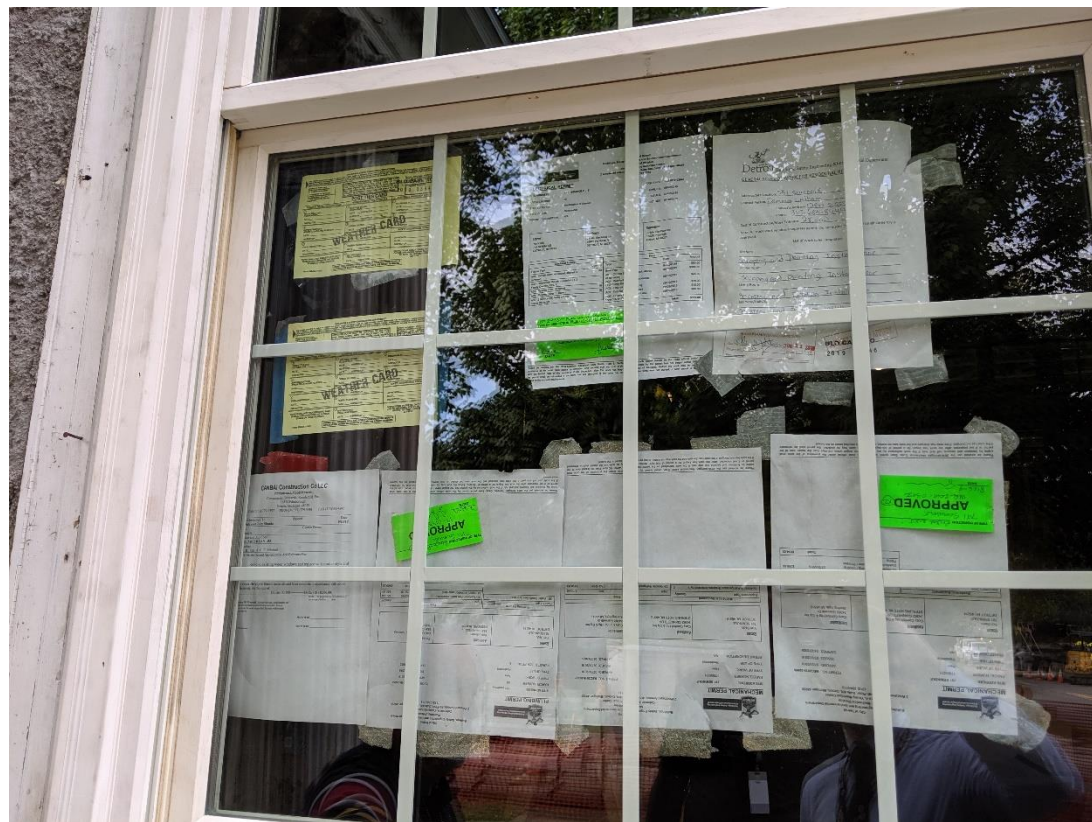
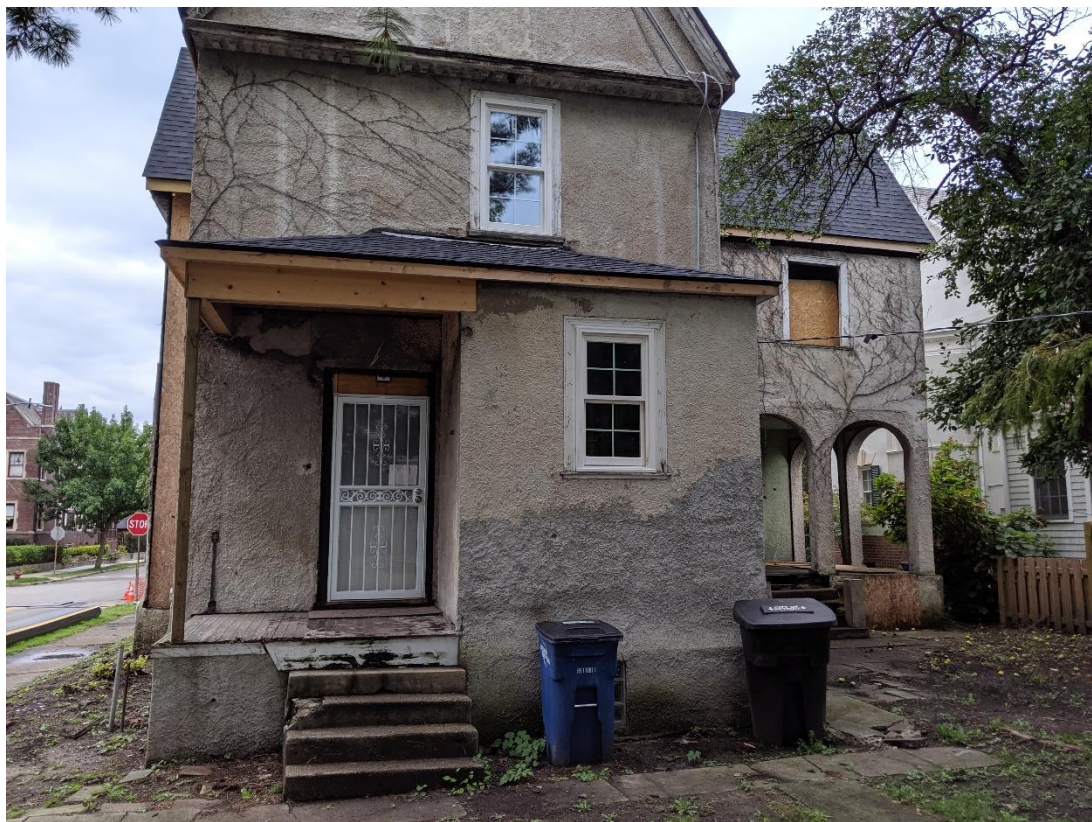
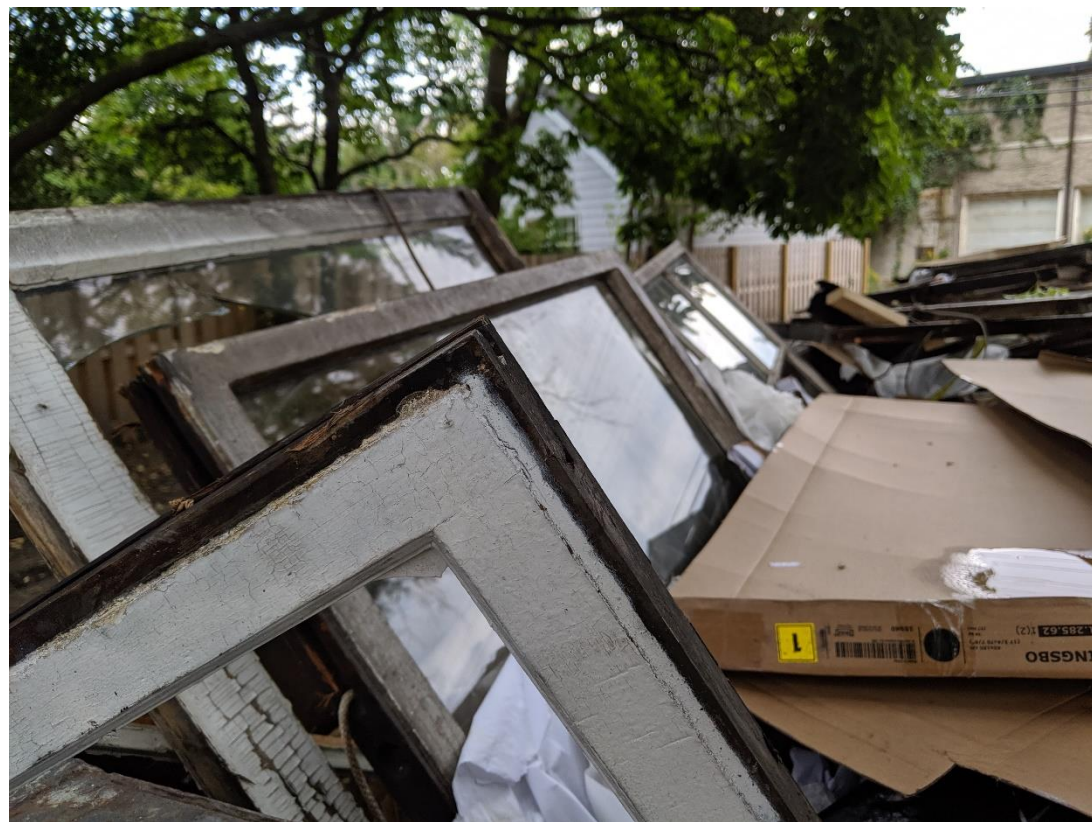
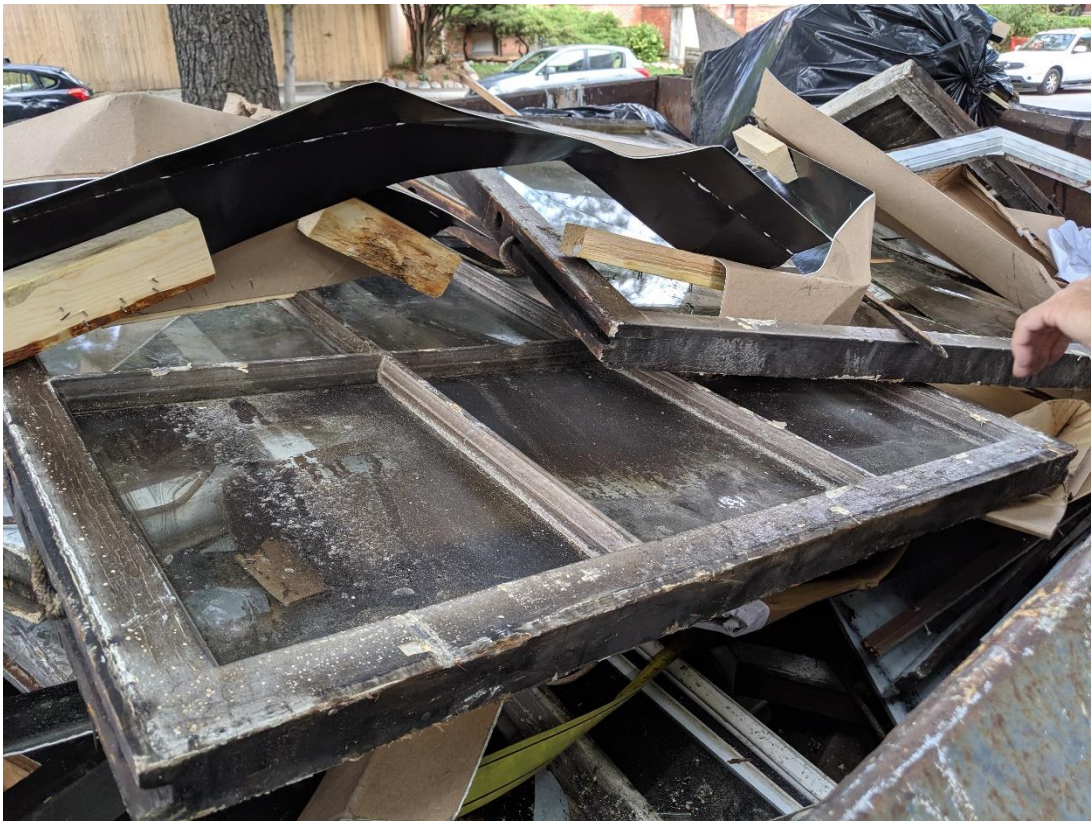
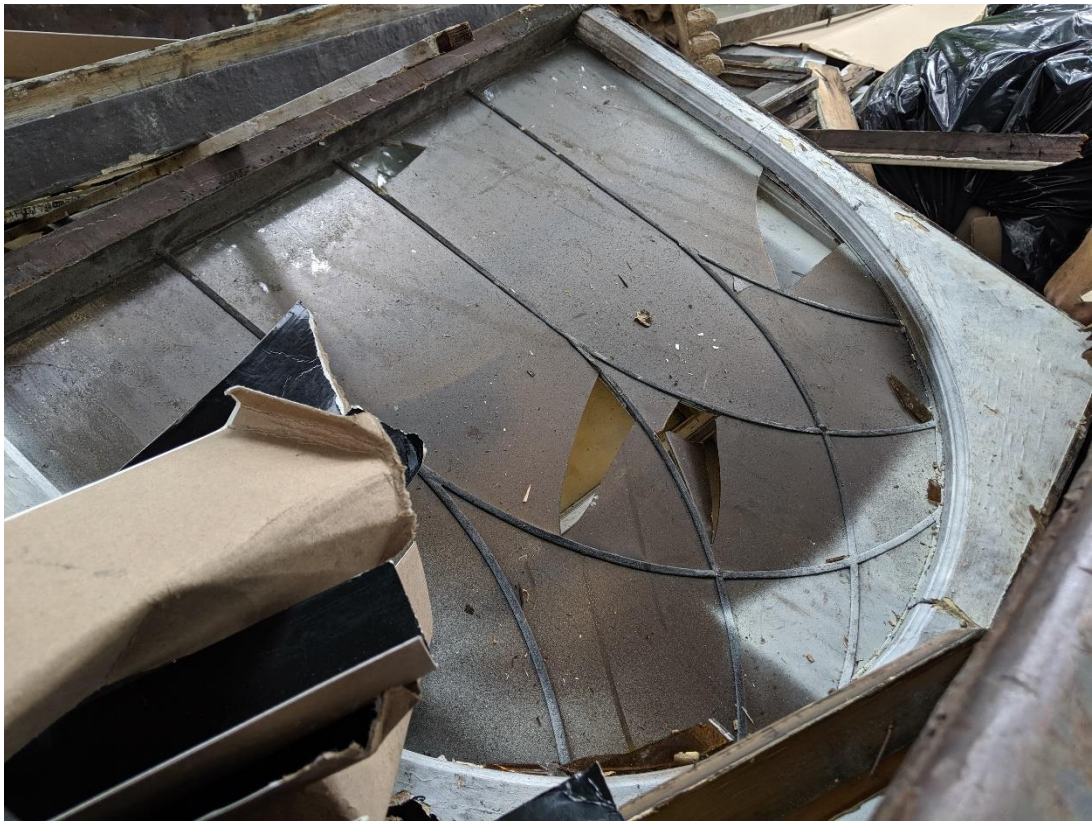
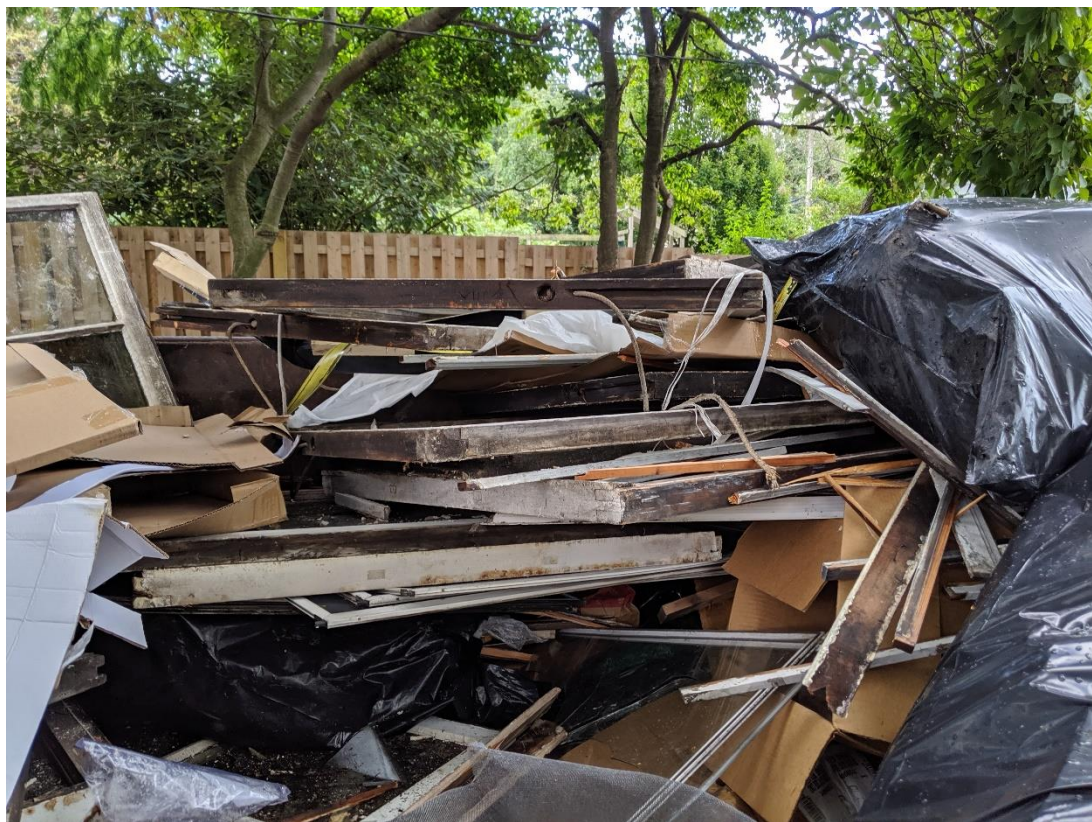
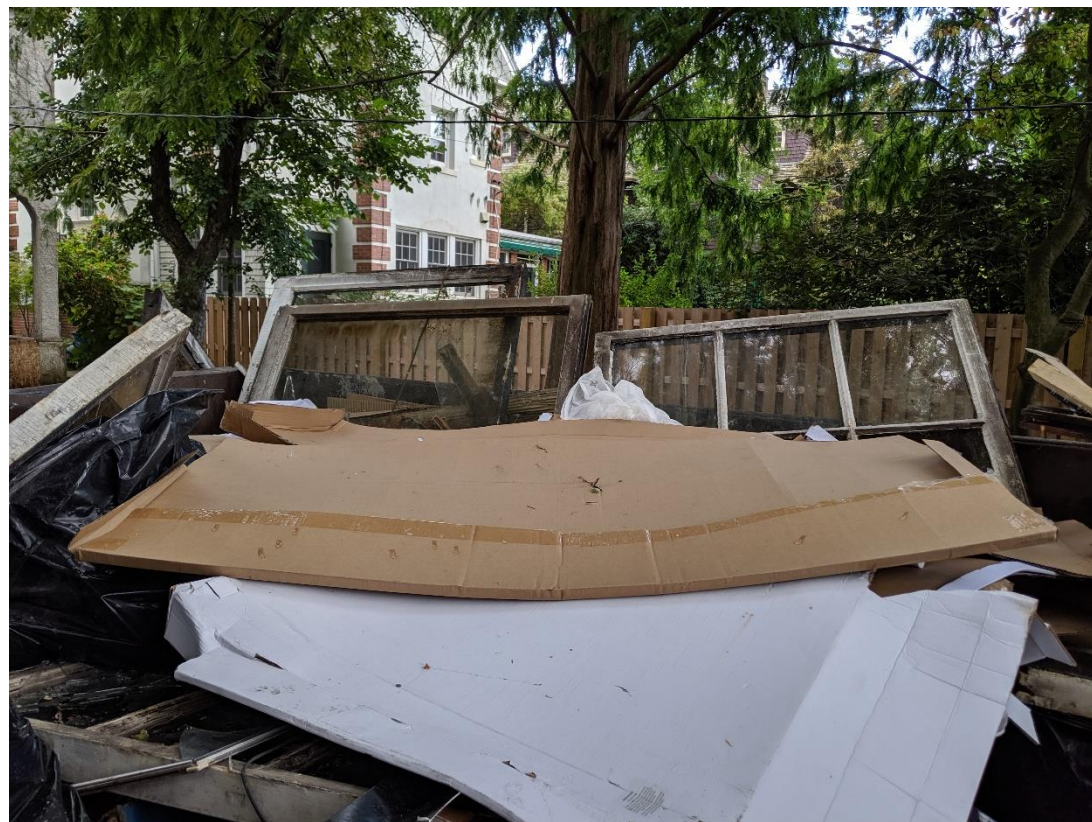
Photos after 9-2019 unapproved window installation

- On 9/13/2019, HDC staff were made aware that the original windows at the property were being removed and replaced. This work was undertaken without permit and/or HDC approval. Please see the **attached photos** of the unapproved windows. Please see the attached photos

- The light configuration of the new windows do not match the old/original
 - The grids at the new windows are between the glass
 - Many of the windows are improperly fitted within their opening. Plywood has been used to infill the gaps in the opening.

- The new windows are not properly recessed with their openings
 - HDC field investigations revealed that leaded glass windows were removed from the building.

- All existing plywood from the home's exterior walls shall be removed and new stucco added to match the historic appearance
- Replace all existing non-historic wood windows and replace with new wood windows, to match the original in dimension, profile, operation and light configuration. The new windows must be true divided light or simulated divided lite (grid applied to the exterior surface of the glass).

- Where windows are missing, new wood windows, to match the original in dimension, profile, operation and light configuration. The new windows must be true divided light or simulated divided lite (grid applied to the exterior surface of the glass). The existing window trim./brickmould must be retained and repaired (where necessary) with new wood to exactly replicate the original.

- Where windows are remaining, they must be retained and repaired

- The existing window trim./brickmould must be retained and repaired (where necessary) with new wood to exactly replicate the original. Where trim is missing, new trim/ brickmould is missing new wood trim must be installed to exactly replicate the original in dimension, profile, and detailing
