**STAFF REPORT: 05/08/2024 REGULAR MEETING**

**APPLICATION NUMBER: HDC2024-00116**

**ADDRESS: 1459 EDISON**

**SCOPE: ERECT GARAGE (WORK COMPLETED WITHOUT APPROVAL), REHABILITATE EXTERIOR OF DWELLING**

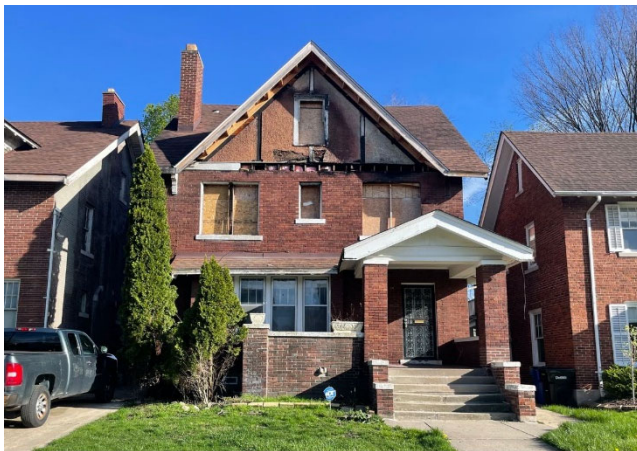
*Site Photo 1, by Staff April 19, 2024: (South) front elevation showing fire damage at front gable and missing windows.*

- Repair half-timbering and stucco at front of house damaged by fire with in-kind materials (wood and stucco), color to match to existing: paint trim board antique white, paint stucco areas antique red.
- Cover soffit areas with aluminum.

- It is staff's opinion that the proposed repair of the front face of the house with in-kind materials and matching color schemes is appropriate.
- It is staff's opinion that the bracketed soffits and fascia board are distinctive, character-defining features of the house that characterize the architectural style of the house. The proposal to cover the soffit areas with aluminum is inappropriate in staff's opinion because it hides the architectural detailing, changes the materiality and alters the design which greatly reduces and alters the roof's distinctive, character defining historic features.

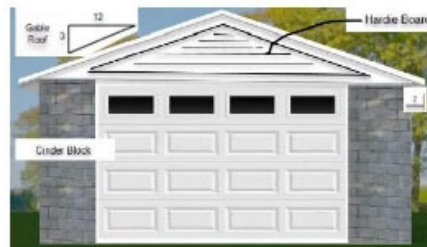
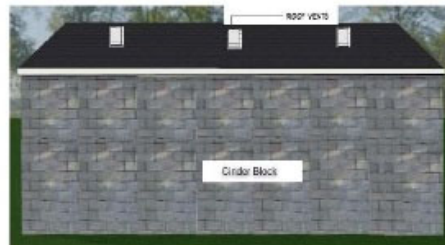
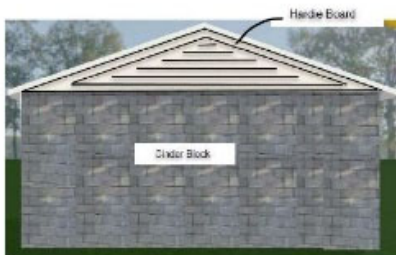
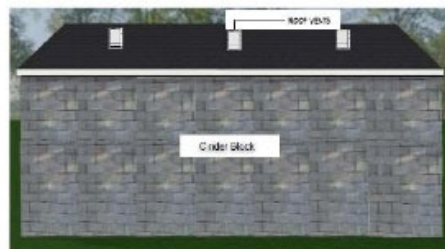
*Fig 1, by Applicant: Proposed garage elevations.*

- Although partially completed without approval, staff observed that the overall scale, roof pitch and location of the garage is appropriate for the district and meets the Elements of th Design. However, the use of concrete block as final external material is not appropriate and would be considered incomplete and inconsistent if left unfinished. Staff recommends an appropriate cladding that matches the primary structure to complete the design of this structure or a finish compatible with the district.

- The remaining materials, including the hardie siding, dimensional asphalt shingles and the steel garage door are appropriate new construction in for the district, in staff's opinion. However, staff recommends that the colors of the siding and garage door be selected from the HDC Color Guide to more accurately coordinate with the historic color palette of the house, which is Color System D.

- While the proposed garage, with modest gable pitched roof, Hardie siding at the gable, garage door, and modest scale are an appropriate scale and form that complements the house, the materiality of the concrete block is not appropriate. Staff recommends a brick cladding that matches the house would be an appropriate solution. Staff recommends also recommends that the color white for the siding and the garage door be updated to one that is selected from the HDC Color Guide, Color System D, for English Revival architectural styles.

- The applicant submits a design that shows exterior cladding, such as brick, that is compatible with the property and/or district.
- The applicant provides HDC staff with a garage door and siding color that is selected from HDC Color Guide.

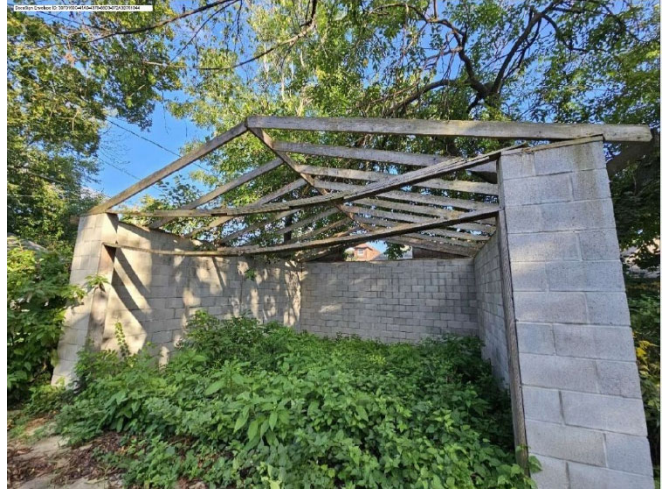
Site Photo 2, by Applicant: (Looking east at rear of property) showing partially constructed garage structure (without approval).

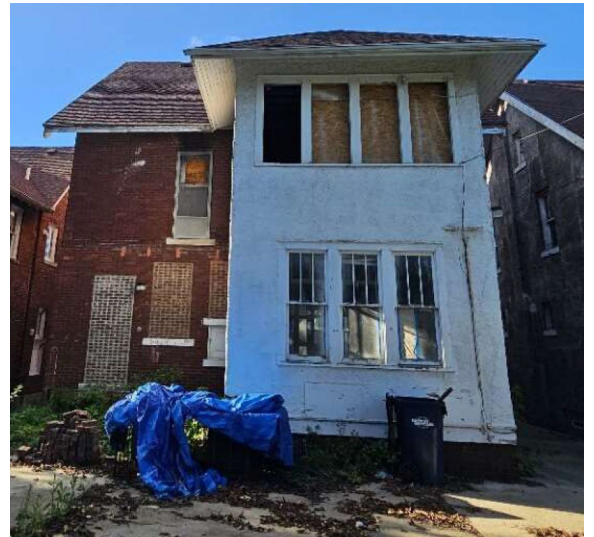
- Rear door and window openings bricked in.
  - Rear porch/balcony removed.
  - Front awning removed.
- **The applicants provided an update on May 7, 2024 informing staff that the original applicant, Ms. Murphy is no longer representing this property or proposal. The new applicants have provided a letter confirming the ownership and that the application as presented is accurate to date.**

Site Photo 3, by Applicant: looking north (rear) side of the house, showing unapproved removal of balcony/porch, bricked-in openings of the rear door and windows.

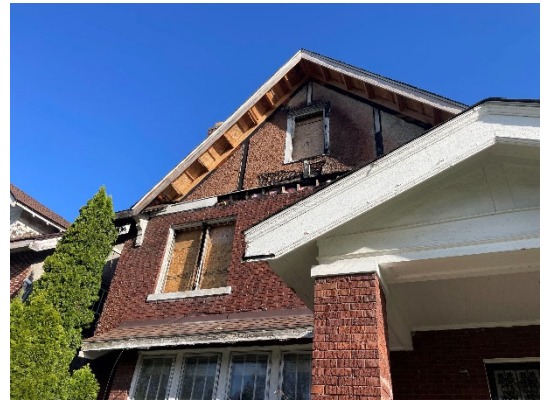
- Although the applicant has indicated a general desire to install aluminum clad wood windows at the front elevation and vinyl windows at the rear and side elevations, there is not substantial clarity on whether this is meant only for missing windows or to include partially damaged and other existing wood windows that remain. Furthermore, there is no clarity on how the windows would be installed, whether the existing brick mould or mullions would remain, and with which design, material, and operation of the window. The proposed windows have not been clearly identified. The conditions of the existing windows to be repaired (or replaced) has not been identified. Staff considers this portion of the application incomplete at the time of this report.

*Site Photo 4, by Staff April 19, 2024: (South) front elevation showing detail of missing windows, soffit, stucco and half-timbering.*

- It is staff's opinion that the covering the original wood bracketed soffits with aluminum destroys historic character-defining features by altering the original *scale*, *design*, and *material* of these elements that characterize the English Revival architecture of the house and therefore does not meet the Secretary of the Interior's Standards for Rehabilitation.
