STAFF REPORT: MAY 8, 2024, REGULAR MEETING
APPLICATION NUMBER: HDC2024-00164
ADDRESS: 1032 VINEWOOD
HISTORIC DISTRICT: HUBBARD FARMS
APPLICANT: JOSHUA BRYAN RILEY
PROPERTY OWNER: JOSHUA BRYAN RILEY
DATE OF PROVISIONALLY COMPLETE APPLICATION: APRIL 12, 2024
DATE OF STAFF SITE VISIT: APRIL 26, 2024

SCOPE: REPLACE WOOD WINDOWS WITH ALUMINUM-CLAD WOOD WINDOWS

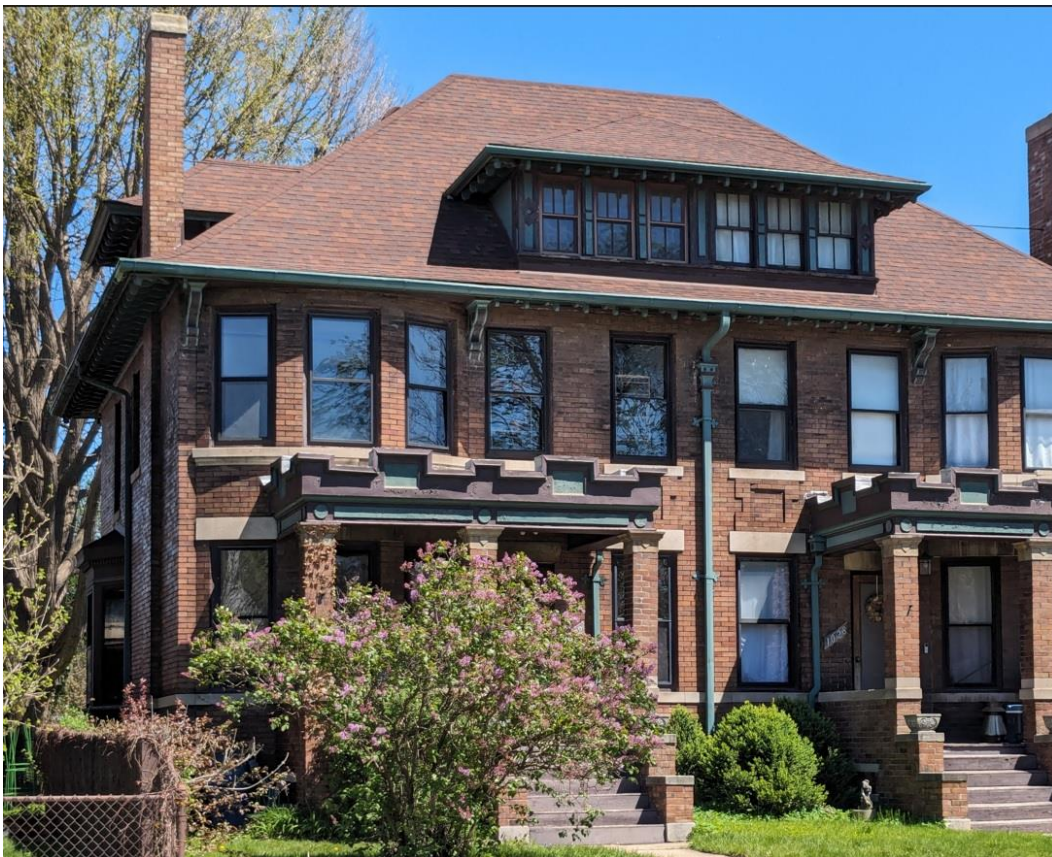
April 2024 photo by staff of the front (west) facade. 1032 Vinewood is the left (northern) half of the building shown.

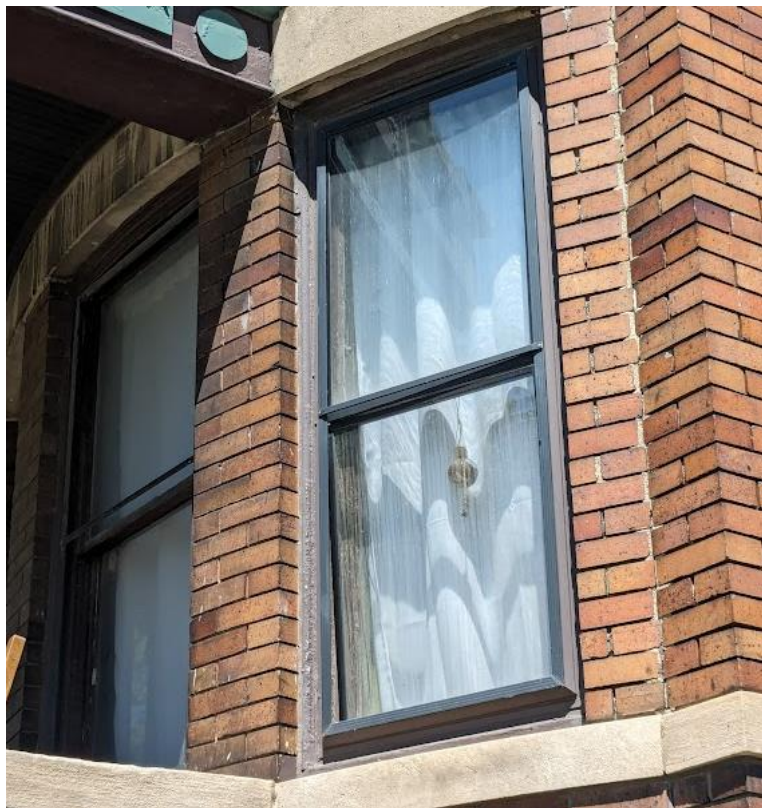
Existing condition showing historic sash window, wood brickmould trim, and storm window track fastened to brickmould. Note: photo is of the 1028 Vinewood half of the building due to greater visibility, but the condition is the same. May 2024 Photo by staff.

- Based on configuration, materials, and style, the existing windows appear to be original to the building.
- As stated by the property owner in the application, the reasons for seeking to replace the windows are as follows:

- The Secretary of the Interior’s Standards require that historic materials and features be retained and preserved (Standard #2, quoted below). The Standards allow windows to be replaced with matching new windows if they are deteriorated beyond repair (Standard #6, quoted below). However, the existing windows do not appear, to staff, to be beyond repair.

- The shortcomings mentioned in the application can be addressed with maintenance and repair. The National Park Service provides helpful guidance, *Preservation Briefs 9: The Repair of Historic Wooden Windows*, describing how to repair these conditions. According to the National Park Service, this work is labor intensive but “uncomplicated” and “allows the do-it-yourselfer to save money” due to the far greater expense of new windows.¹

- Repair or replacement of storm windows would also likely be an appropriate intervention, meeting the Secretary of the Interior’s Standards for Rehabilitation while also protecting the historic windows from the elements and reducing drafts.

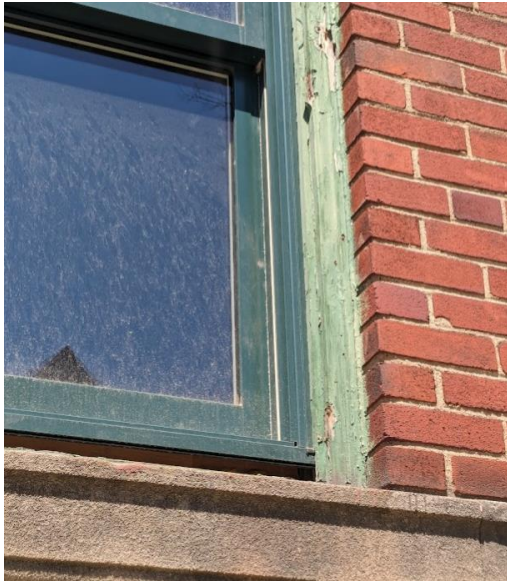
been taken to make custom windows for each of our window boxes.” It is unclear how the windows would be installed. Replacement window units should be sized to fit the rough opening, not the original sash box, as the latter installation would effectively reduce the size of the glazed window opening, also contrary to Standard #2.

Example (from another property) of a window installed within a sash box, reducing the size of the opening. This is an inappropriate installation. May 2023 photo by staff.

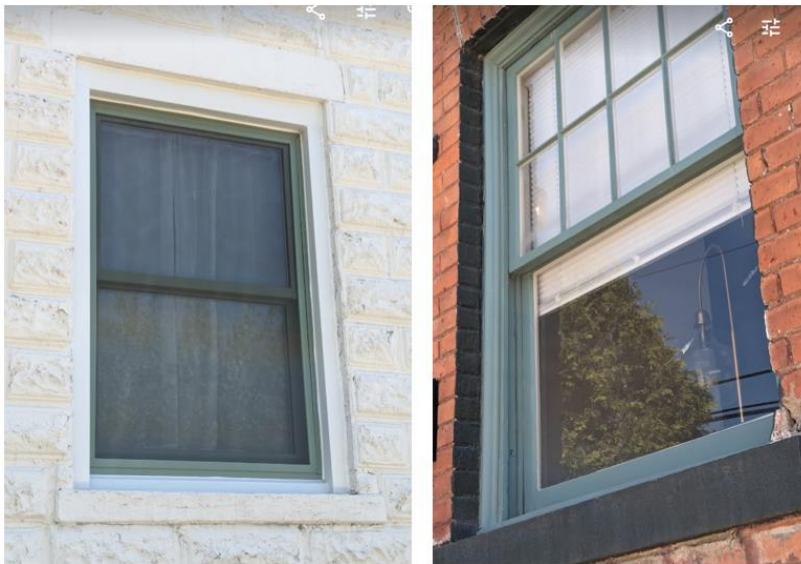
- It is unclear if the existing brickmould would be retained. Although application states “the original window box will not be altered,” it is unclear if this is meant to include the brickmould. The application materials include a quote for 300 units of 12” aluminum wrap, suggesting that the existing brickmould and, possibly, other elements such as sills and lintels, would be concealed behind new material. This would contradict Standard #2 and interfering with the “arrangement of elements and quality of design” described by the Elements of Design referenced above.

Left: Example of aluminum wrap covering brickmould, an unappropriated installation. Right: example of historically appropriate brickmould. Photos by staff. The type of installation proposed is not clear from application materials.
