**STAFF REPORT: 12-11-2019 MEETING**

**APPLICATION NUMBER: 19-6525**

**ADDRESS: 2475 CHICAGO**

**SCOPE: DEMOLISHED REAR PORCH, ERECTION OF NEW PORCH**

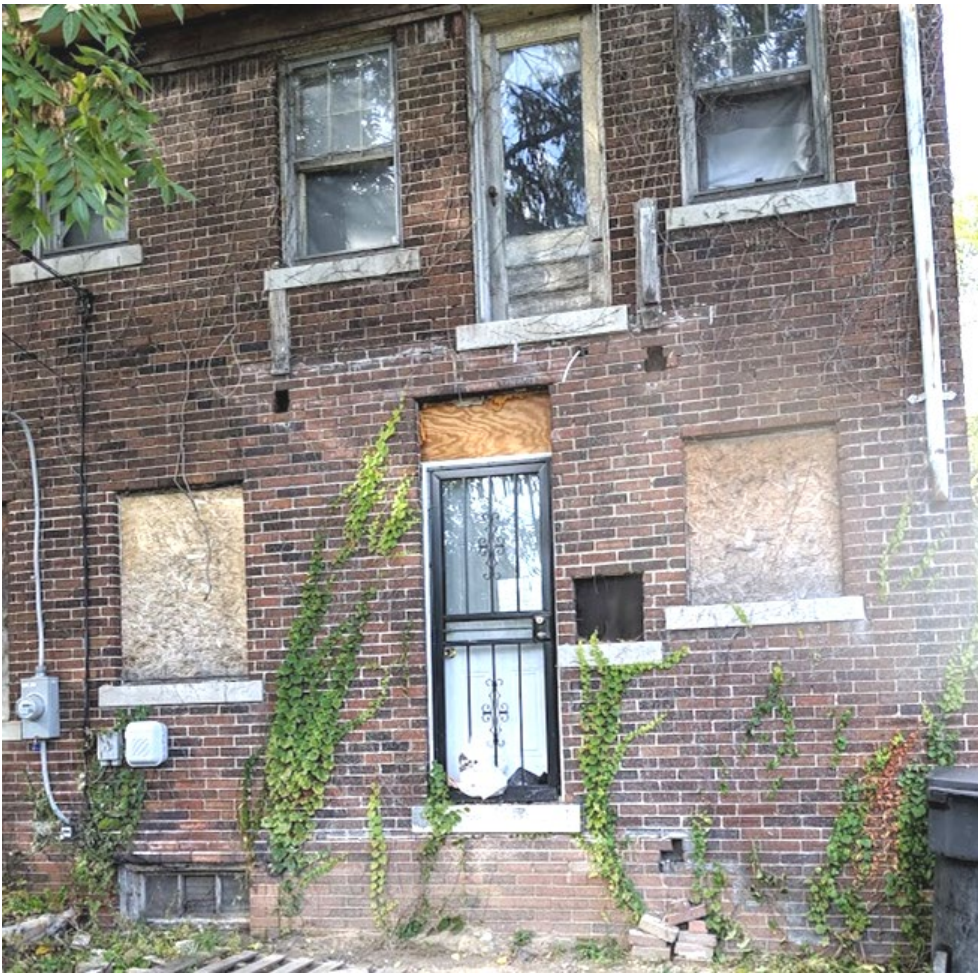
The applicant stated the balcony on the rear porch collapsed a few years ago and removed it without prior HDC approval. Evidence of the porch remains through the upper porch pilasters, the holes in the brick where the joists were secured, and the shadow lines left from the stairs and past painting projects.

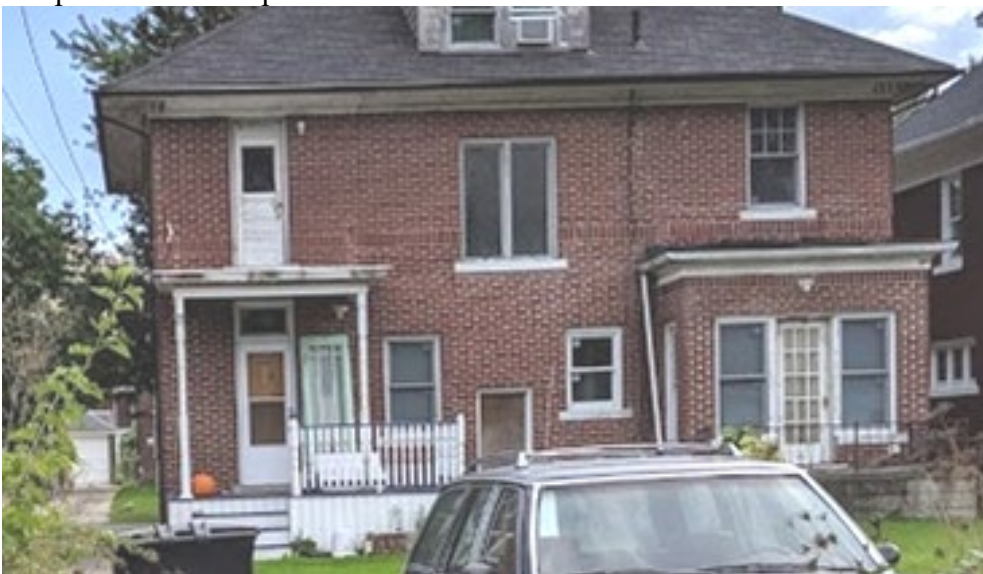
The applicant would like to build a new porch in the same location and match the design of a neighbor's porch which is shown below. The stairs would extend from the porch into the rear yard. Four-by-four posts would support the upper balcony; the first and second floor balusters (36-inches in height) would have a turned spindle design (catalog cut included in staff report). The applicant did not supply a catalog cut for the balustrade. While the railing shows a white finish, the applicant didn't state if, or how, the full porch would be painted.

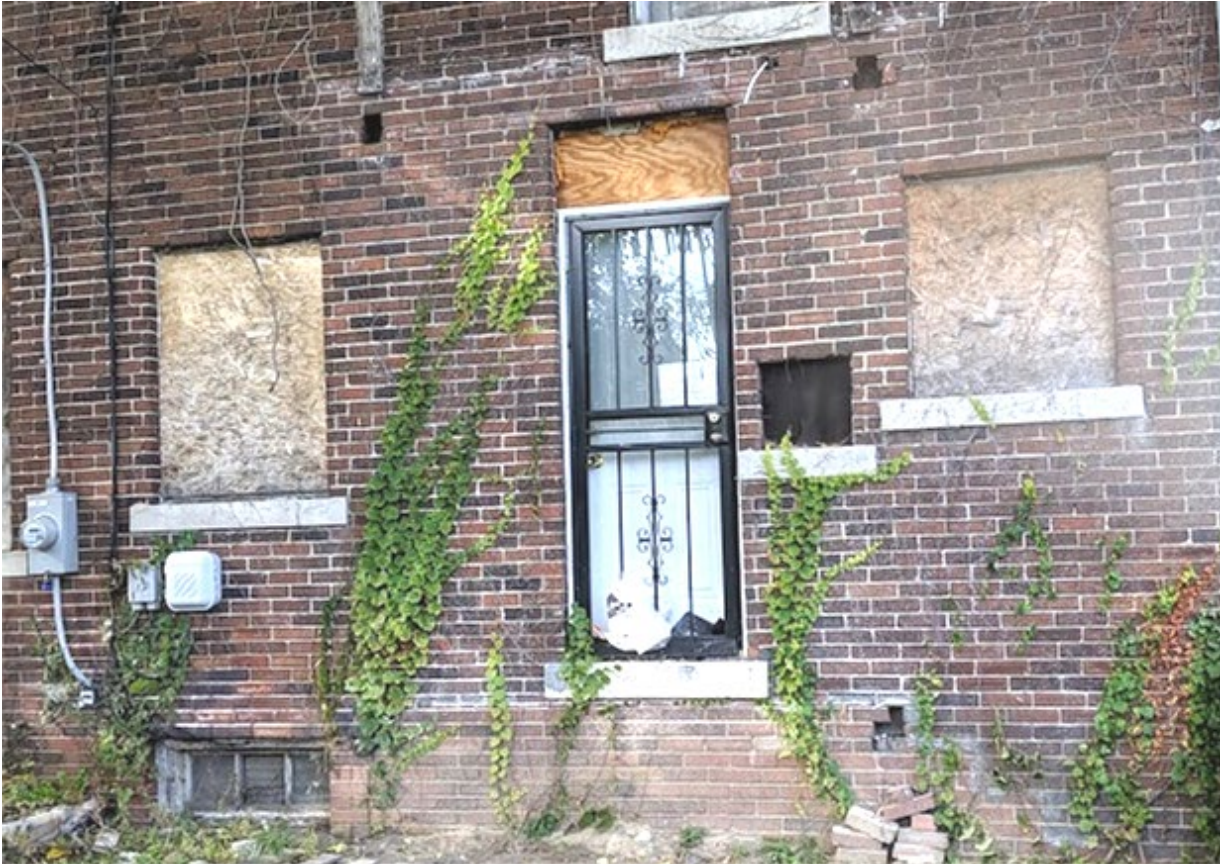
From the ghost images on the brick, the original porch stairs led to the driveway, at a right angle to the house. There is also evidence (through the protected brick spanning the area below the door and ghost lines of paint), the first floor porch may have likely extended left under the window, similar to the example submitted of the neighbor's house.

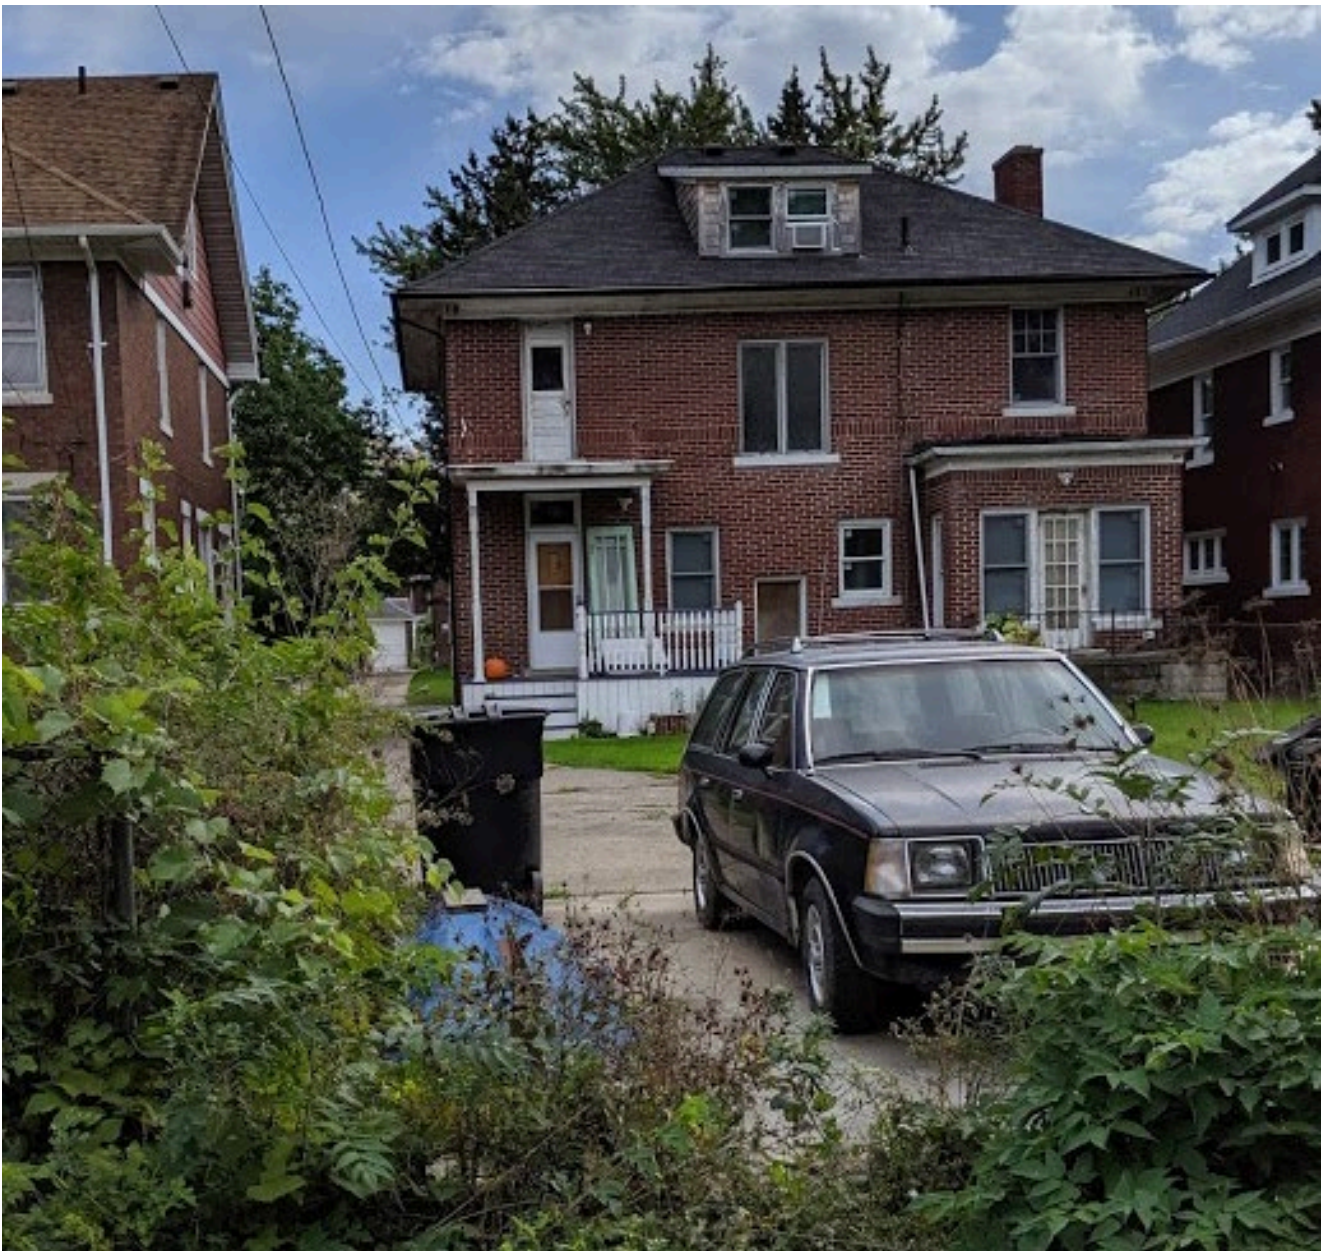
Due to the difference in surface color of the brick below the door, and the paint lines, both of which extend to the right (former stairs) and to the left beyond the basement window, physical evidence remains to show the width/footprint of the original porch.

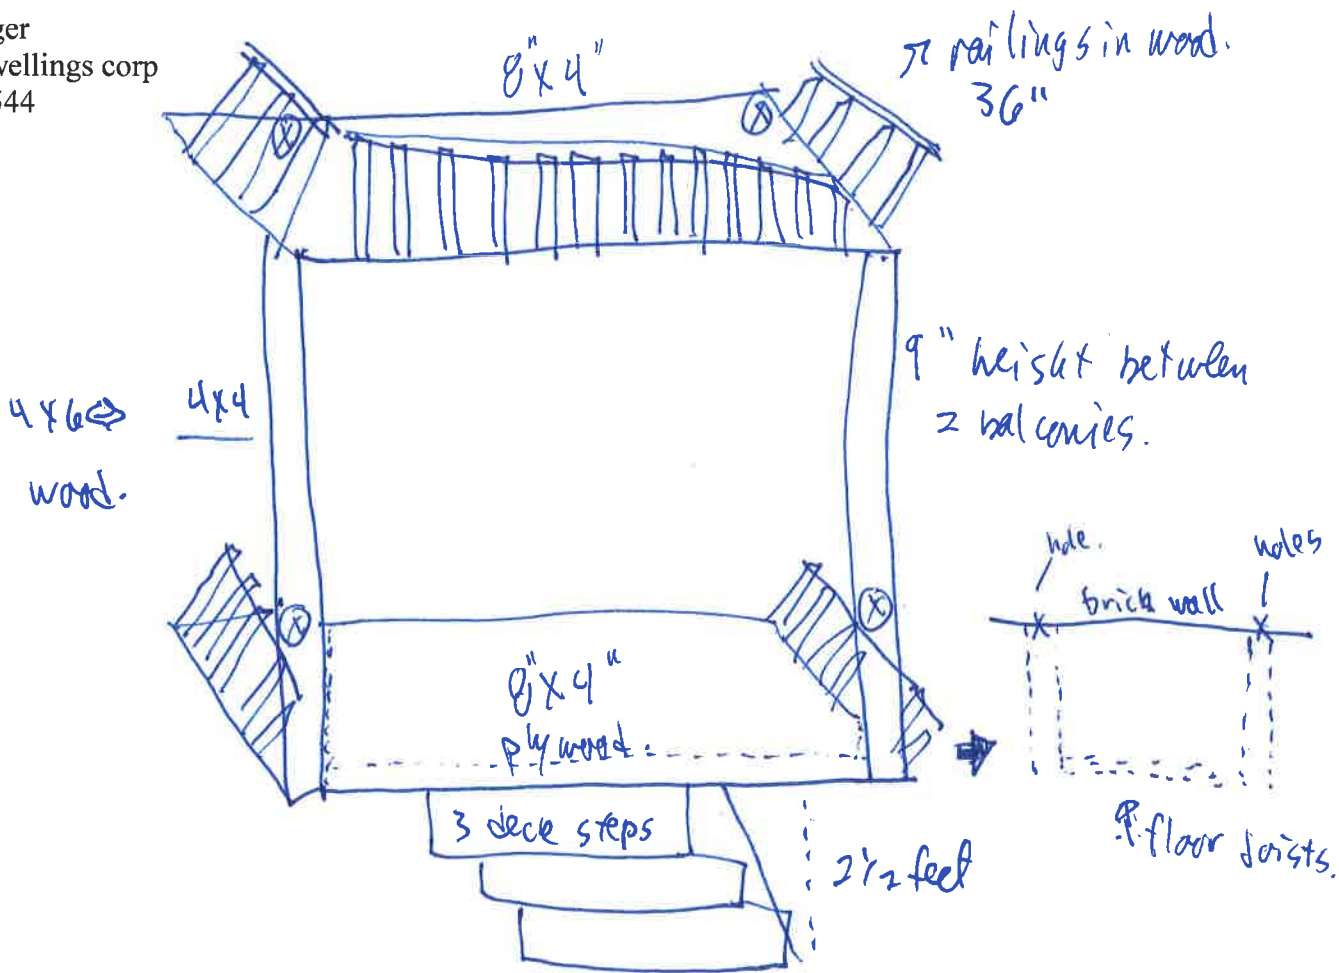
The four holes of the floor joists are still happening in the brick wall of the house. Paint lines are still showing where was the previous wood balcony. I took pictures of neighbors to give an idea of this basic balcony. My balcony collapsed 3-4 years ago it was rotten.

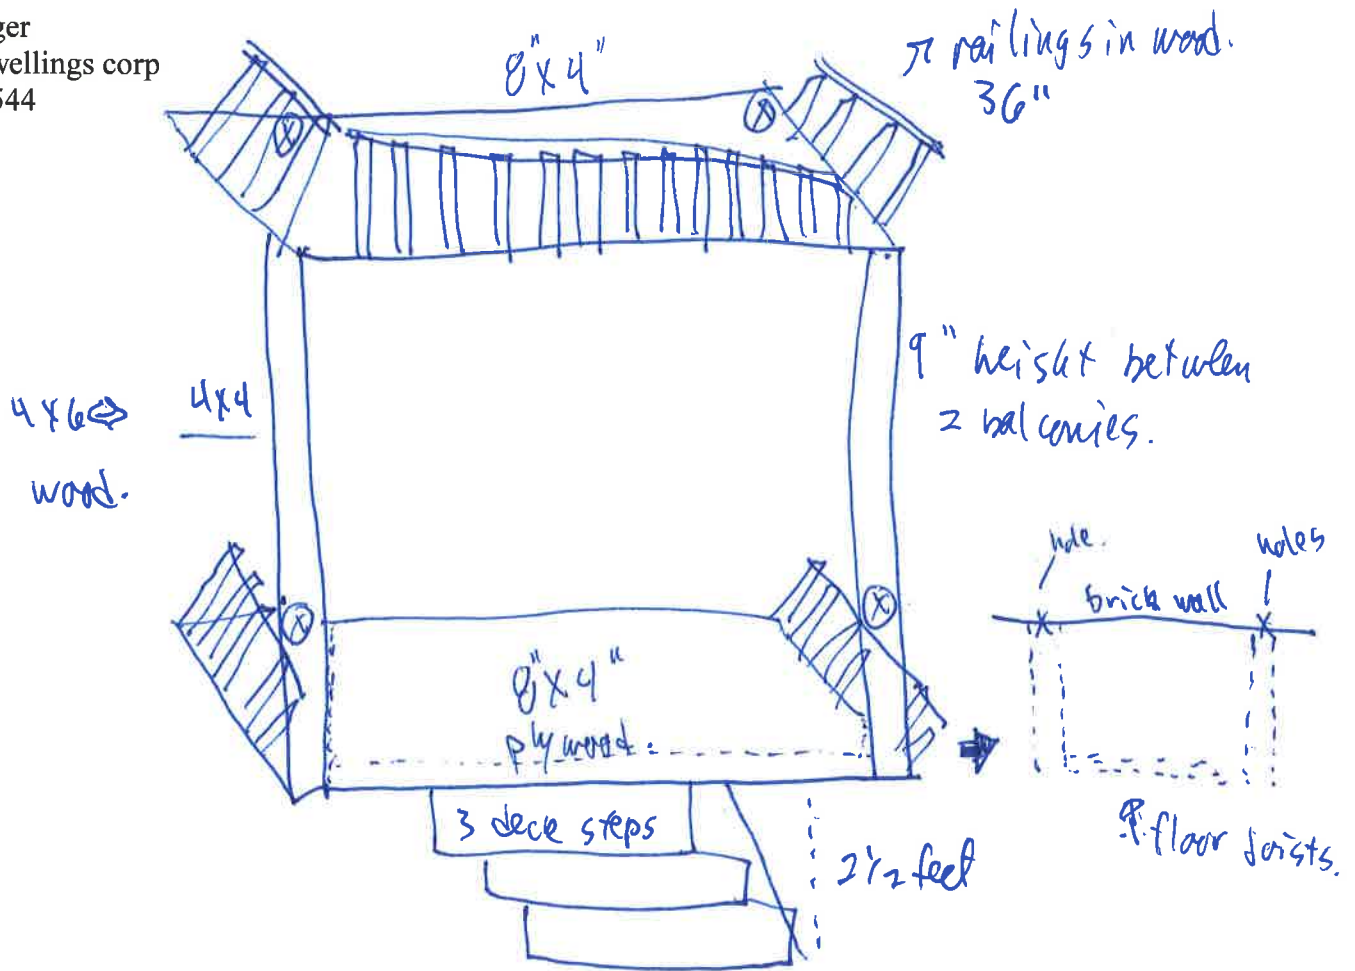
The four holes of the floor joists are still happening in the brick wall of the house. Paint lines are still showing where was the previous wood balcony. I took pictures of neighbors to give an idea of this basic balcony. My balcony collapsed 3-4 years ago it was rotten.
