STAFF REPORT: 12-11-2019 MEETING

APPLICATION NUMBER: 19-6578

ADDRESS: 19650 STRATFORD

SCOPE: PARTIAL WINDOW REPLACEMENT ON SIDE AND REAR ELEVATIONS

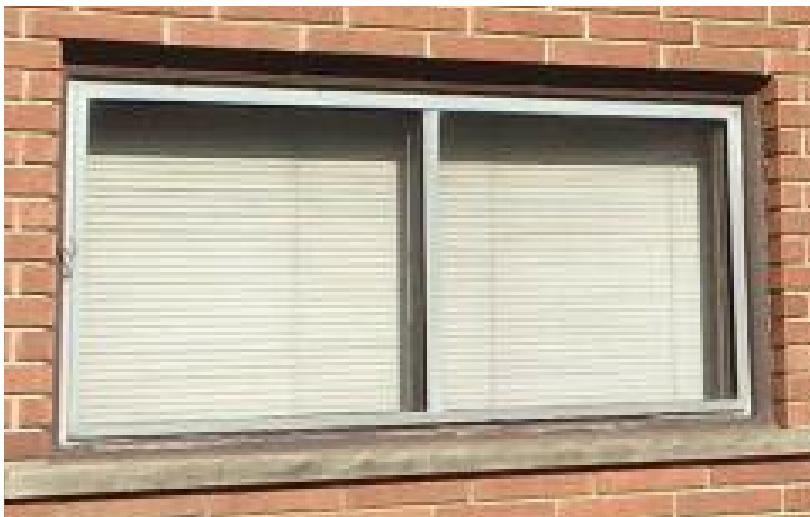
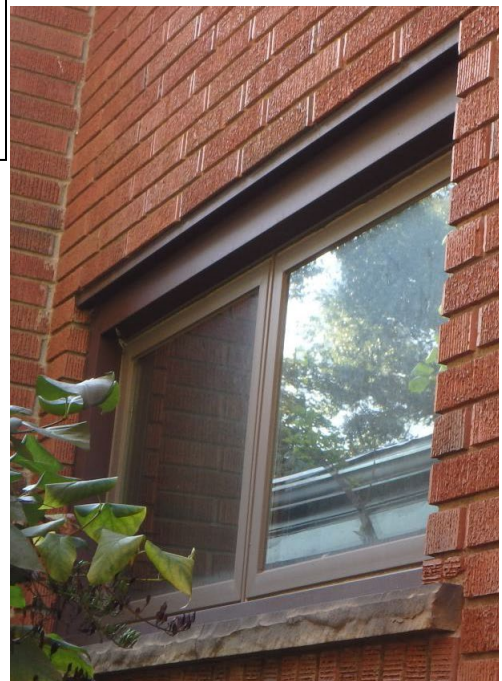
The size of the new frames will not match the existing frames. As Renewal by Anderson is specific to the Fibrex material, there are no other options within the replacement system that could offer a thinner frame.

Window below is an example of an original sliding window (location: rear of house and not to be replaced at this time.)
 Window on the right is one of the two Renewal by Anderson casement windows installed 20 years ago.
 Renewal by Anderson also provided elevation comparisons within their application packet.

It is staff’s opinion the removal of the four original sliding windows and installation of Renewal by Anderson Fibrex replacement sliding windows will alter features that characterize the property. The frame width for the proposed windows is too great and will not only reduce the glass size within each window, the thick frames will create a heavier appearance for each window opening.

Therefore staff recommends the Commission deny a COA for the four window replacements as they do not meet the following Secretary of the Interiors Standards for Rehabilitation, especially:

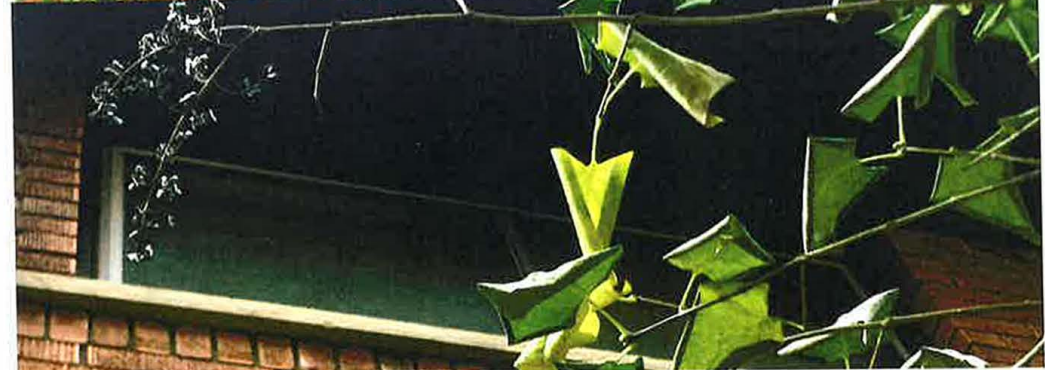
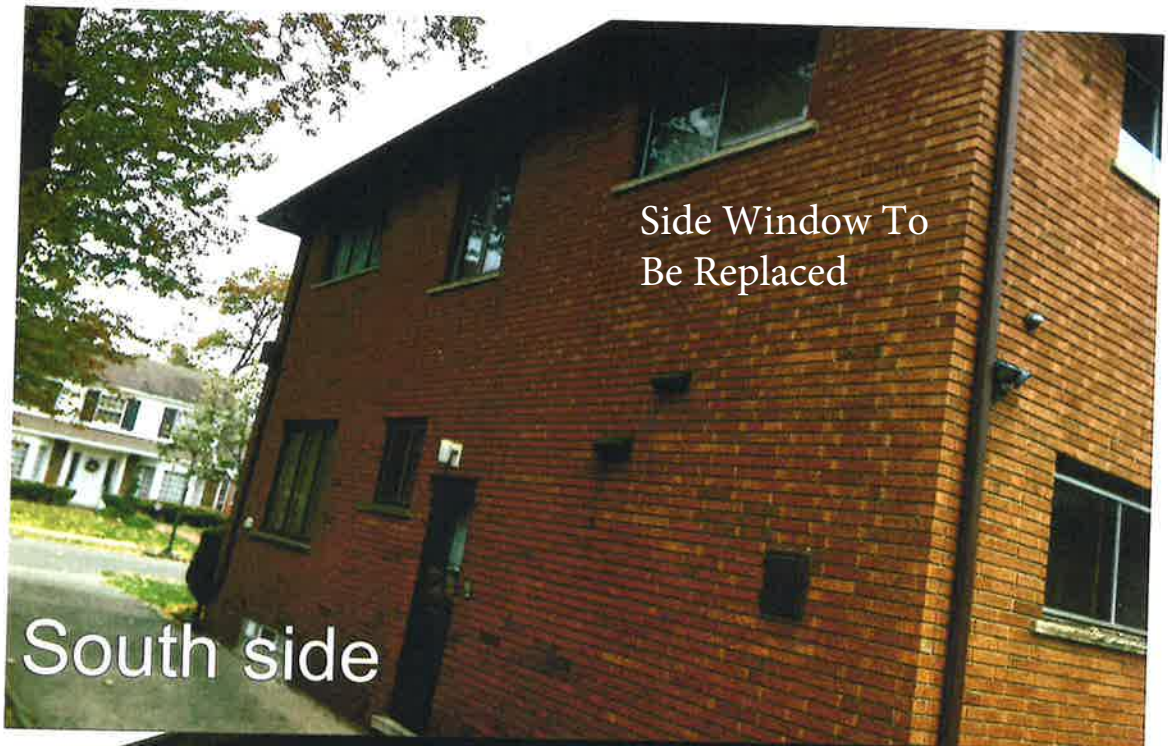
Side Window To Be Replaced

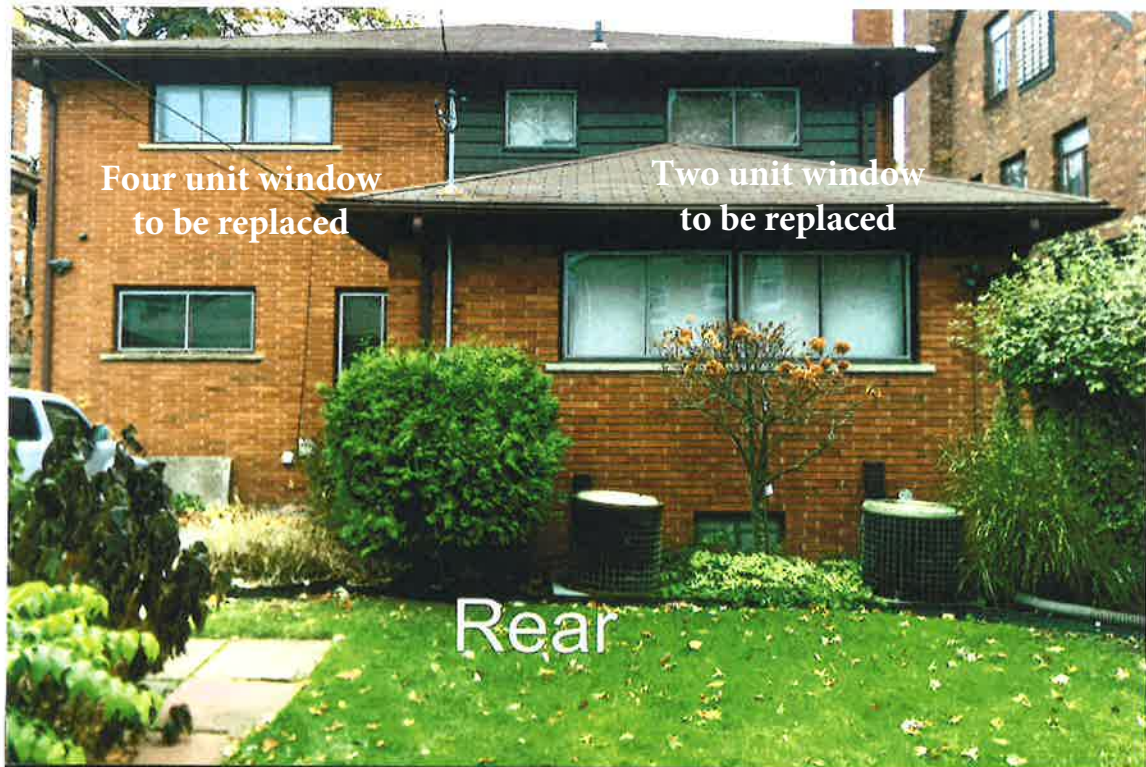
Four unit window
to be replaced

Two unit window
to be replaced

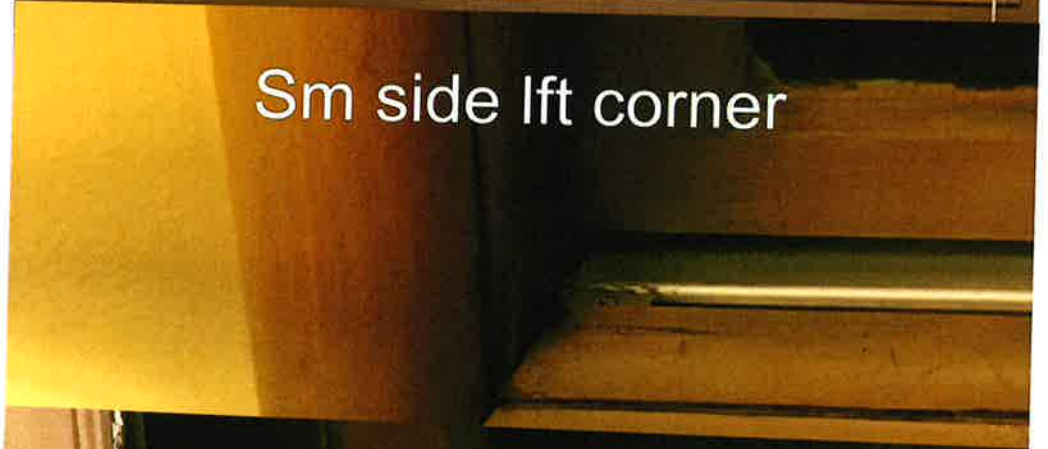
Sm side gap in pane

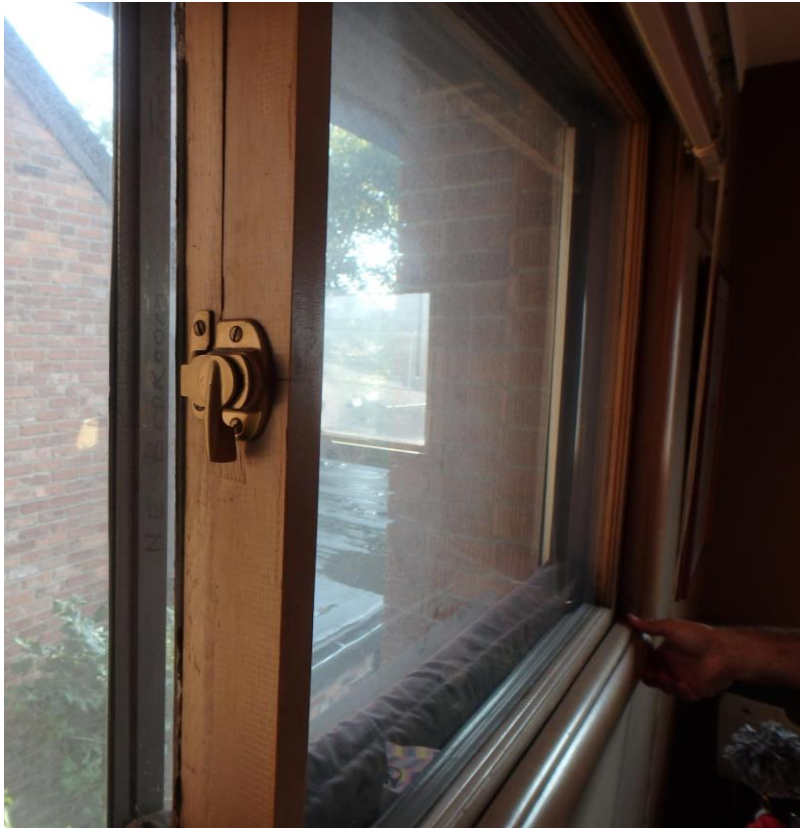
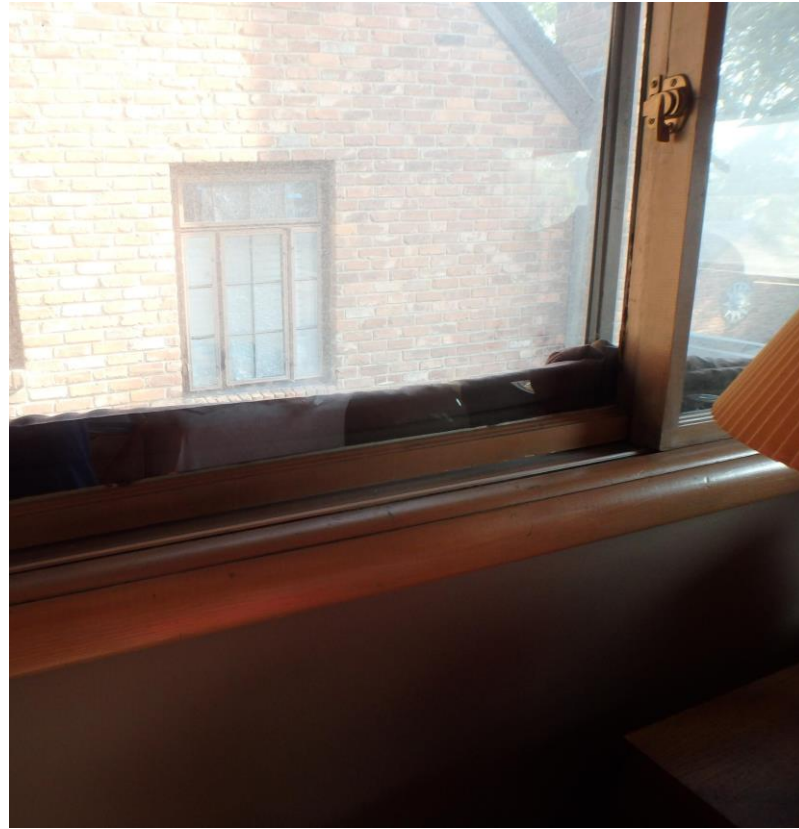
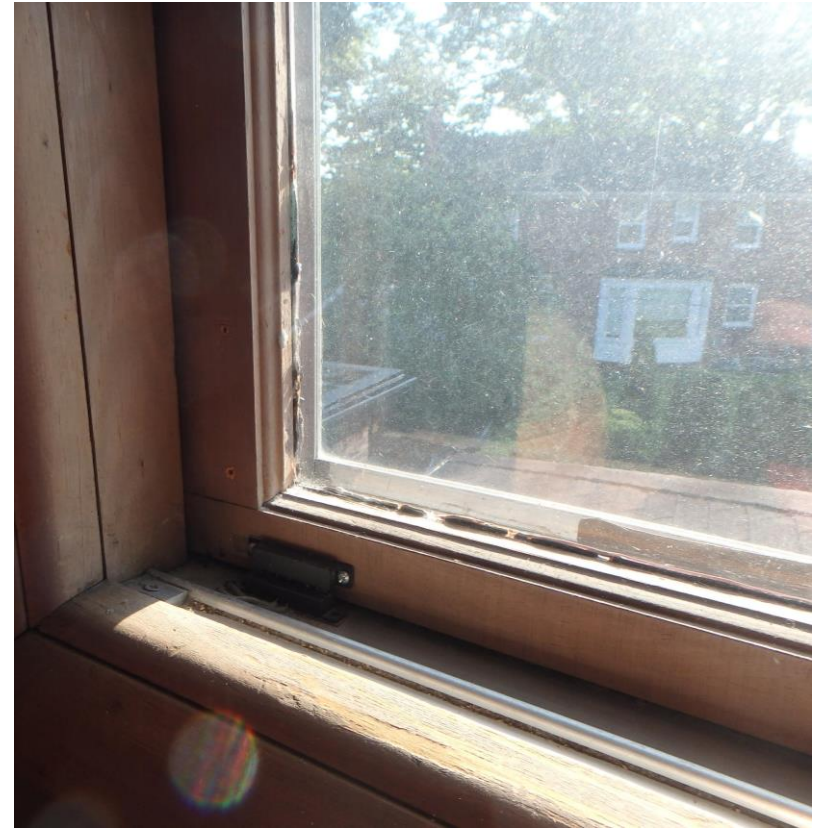
Windows have plastic tightly secured over interior of windows

Windows leak air (see rolled towels)

Large gliding window has some rotting on exterior brickmold
