STAFF REPORT: 07-08-2020 MEETING

APPLICATION NUMBER: 20-6761

ADDRESS: 221 EAST BOSTON BOULEVARD

SCOPE: REPLACE COPPER ROOF WITH EUROSHIELD RUBBER SHINGLES

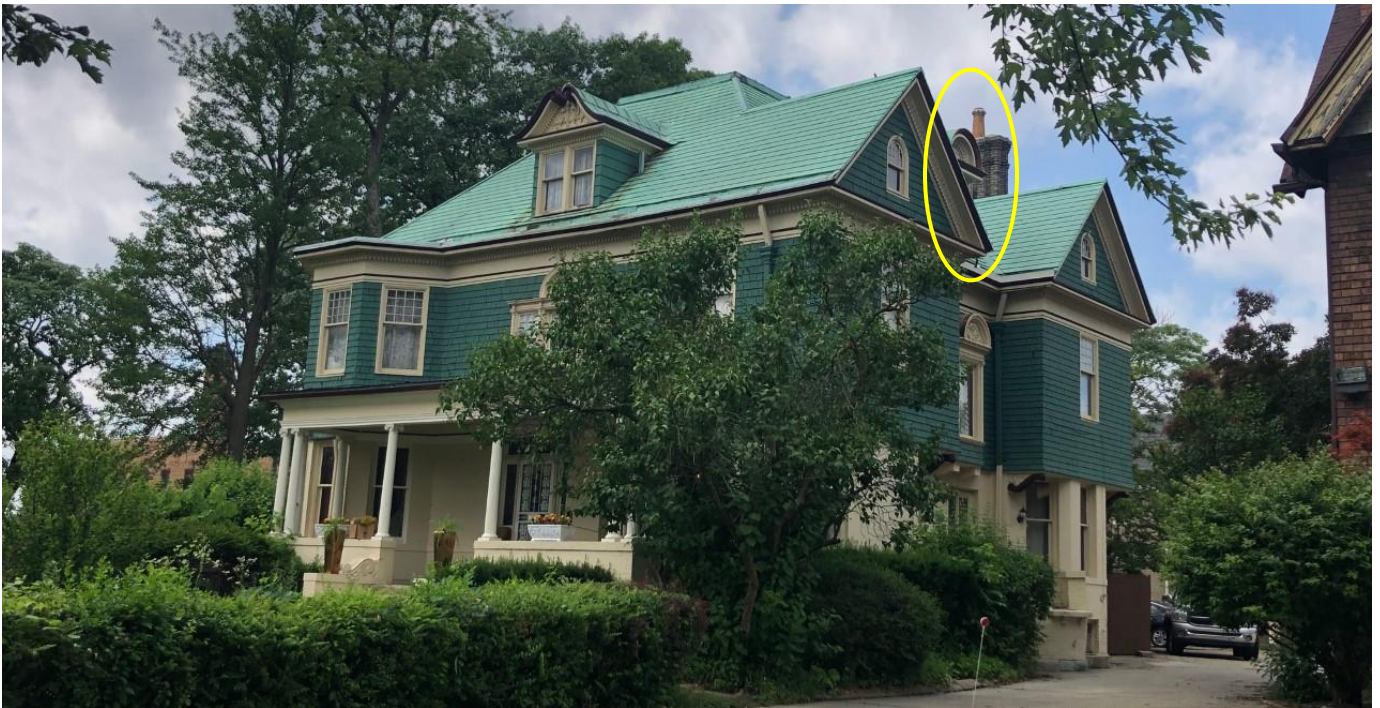
East Elevation, Arched dormer partially seen.

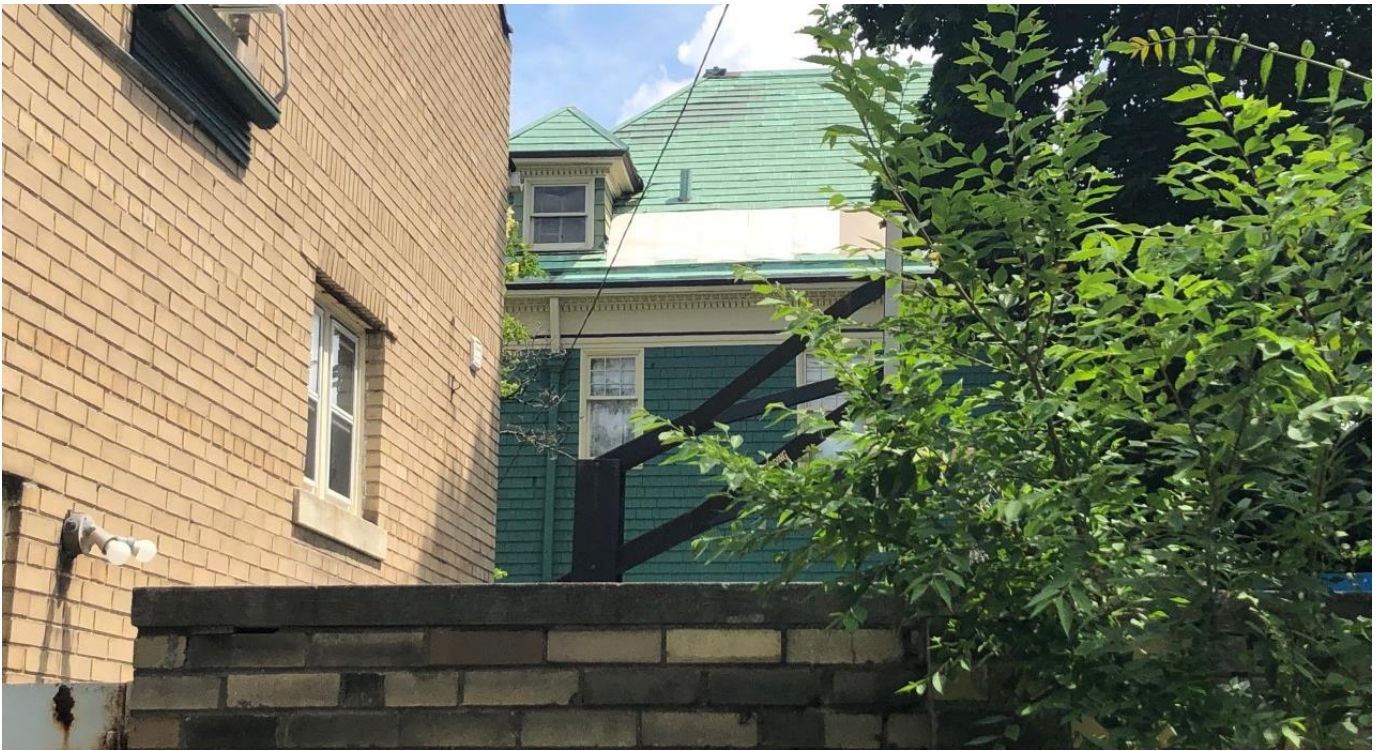
Rear elevation of house, with standard dormer. Largest area of missing roofing.
