STAFF REPORT: 03/13/2024 MEETING P APPLICATION NUMBER: HDC2024-00019 ADDRESS: 4205 CASS AVE (422 W WILLIS) HISTORIC DISTRICT: WILLIS-SELDEN LOCAL APPLICANT/TENANT: AHMED ALWHYSEE DATE OF PROVISIONALLY COMPLETE APPLICATION: 02/19/2024 DATES OF STAFF SITE VISITS: 01/11/2024, 02/23/2024

# SCOPE: PAINT BUILDING, INSTALL SIGNAGE (WORK COMPLETED WITHOUT APPROVAL)

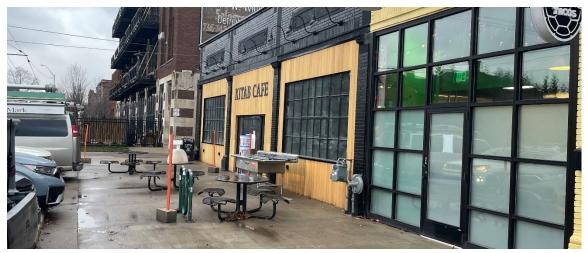
Site Photo1, by Staff January 11, 2024: (North) front elevation, showing current, unapproved paint and sign installation condition.

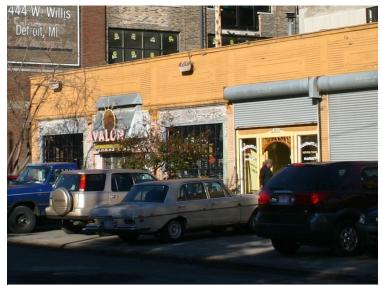
*Site Photo 2, by Historic District Advisory Board, 2011: (North) showing painted masonry conditions at time of designation.*

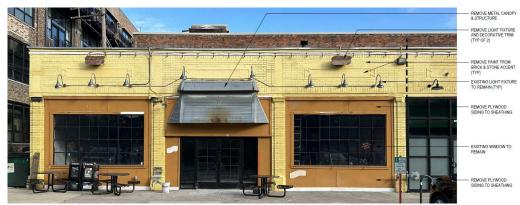
• Staff issued a Certificate of Appropriateness (COA) in late October 2023, for the removal of paint, and non-historic features such as light fixtures and a sign mount. *(See site photo 3.)* Upon receipt of the COA, the applicant removed the paint in early December 2023 and took the photos of the completed work. *(See site photo 4.)* At this point, in staff's opinion, the applicant completed the COA's work for paint removal and the precedent of a previously painted masonry building no longer applies to allow the applicant to repaint the building without a new review and approval cycle. The applicant states that they had trouble removing all the yellow and orange paint despite the paint removal process. However, in Staff's opinion, the work appeared to be removed enough to reveal long-hidden and important historic character and detail.

*Site Photo 3, excerpt from applicant's previously approved application, October 2023: showing conditions prior to paint removal.*
