STAFF REPORT 7-24-2019 MEETING APPLICATION NUMBER 19-6346 ADDRESS: 3475 IROQUOIS HISTORIC DISTRICT: INDIAN VILLAGE APPLICANT: BEN CARBURY DATE OF STAFF VISIT:

PROPOSAL

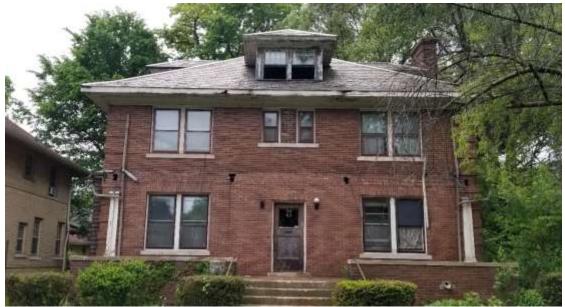
Front

(A)Front Porch: At present the front porch roof, pillars and supporting wood is completely water damaged and in need of complete replacement. Pillars are split and damaged and roof sheathing has in numeral leaks and sunlight is visible in numerous areas through the roof decking. Porch ceiling completely non-existent.

For the front porch, the actual floor and brick of the porch floor is completey fine. We will be leaving that. What is damaged is the porch roof and the pillars and supporting wood beams. As you can see from the photos the roof on that has not been replaced in many many years and has made the structure a safety hazard. Pillars are split in 2 so they are not usable and almost all the dimensional structural lumber that holds up the porch roof decking is water damaged and soiled. We plan on rebuilding the porch as it currently stands. Including matching the exterior trim around the house We will reinstall an architectural shingle as the final roofing (at the present roof pitch it is barely visible)

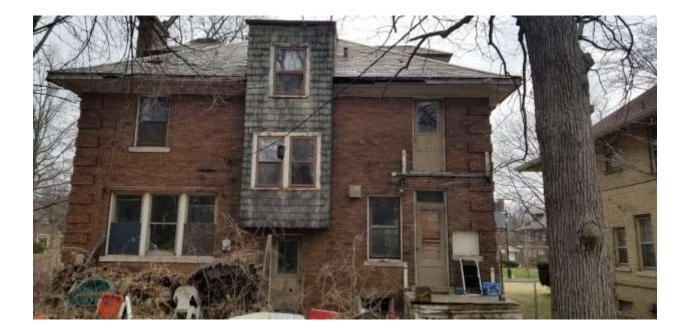
BACK

(B) Back Porches (both stories): At the back of the house, the 2-story porch is completely removed and needs to be replaced. There is a porch for the lower, and a porch for the upper. Only the lower porch exists, which is water damaged, unsafe stairs, porch incline is not correct and needs complete replacement

The back porch is completely missing the 2nd floor. We plan on removing the first floor porch which is damaged and is not structurally sound anymore. Afterwards we will rebuild the 1st and 2nd floor porches.

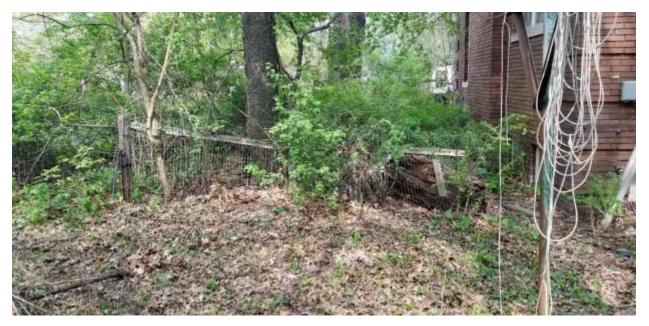
Porch Trim Details (original, above), Side yard completed trashed and broken fencing and junk bushes

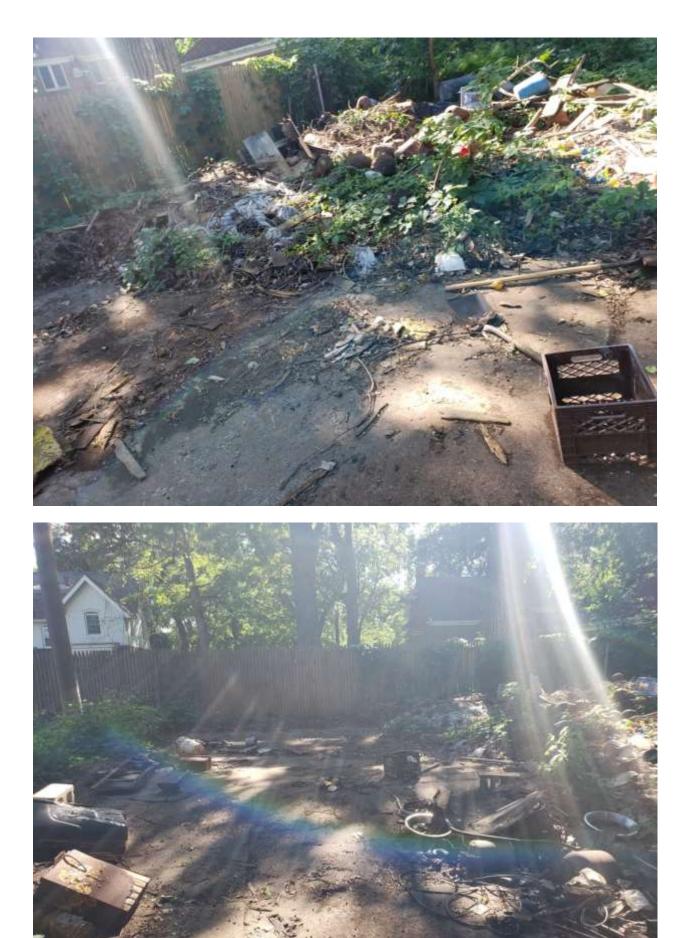
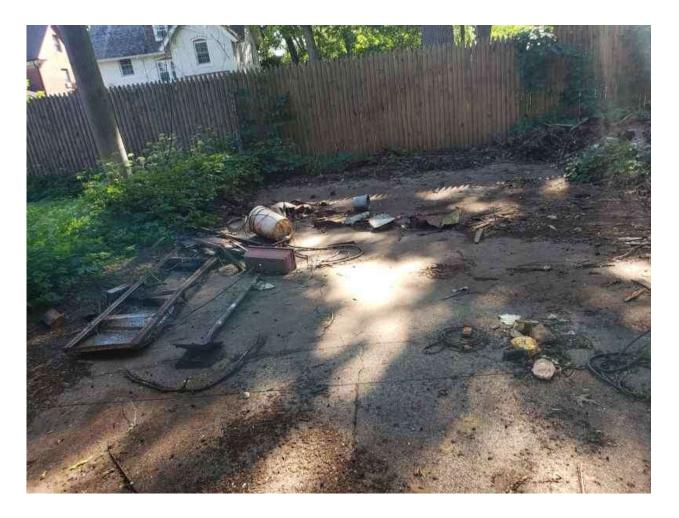
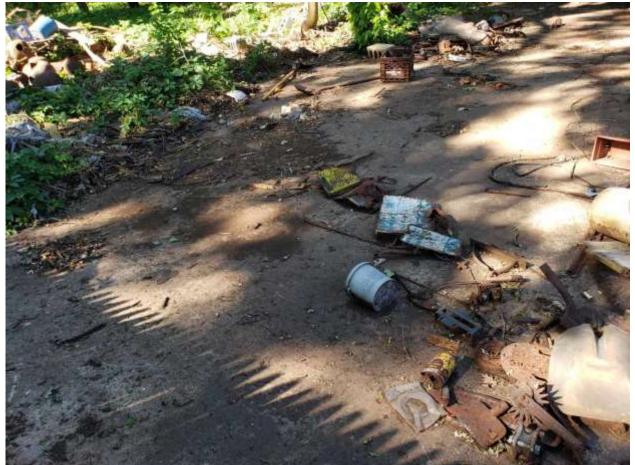
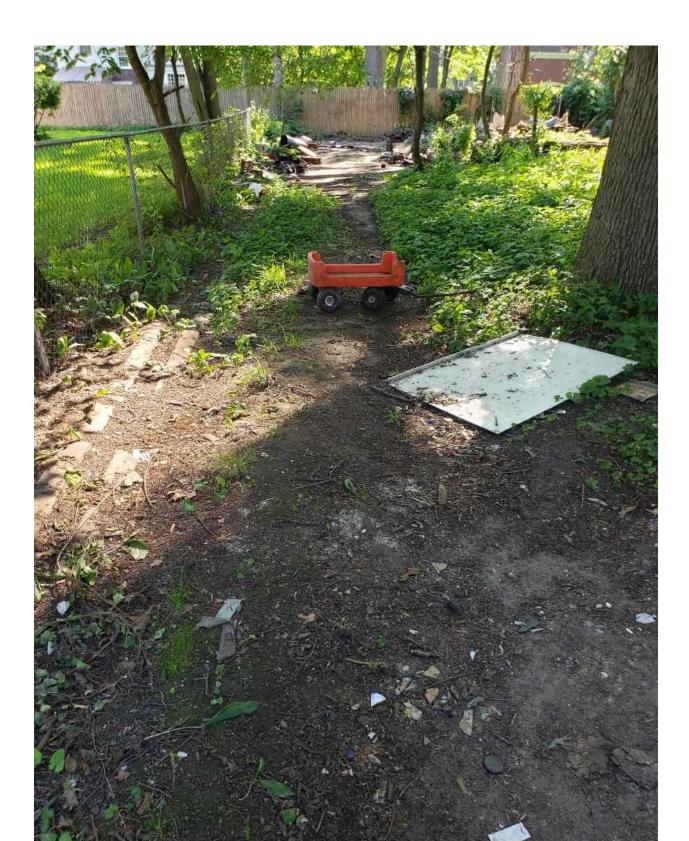
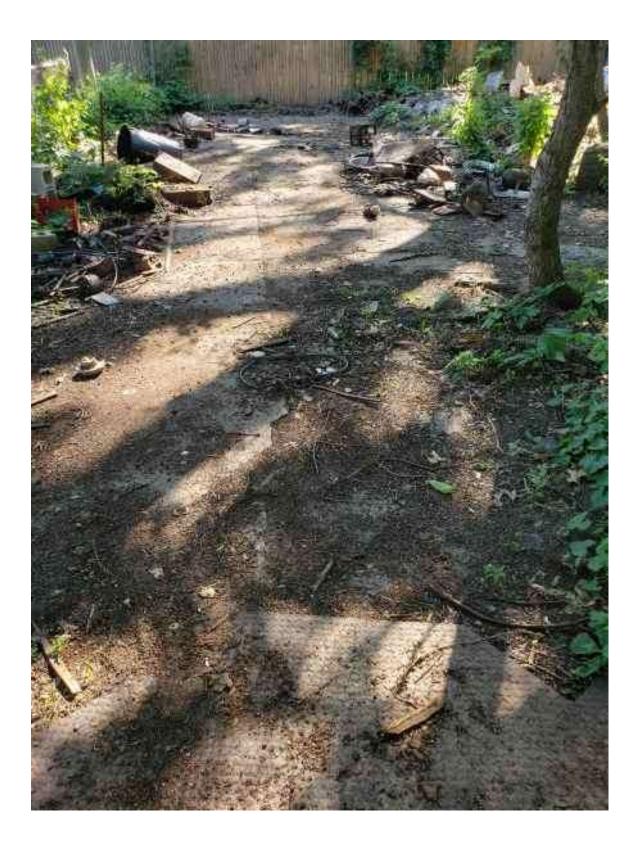
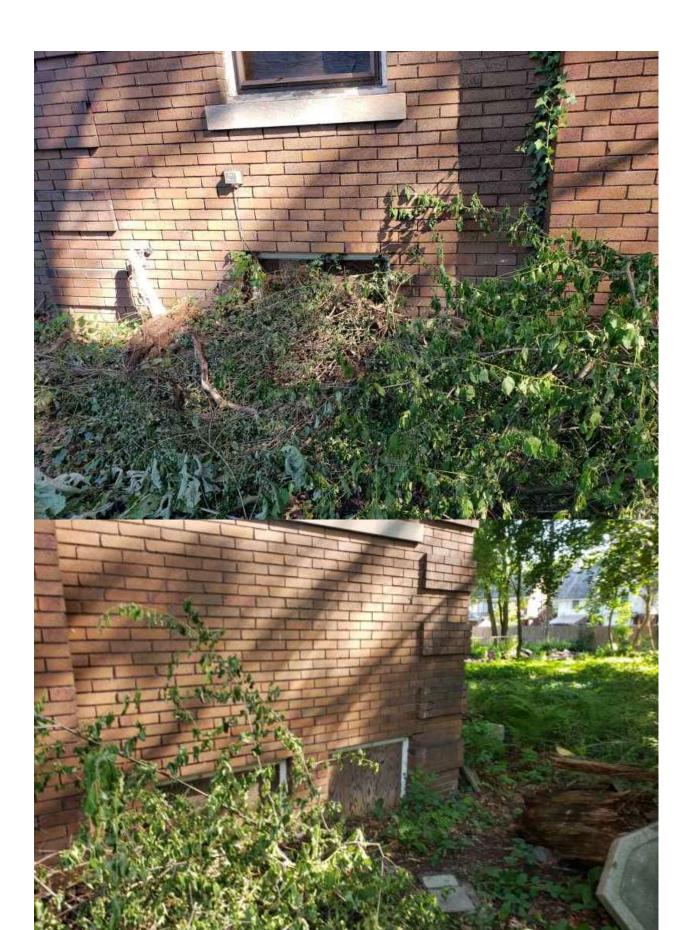
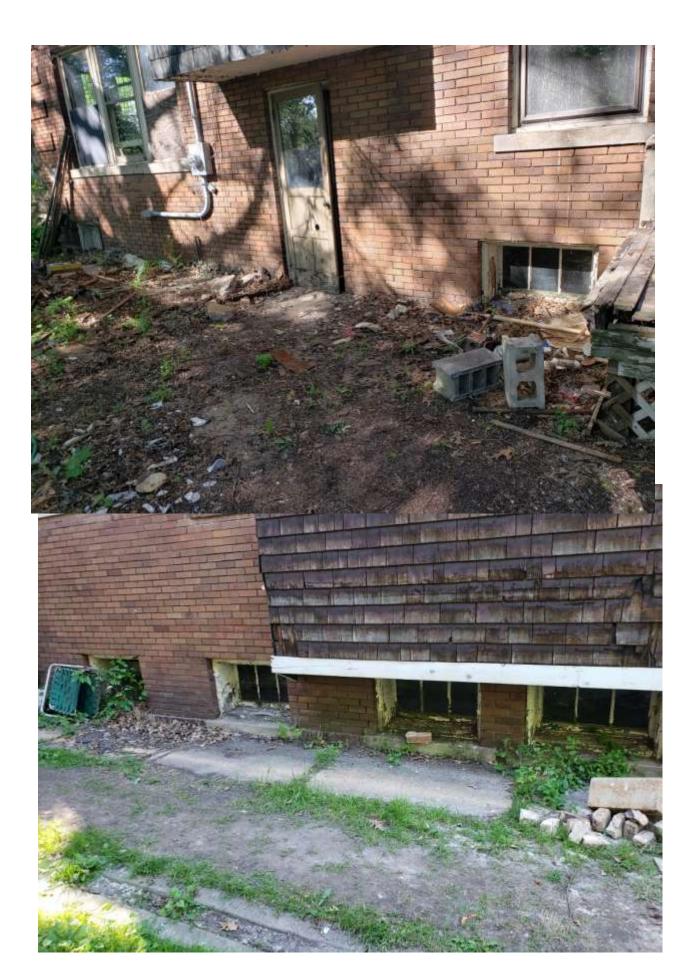
Below are the Current Photos of the backyard, driveway and glassblock windows. We are planning on cleaning up debris in the yard, replacing the driveway and garage slab, building a new garage and installing new glassblock windows

Driveway is strips of concrete with grass inbetween them from the sidewalk to about 10 feet past the back of the house. At that point it converts to a full driveway sweeping open to a 30ft wide garage. Garage slab is old, and in need of replacement. Driveway is also in need of replacement, has many cracks and concrete strips are pitched and not horizontal in many places

(G) **Glassblock:** Currently on the basement windows there are old and damaged single pane wood windows.

Driveway: Remove and replace the driveway and garage slab. Repour concrete strips and then enlarge to full driveway and full slab (30x20) for garage. The driveway and all concrete work is designed to replicate the current concrete work, with the exception that the current garage slab is 22 feet deep and the proposal is for a 20 foot deep garage. Besides that no alterations from the original historical design are made. Please see site plan below.

Glassblock: Remove existing wood single pane windows and replace with standard glassblock windows. Install wood frame and screen over the exterior of the glass block to comply with Historic commission requirements
