**STAFF REPORT 09-11-2019 REGULAR MEETING**  
**APPLICATION NUMBER: 19-6410**  
**ADDRESS: 1682 LONGFELLOW STREET**  
**HISTORIC DISTRICT: BOSTON EDISON**  
**APPLICANT: MARIE BROOKS**  
**DATE OF COMPLETE APPLICATION: 8-7-2019**  
**STAFF SITE VISIT: 08-30-2019**

**SCOPE: DEMOLISH EXISTING GARAGE (PUBLIC HEARING)**

# GARAGE INSPECTION REPORT

1682 Longfellow St.

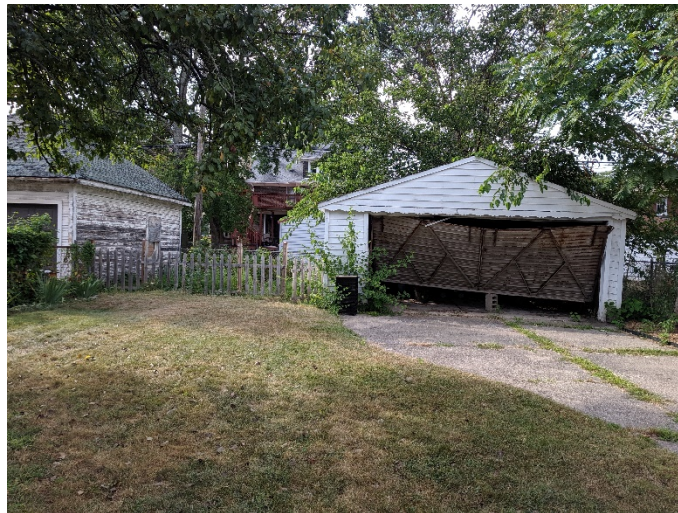
FIGURE 1 – EXTERIOR OF EXISTING GARAGE

Red Line Contracting & Consulting Ltd. visited the site on August 19<sup>th</sup> 2019 to perform an inspection on the existing standalone garage. The garage is a typical wood frame building that sits on a concrete slab. Red Line Contracting & Consulting Ltd. inspected the following components of the building: concrete slab/foundation, wood structure and building envelope. Upon inspection and review the building is not repairable and needs to be removed and replaced.
