STAFF REPORT: 10-9-2019 MEETING
APPLICATION NUMBER: 19-6490
ADDRESS: 791 SEMINOLE
HISTORIC DISTRICT: INDIAN VILLAGE
APPLICANT: YURI DADO
DATE OF COMPLETE APPLICATION: 11/13/2019
DATE OF STAFF SITE VISIT: 12/4/2019

PREPARED BY: J. ROSS

SCOPE: INSTALL NEW WINDOWS

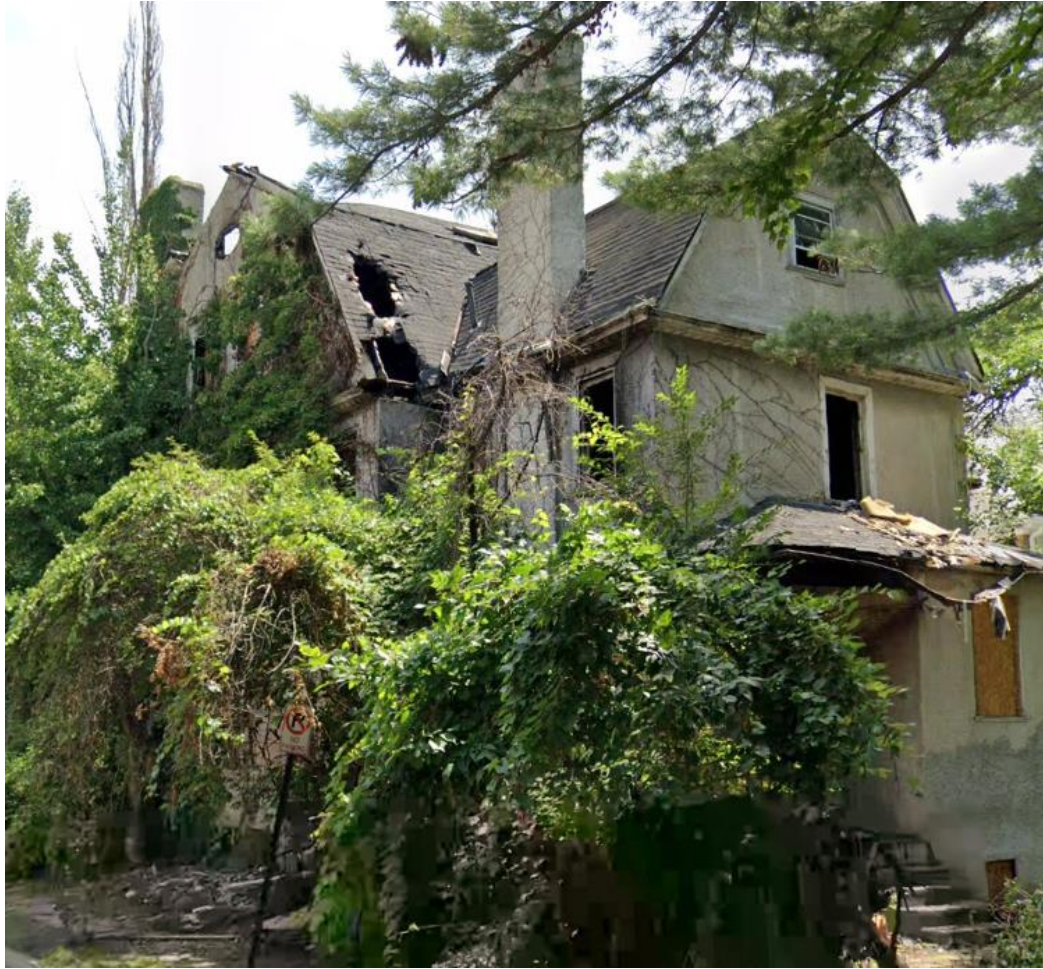
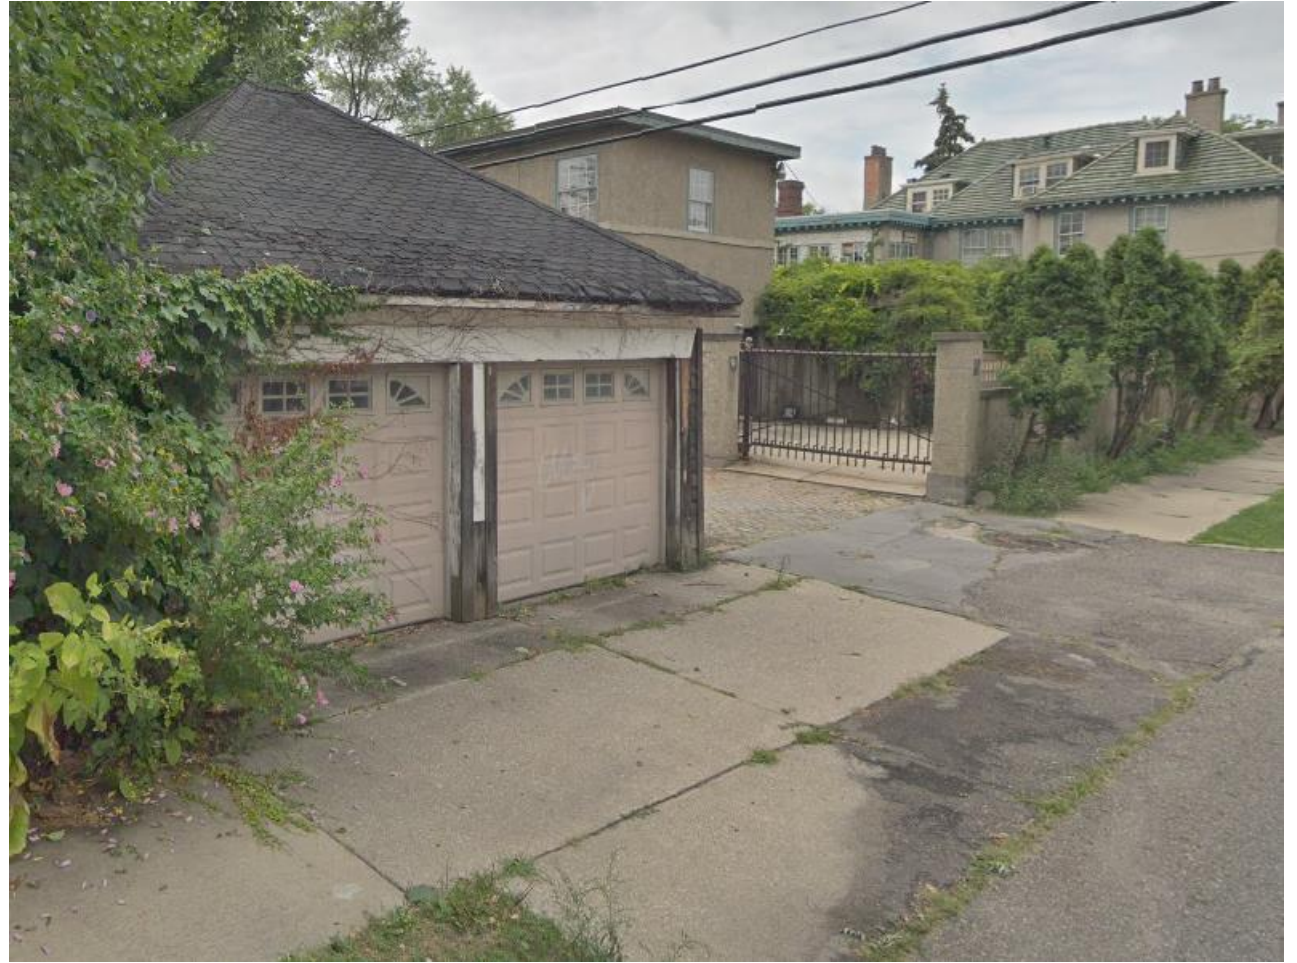
Photos of building after 4-2019 unapproved work

- The light configuration of the new windows do not match the old/original
 - The grids at the new windows are between the glass
 - Many of the windows are improperly fitted within their opening. Plywood has been used to infill the gaps in the opening.

- All existing plywood from the home's exterior walls shall be removed and new stucco added to match the historic appearance
- Replace all existing non-historic wood windows and replace with new wood windows, to match the original in dimension, profile, operation and light configuration. The new windows must be true divided light or simulated divided lite (grid applied to the exterior surface of the glass).

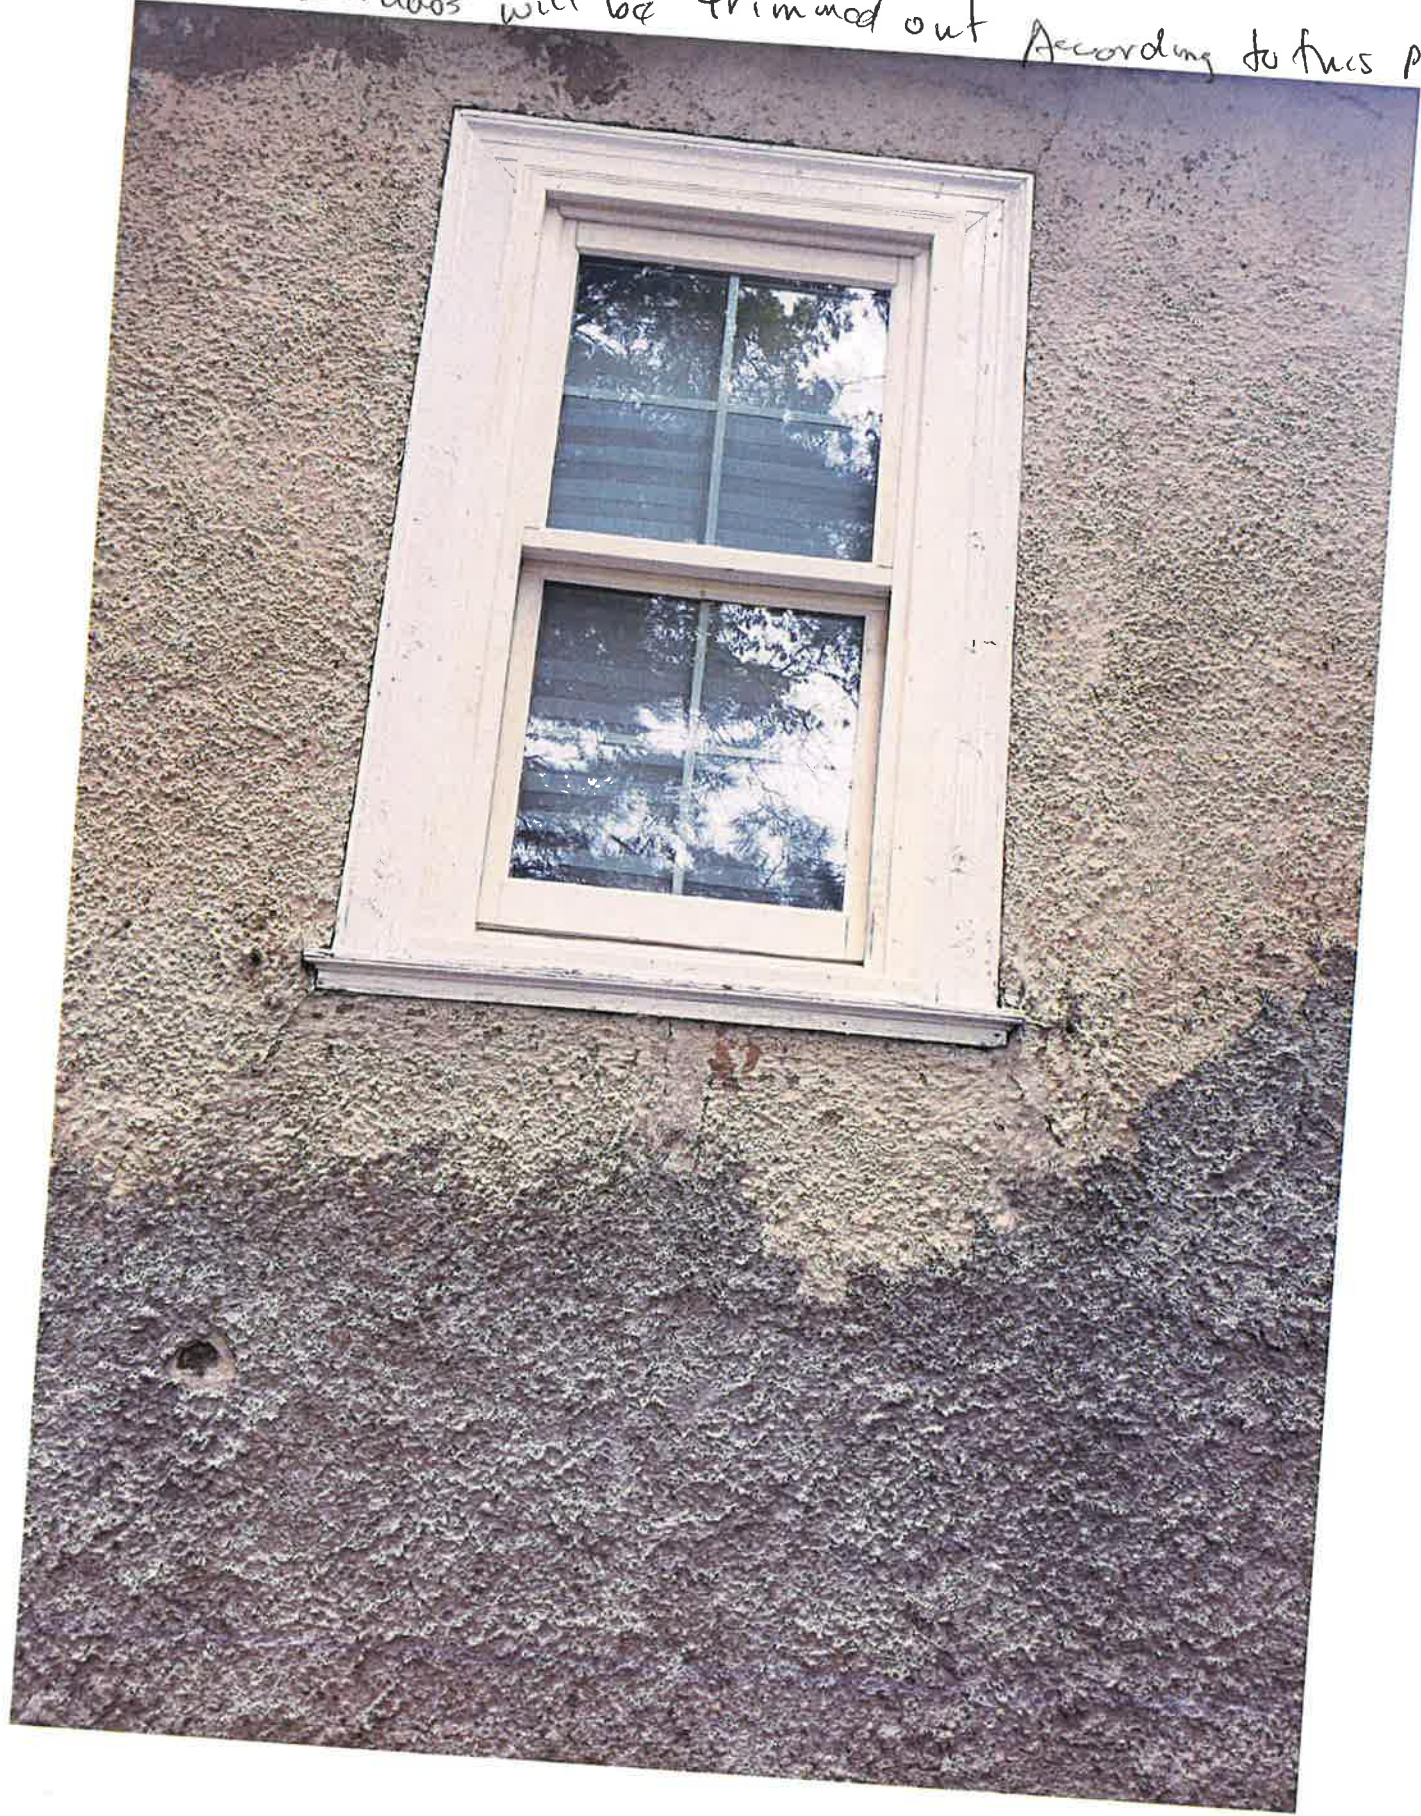
Windows will be trimmed out according to this picture
