STAFF REPORT: 12-11-2019 MEETING

APPLICATION NUMBER: 19-6578

ADDRESS: 19650 STRATFORD

SCOPE: PARTIAL WINDOW REPLACEMENT ON SIDE AND REAR ELEVATIONS

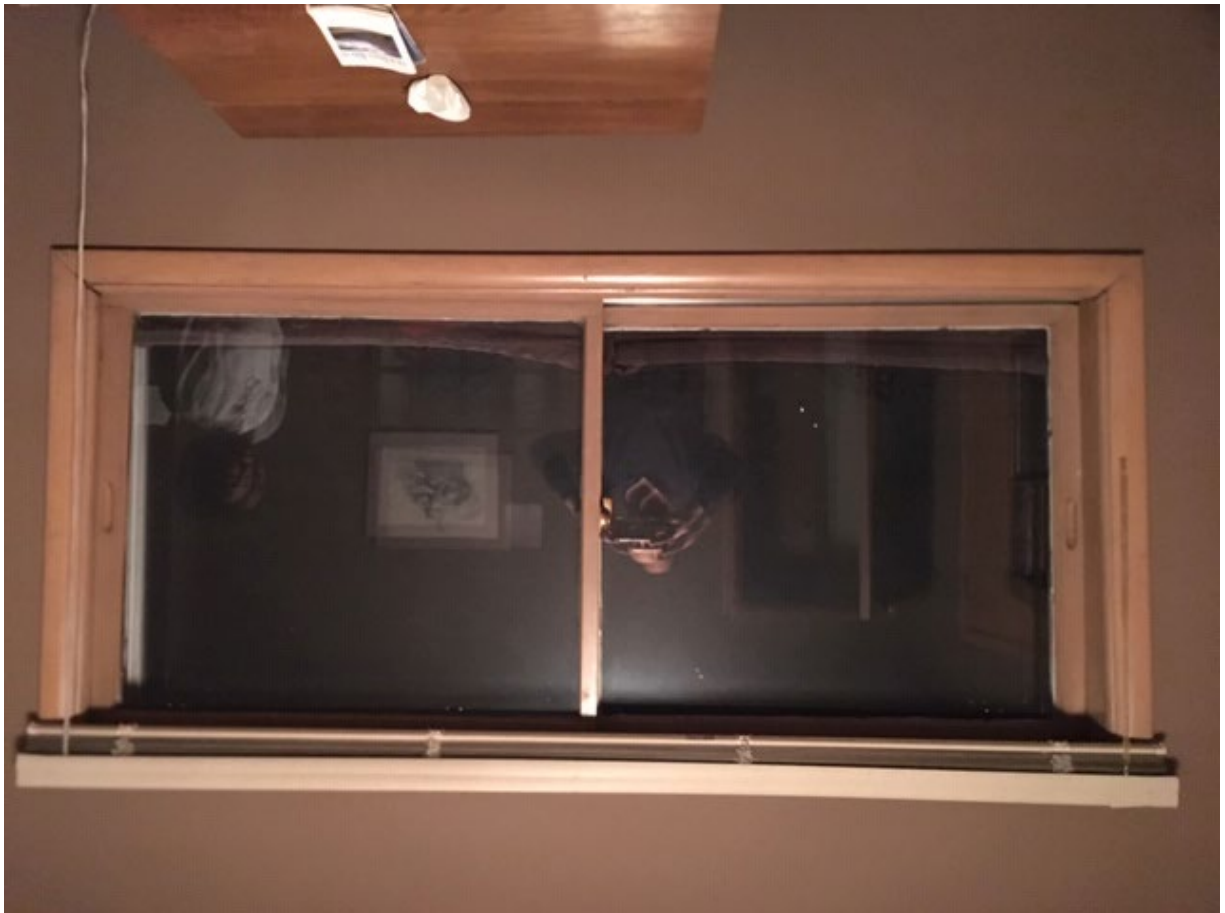
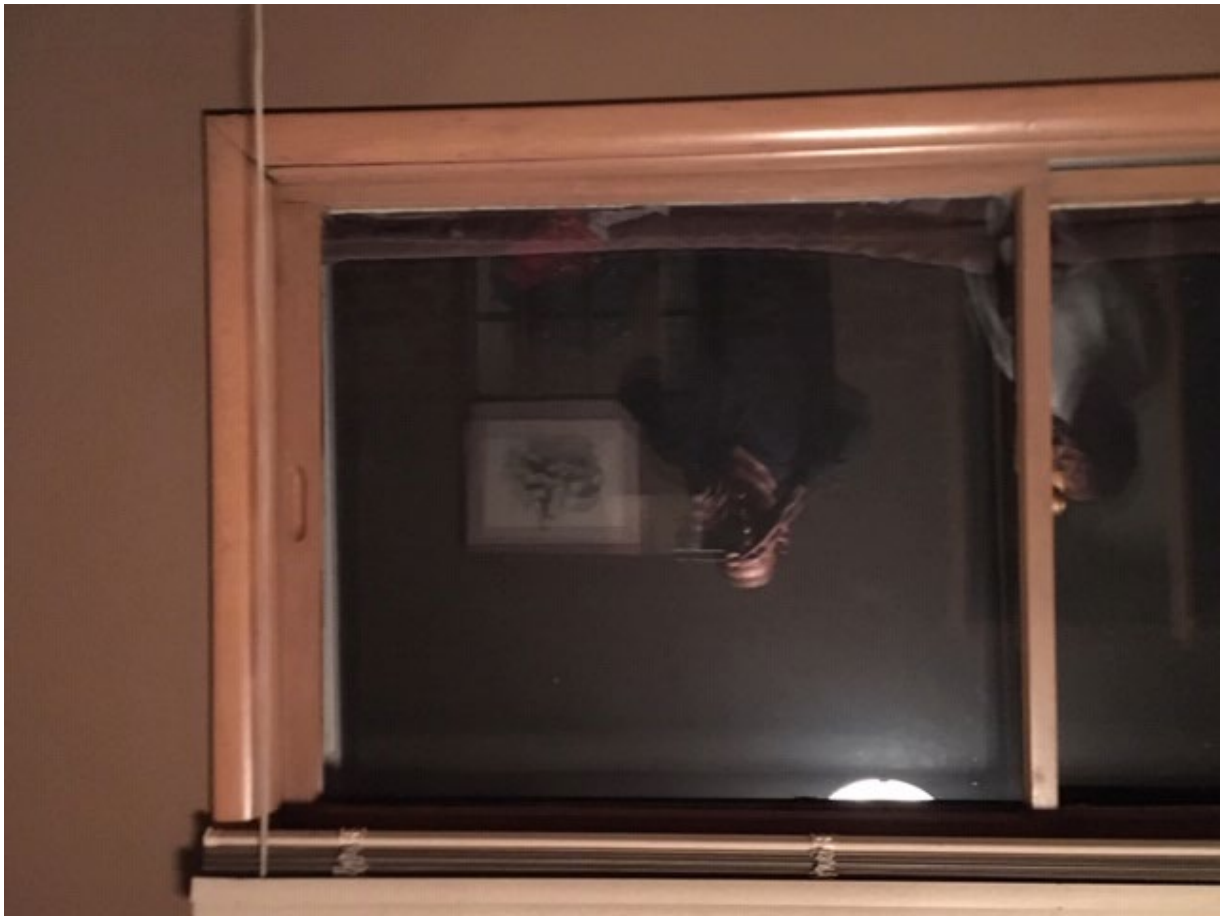
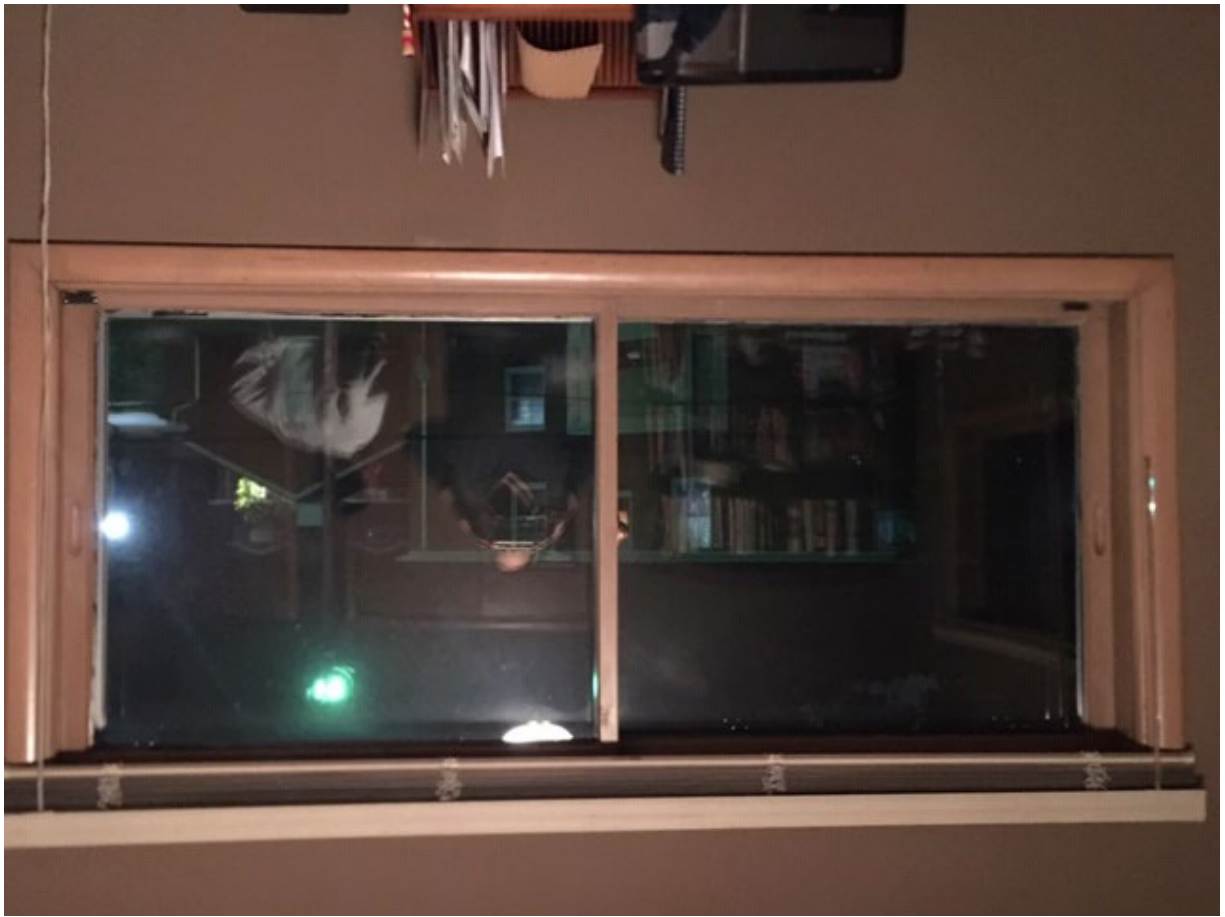
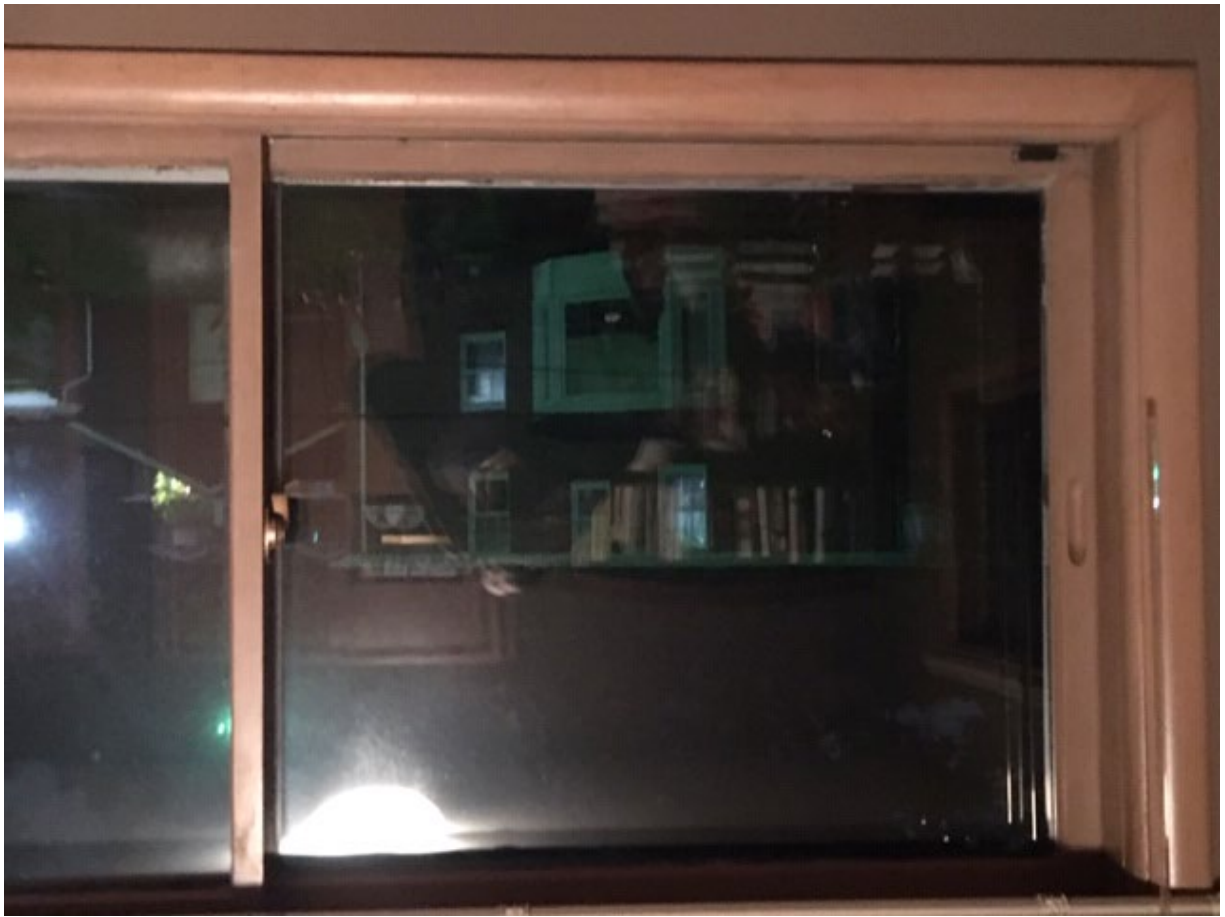
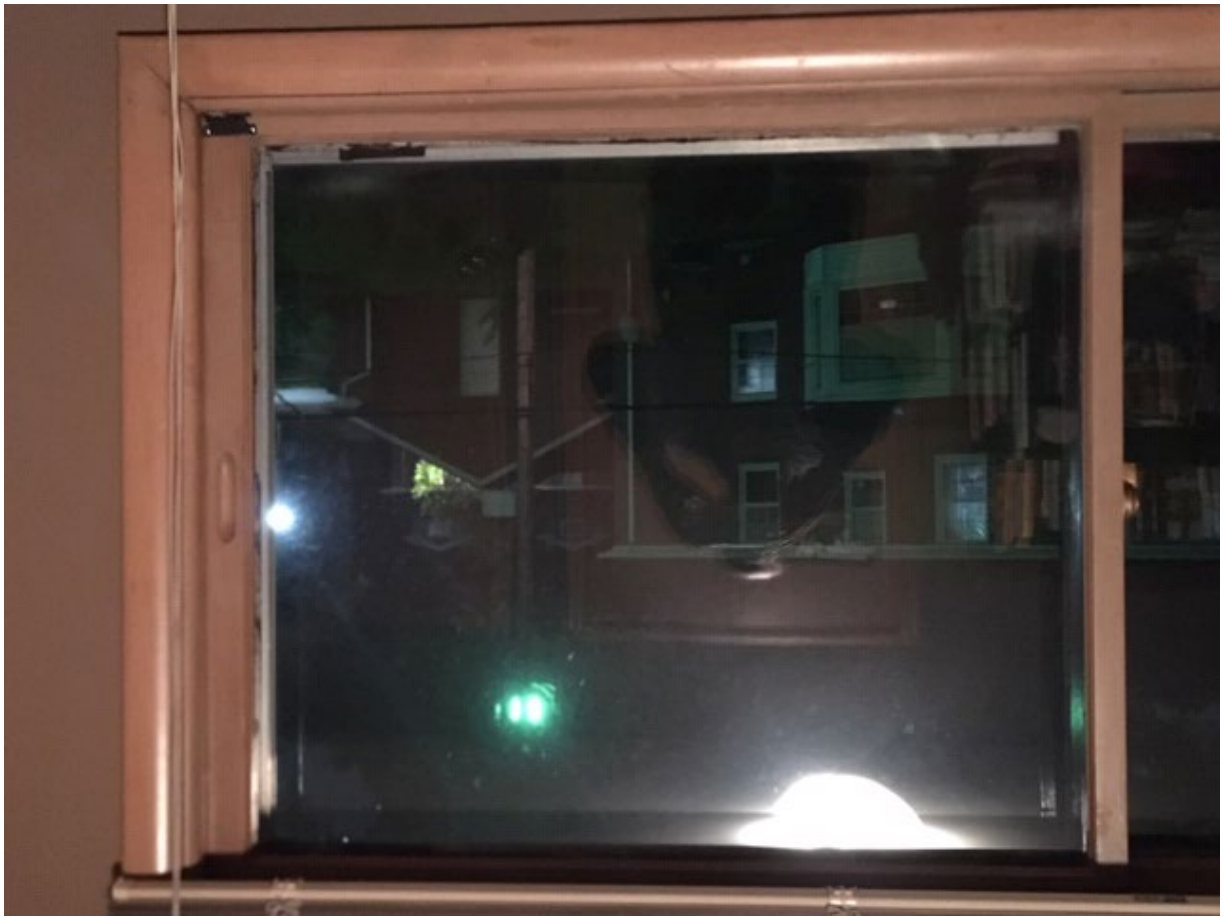
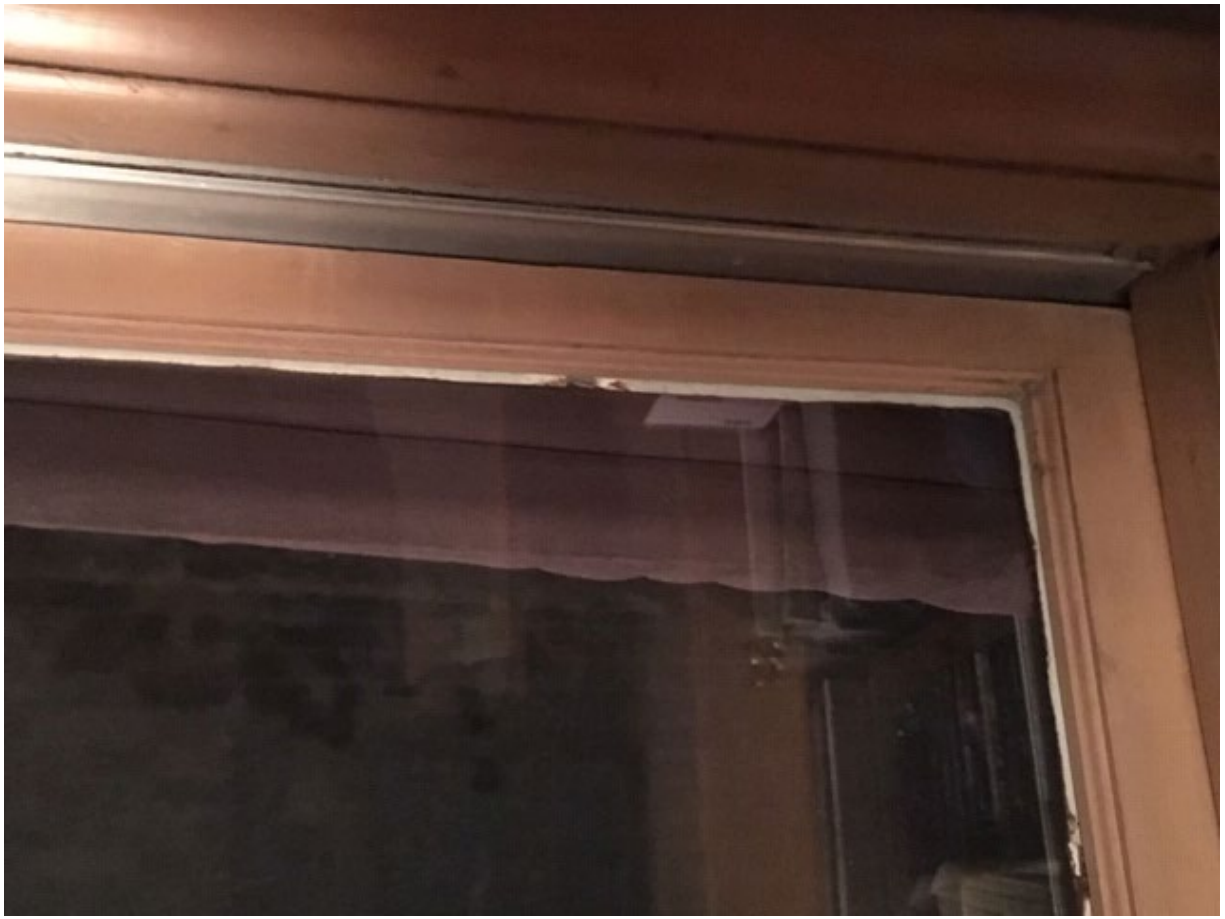
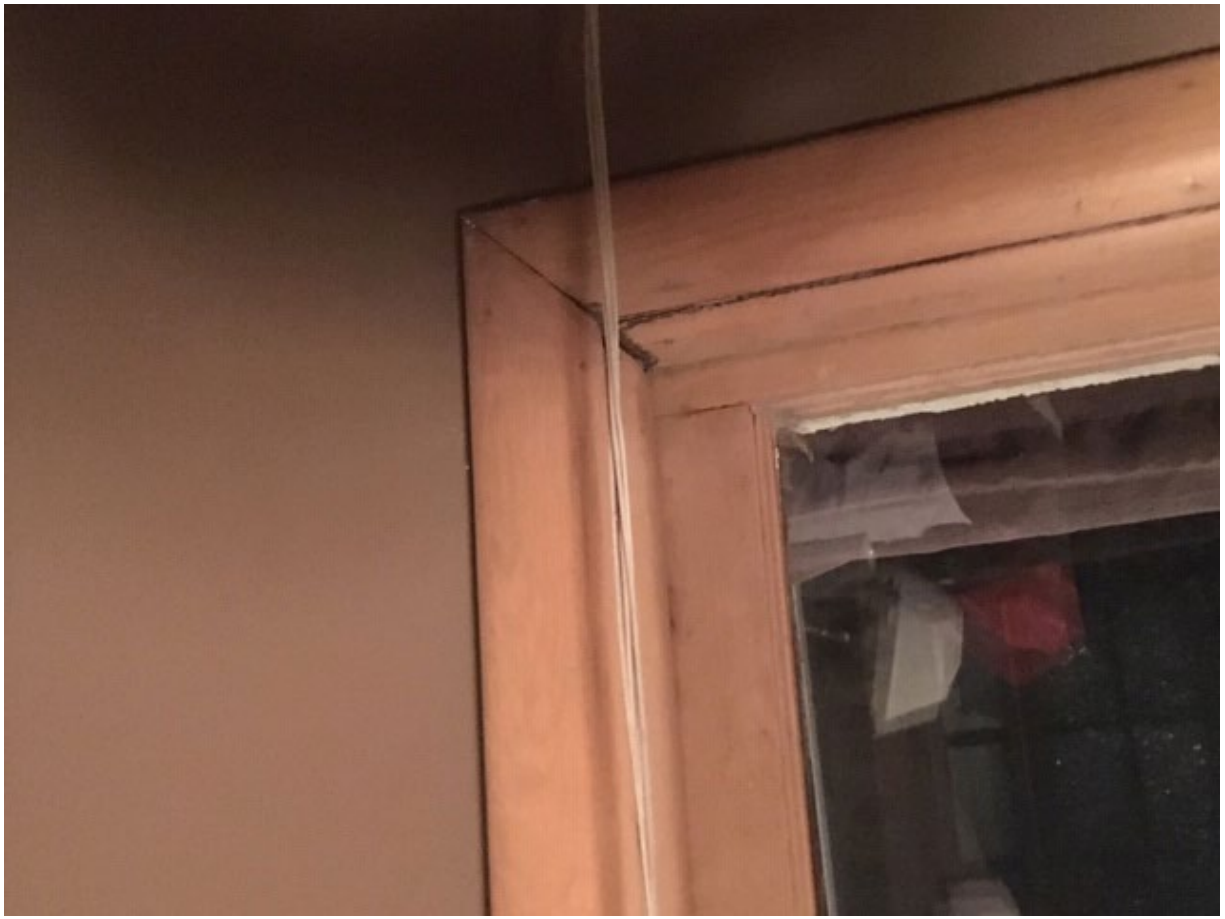
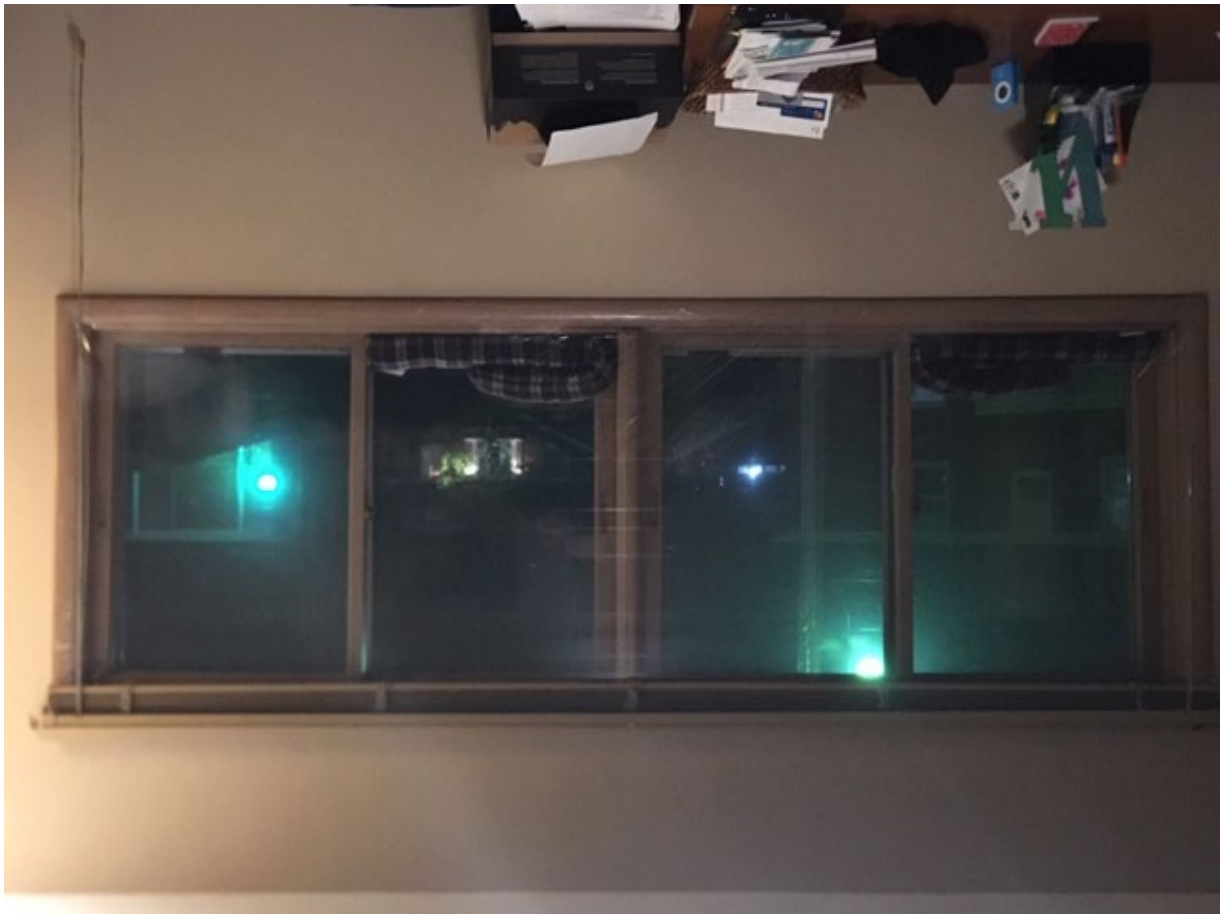
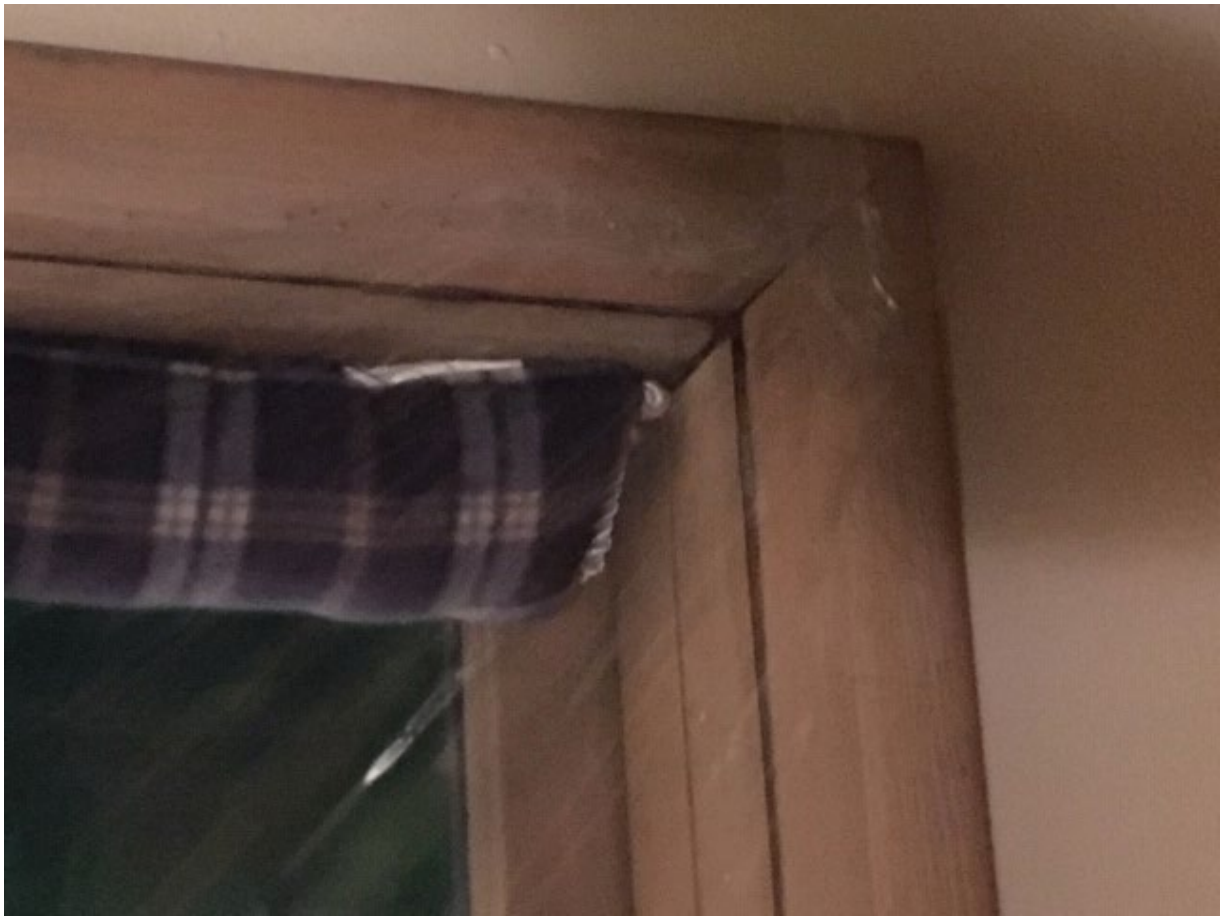
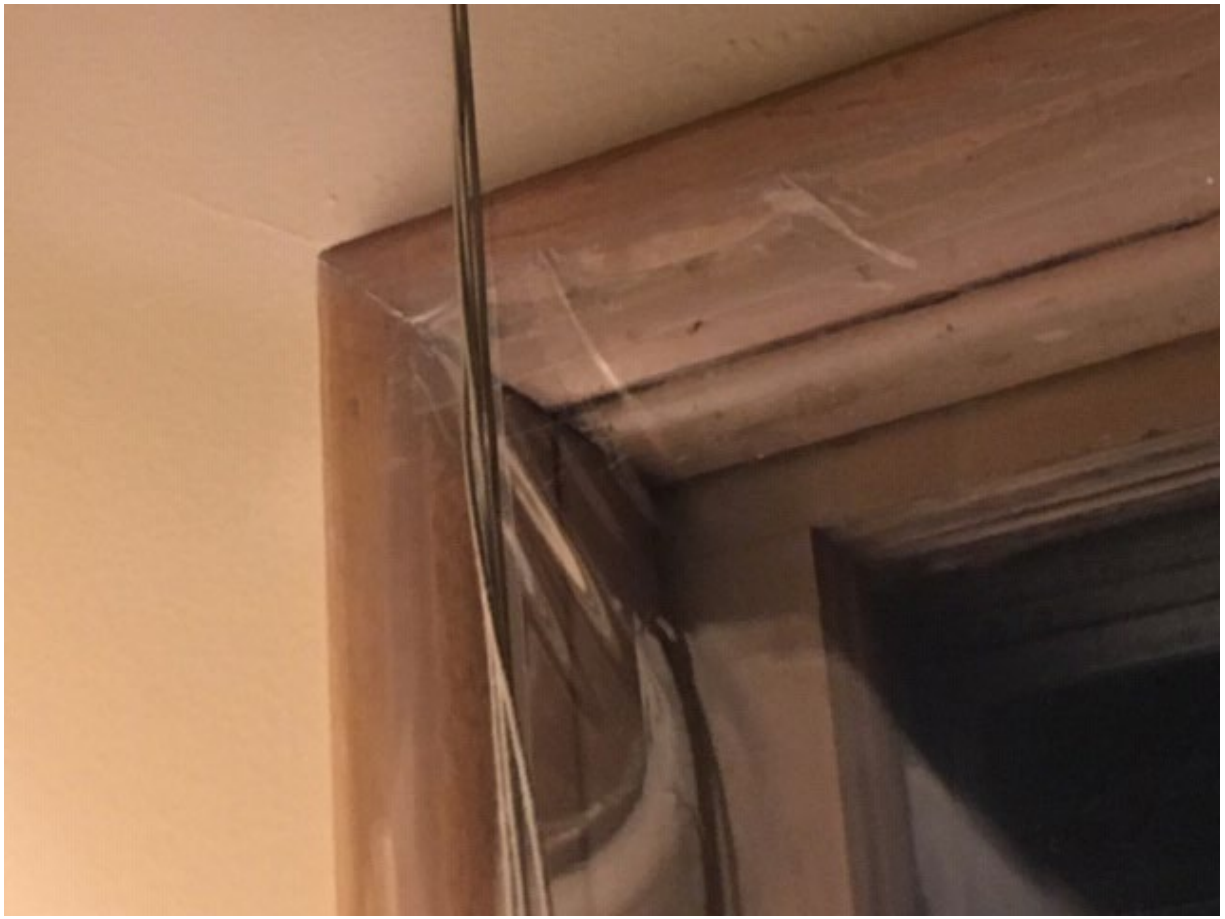
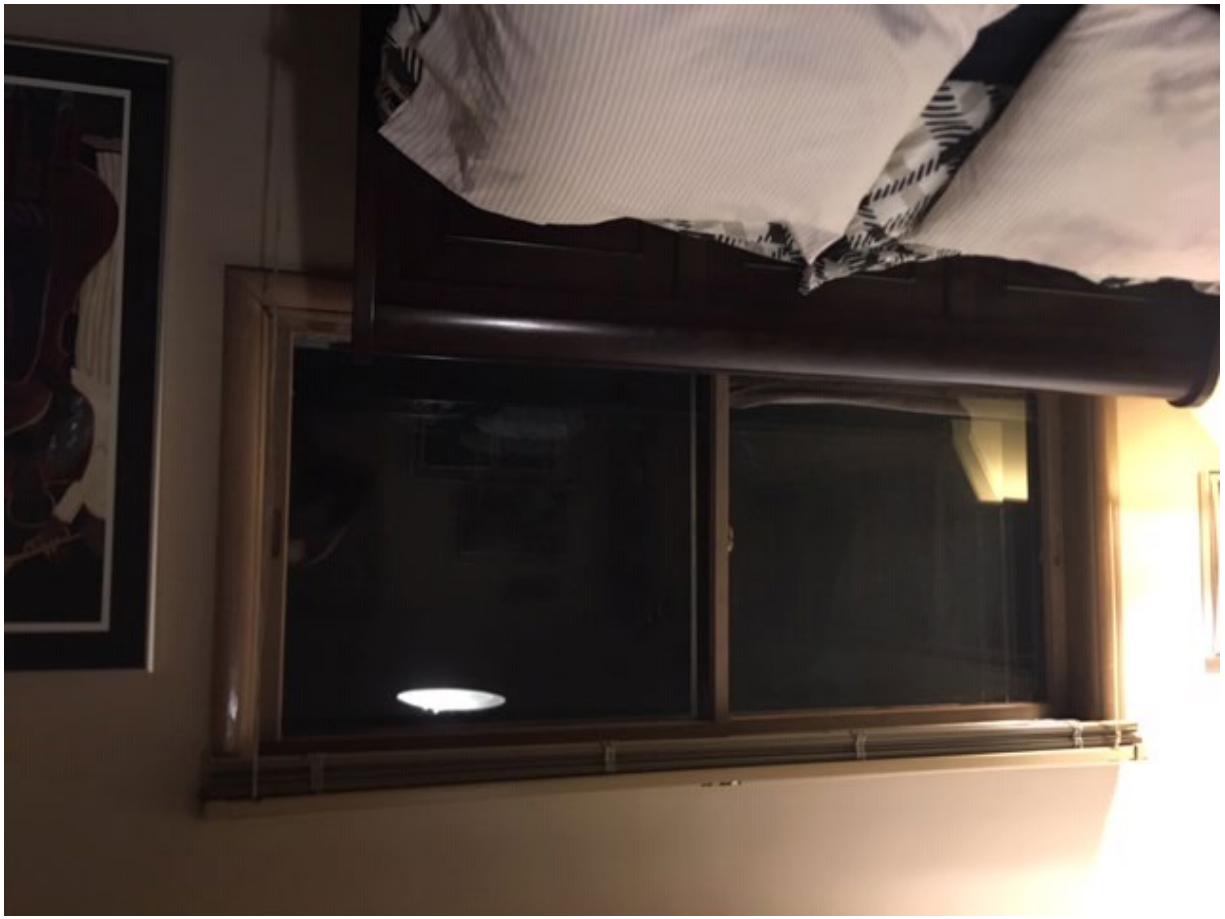
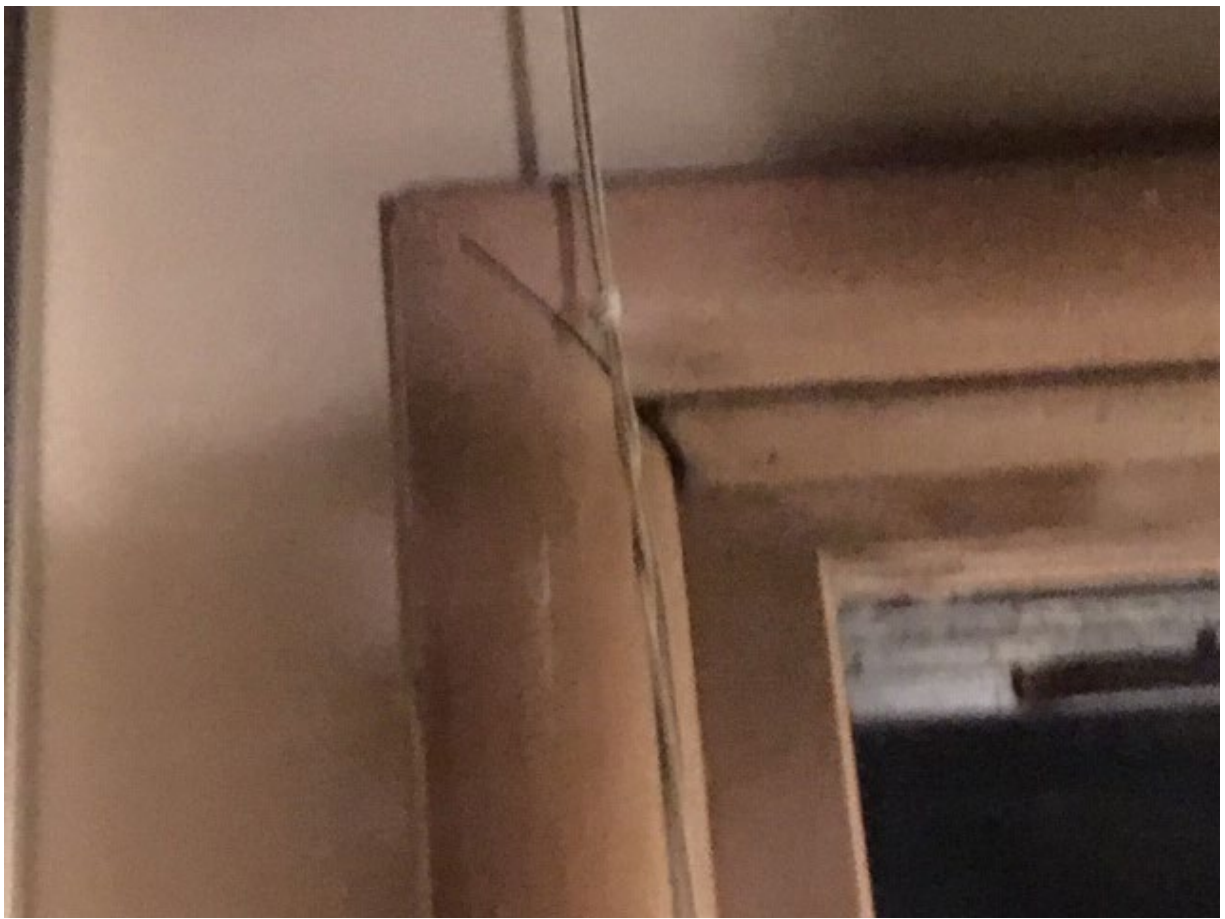
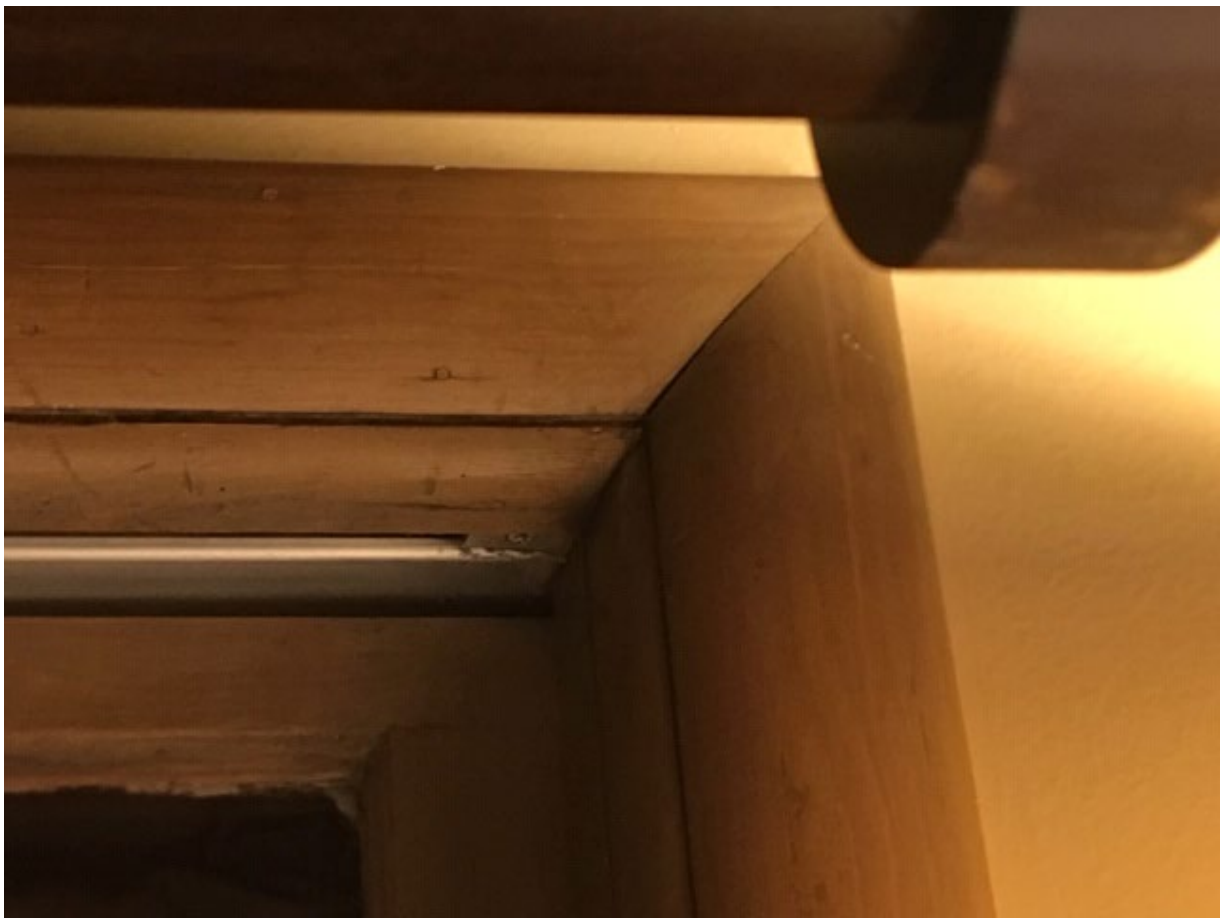
In looking at the photos sent it appears as though the window frames are out of square. Which is why air is getting around the sash, also separation at the interior corners of main frame indicates the frame is under pressure and twisting. This is most commonly caused by interior structure frame lowering (settlement) and exterior wall surface is not, house is trying to slide window down behind sill causing a "crowning" problem.

Unfortunately the cost of repairs would most likely exceed replacement cost and you would still have same old window framing.

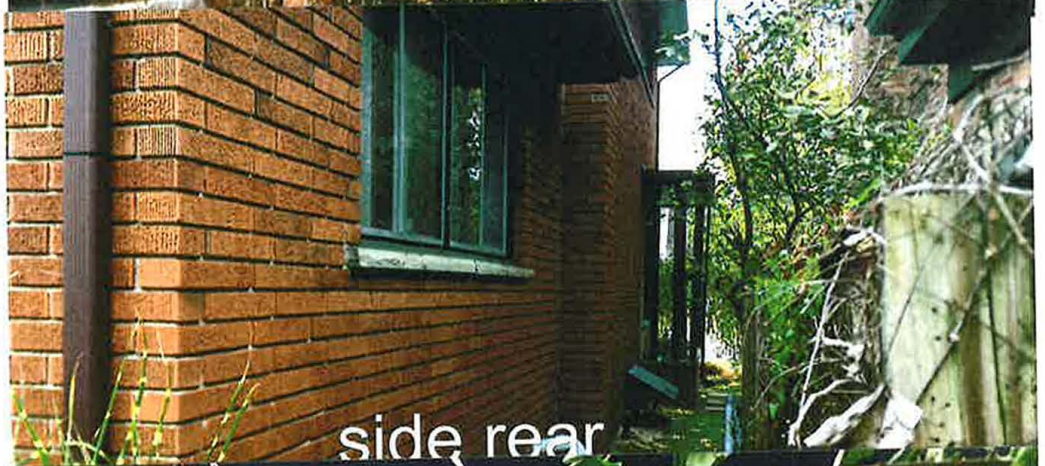
side rear

Side Window
To Be Replaced

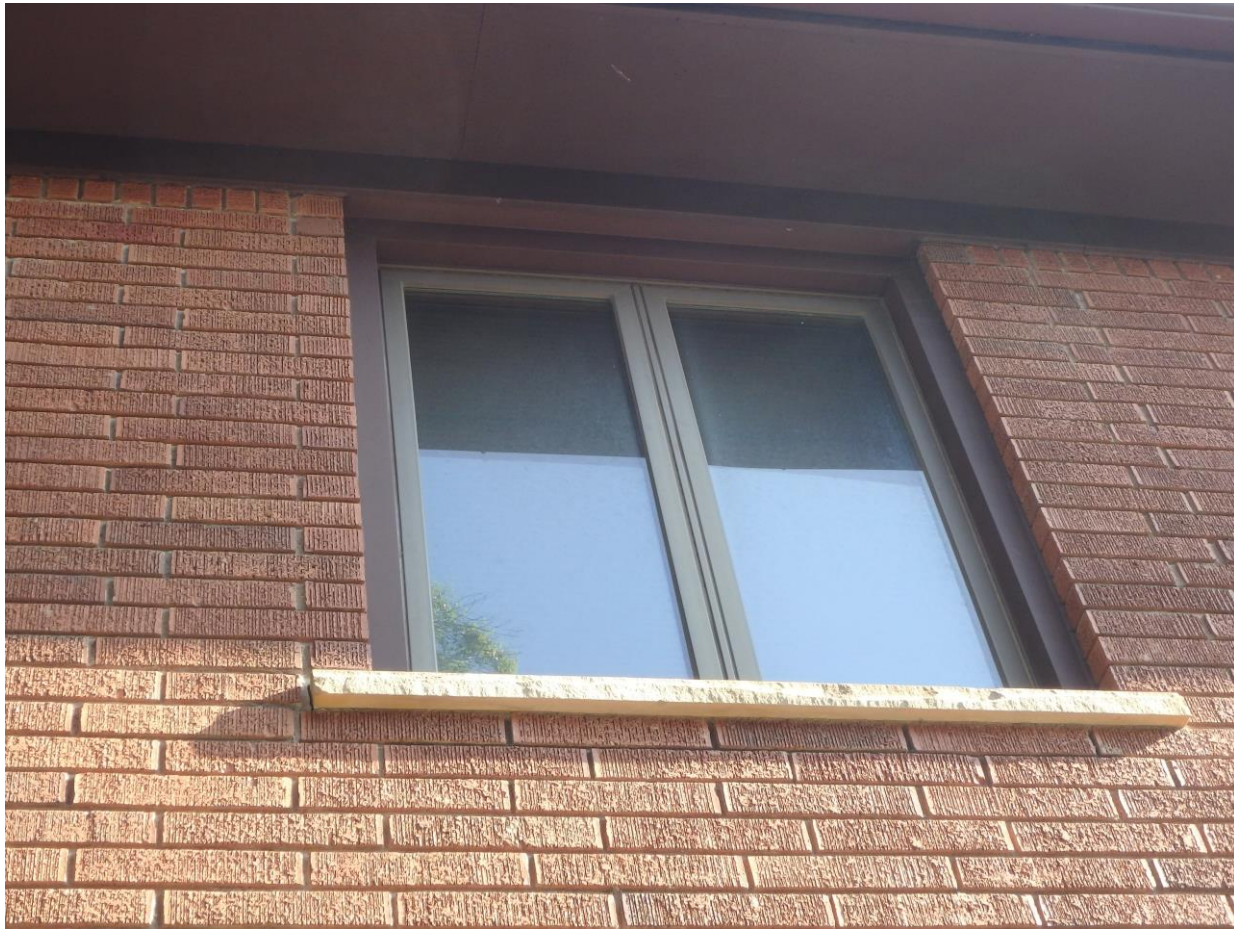
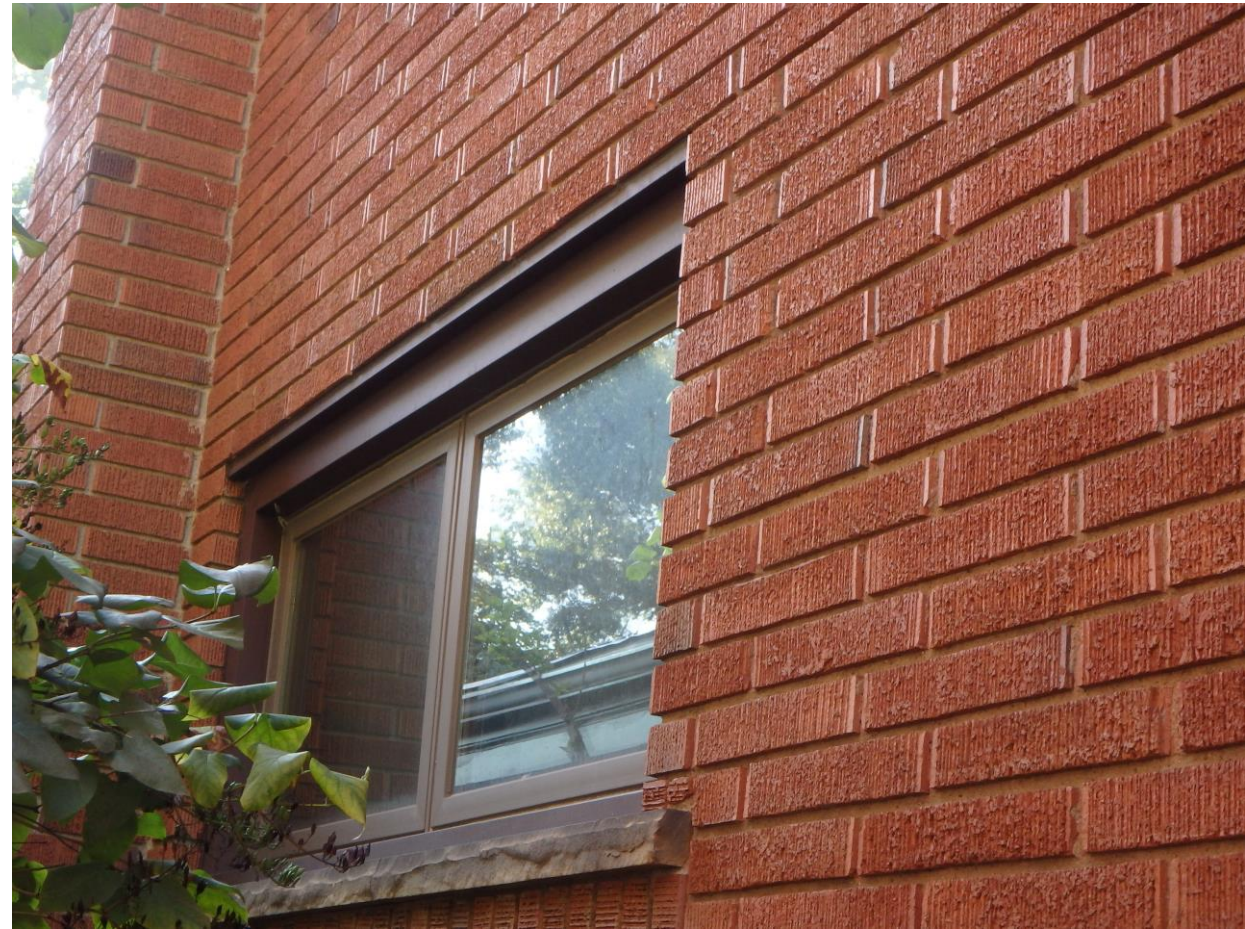
19650 Stratford Rd

2 insert windows replaced 20 years ago (each side of house)

Homeowner wants us to match the exterior look of what was done on these two window units.
