STAFF REPORT: APRIL 10, 2024 MEETING

APPLICATION NUMBER: HDC2024-00142

ADDRESS: 3627 LINCOLN

SCOPE: ERECT FRONT PORCH

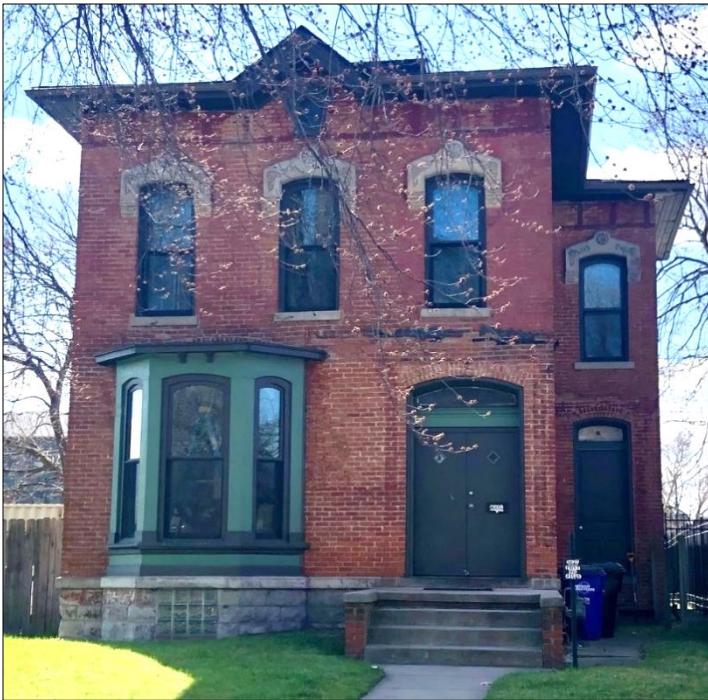
Staff photos, March 28, 2024.

The red brick walls are contrasted by stone sills, carved window hoods and the slightly above grade water table. An extension on the north wall of the house balances the slight extension and box bay at the south wall.

The front and side porches have been missing from the house since at least 2011, according to photos within the city’s property folder. The window openings have aluminum-clad wood double-hung windows and solid painted panels cover the bay window’s wall surface.

The existing front doors are solid non-historic panel units with small diamond-shaped glass openings, which have been in place since at least 2011. The side porch door is a wood paneled door with a large glass area above and is likely historic age.

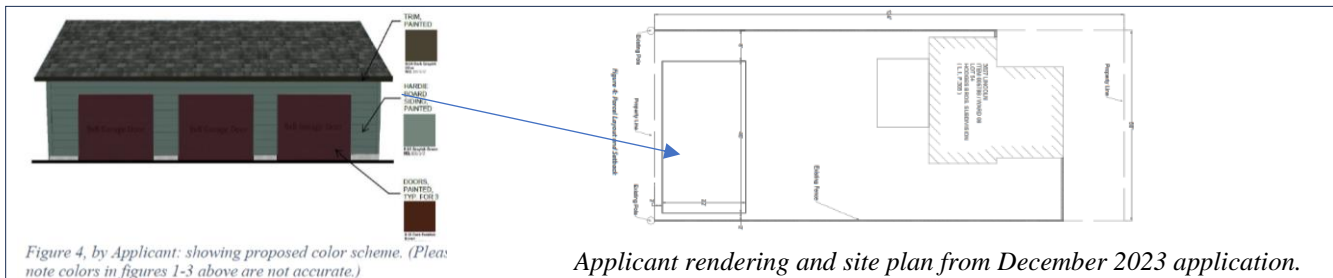
Figure 4, by Applicant: showing proposed color scheme. (Please note colors in figures 1-3 above are not accurate.)

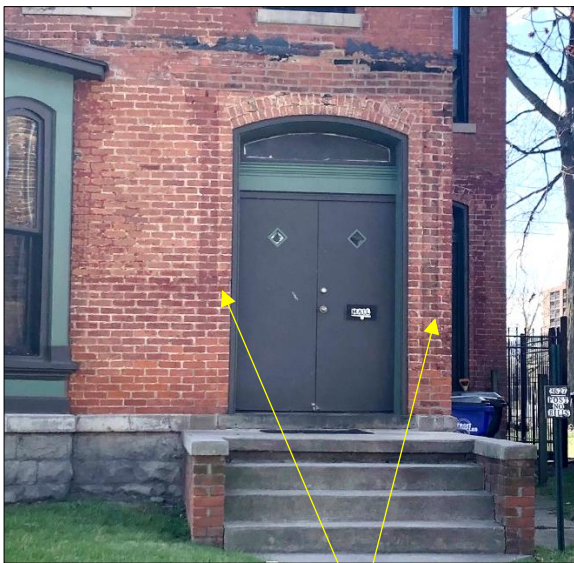
Existing conditions. Staff photo, March 28, 2023.

- The ghost images of the historic pilasters are visible against the brick, confirming the location of the original entry porch and width of its supporting components. The applicant's narrative states that the intact wood porch from a neighboring house (of similar age and architectural style) was used as a base point for the new design. It is staff's opinion the new porch offers a level of filigree appropriate to an Italianate house but doesn't recreate the opulent detailing on the 19th century porch, allowing this porch to read as new construction.

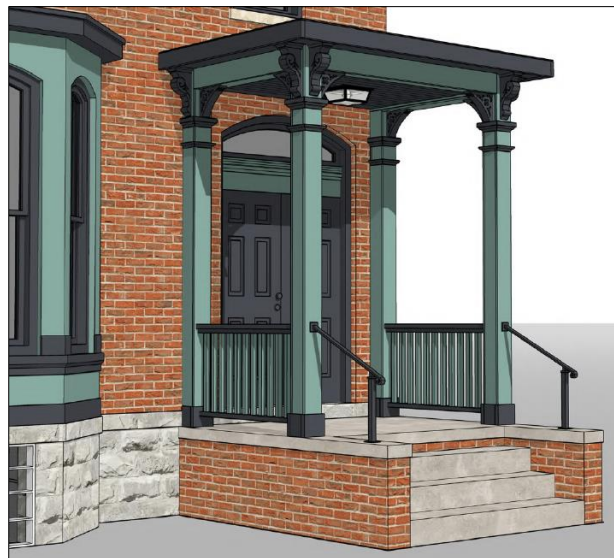
Applicant rendering.

- The porch and railings, based on their design, materiality, and finishes, are compatible with the historic appearance and character of the building. However, it is staff’s opinion that the selected door is not compatible with the primary façade due to its materiality, texture, and visual qualities:

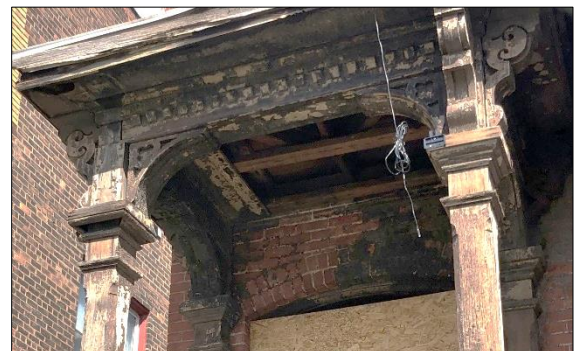
Intact 19th century porch at 3644 Lincoln. Nearby property referenced by applicant. Staff photo.

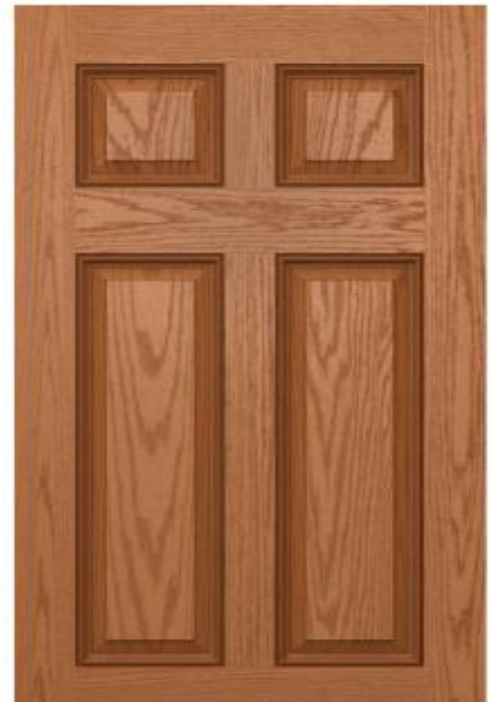
Partial view of exterior (stained?) surface of six panel door, copied from PlastPro website.

- The selected door is a fiberglass product that “mimics” the texture of wood grain. Based on the promotional material on the company’s website, this door is likely similar to vinyl siding products that offer a raised grain to “mimic” wood siding, overlooking the fact that real wood products don’t have highly visible, raised grain surfaces. A fiberglass door stain kit is sold as a finish color option.
